**From:** Dana <dgaya73@gmail.com>  
**Sent:** Monday, August 7, 2023 5:49 AM  
**To:** Jennifer Blackman; dennisgaya@comcast.net  
**Subject:** East Tank Touch up  
**Attachments:** DIS Report 2.0A2 8-5-2023 8-09-26 AM.pdf

Attached is Saturday's report for the exterior touch up of the East Reservoir.

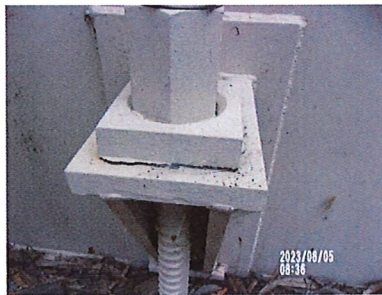
Showing gaps in the anchor chairs from the tank settling.

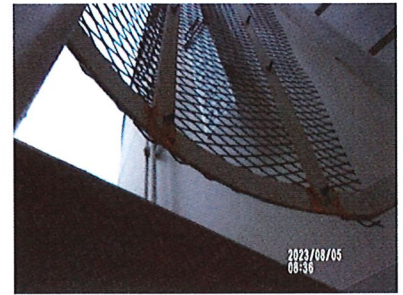
Isolated locations of the ladder cage to be touched up.

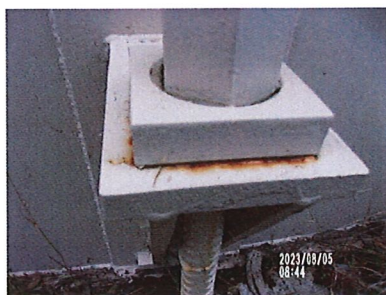
Rust leeching from the top of the anchor chair and bottom of the washer.

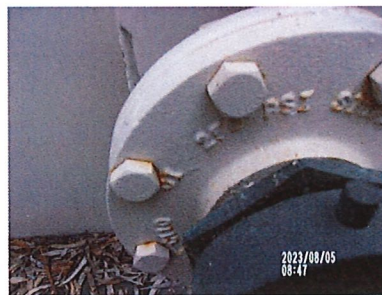
Bolts prior to prep and re-coating.

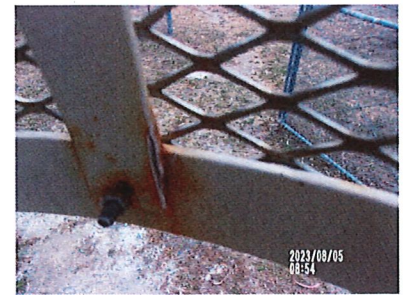
Example of ladder cage to be prepped caulked and re-coated.

It appears that the exterior ladder cage was shop prime coated and not abrasive blasted. During the surface preparation on the ladder cage, mil scale was apparent under the existing coating. The tight gaps and facing surfaces on the ladder cage were caulked with SikaFlex 1A to help stop the rust bleeding. A total of (4) small holidays were noticed at the top of the hand railing and exterior of the ladder cage. Unfortunately, they were noticed after the painter had coated the ladder rungs and cage surfaces and could not be re-coated today due to wet paint.

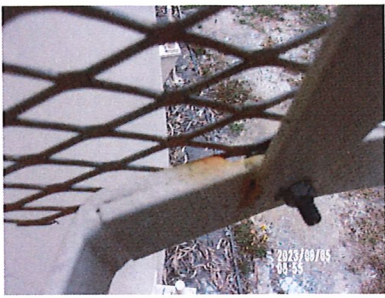
Ladder with rust bleed

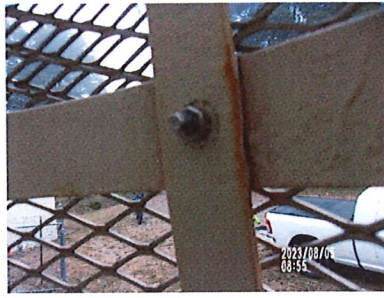
Rust bleed from inaccessible gaps.

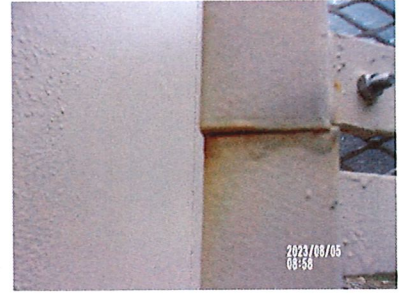
Ladder cage joint prior to sanding and caulking.

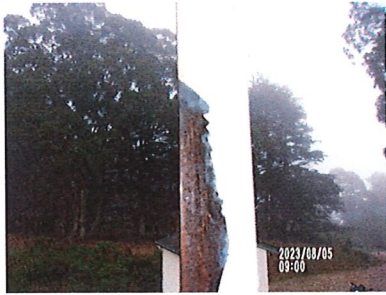
Showing what appears to be mil scale on the shop coated ladder cage.

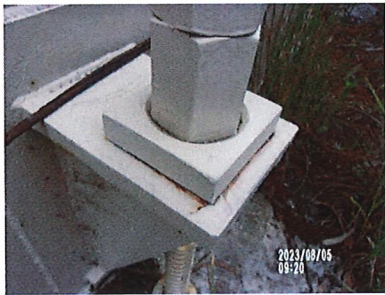
Anchor after sanding prior to prime coating.

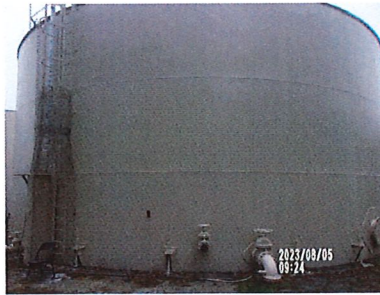
Showing the exterior shell after 3 years of service.

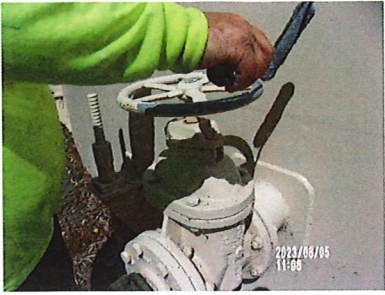
Touching up valve handles.

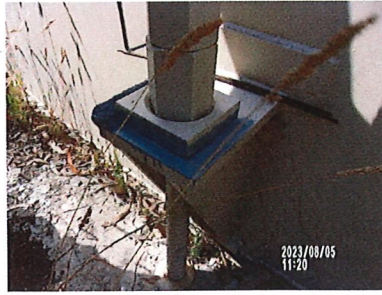
Anchor chairs with prime coat applied.

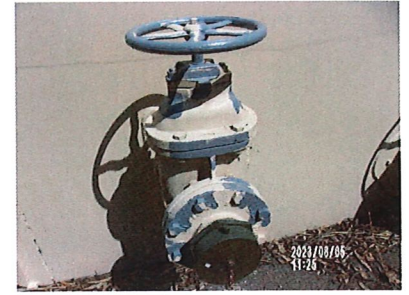
Valves with prime coat applied.

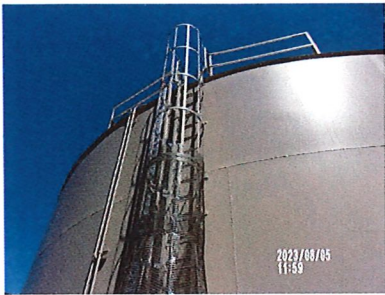
Showing the ladder cage with spot primer applied.

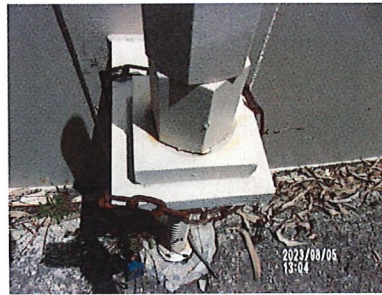
Showing rust stained from chains on the anchor chairs.

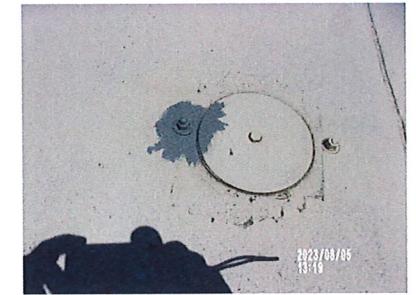
Spot prime coated C.P. Hand hole cover bolts.

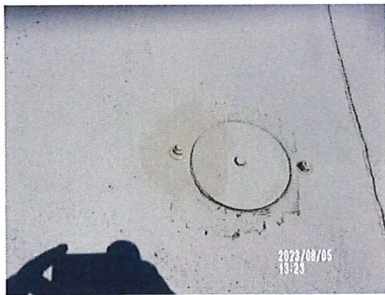
Touched C.P. Hole bolts.

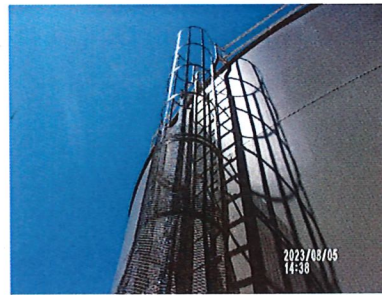
Ladder cage after spot repairs.

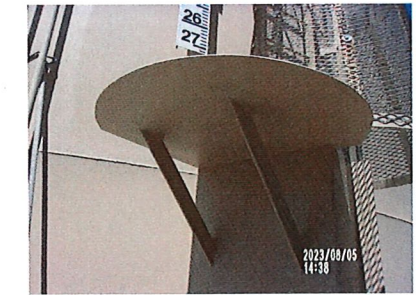
Ladder anti climb after touch up repairs.

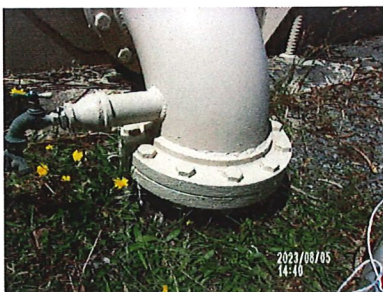
Bottom bolted flange after priming and finish coating.
