***Eucalyptus and Monterey Cypress Tree Failure Analysis and Risk Assessment***

**Bolinas Community Public Utility District**  
270 Elm Road  
Bolinas, CA. 94924

## 270 ELM ROAD RISK ASSESSMENT

### **290 MESA ROAD EUCALYPTUS WINDROW**

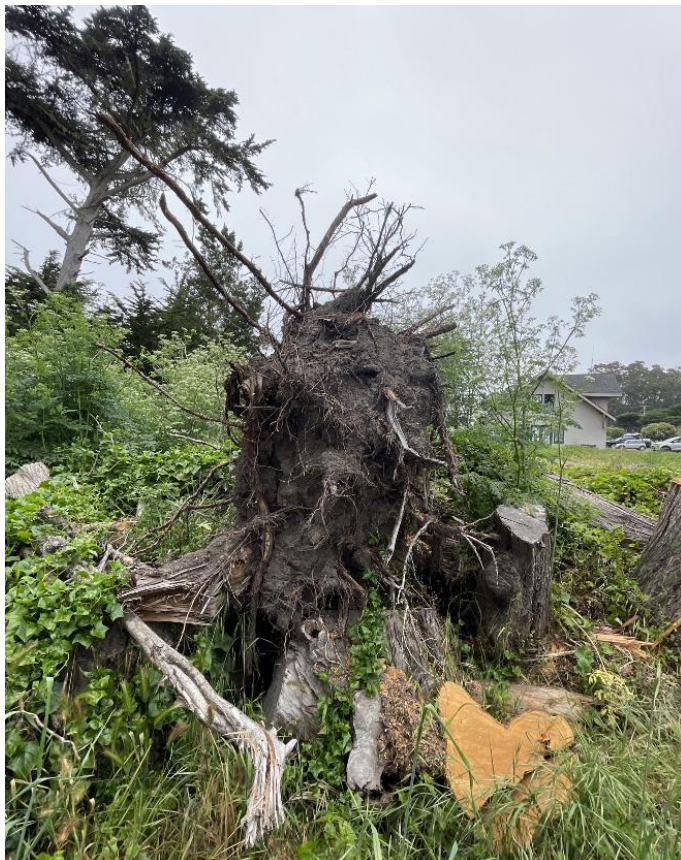
**Crowding = Deformed Root System**

The depletion down to just 17 trees remaining from the original planting of about 50 trees along these two roads attest to the common structural defects of the entire windrow.

Figure 1 – The crowded planting of the cypress border planting allowed little room for root growth.

**Recommendation:** Directional fell the entire windrow into the field. Remove and chip branches for fire prevention. If the border planting is replaced consult a consulting arborist about species selection and spacing.

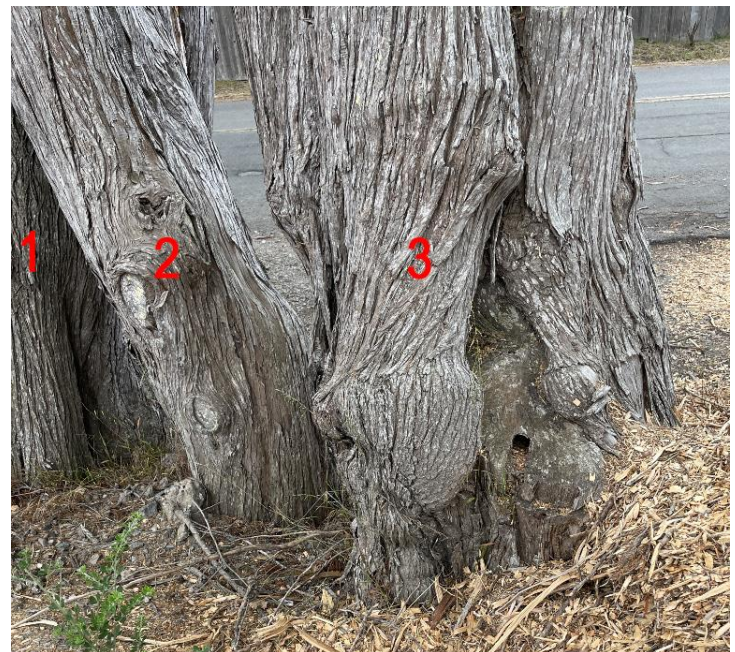
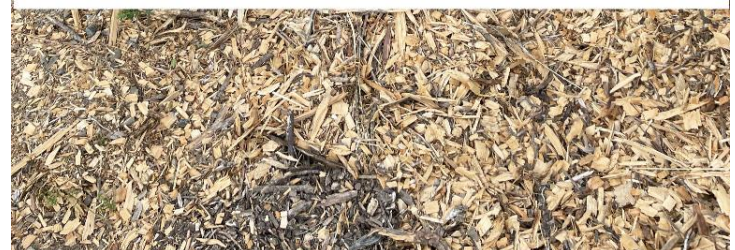
**Crowding Due To Dense Planting**

Figure 2 – The crowding of the trees has led to abnormal root and canopy development.

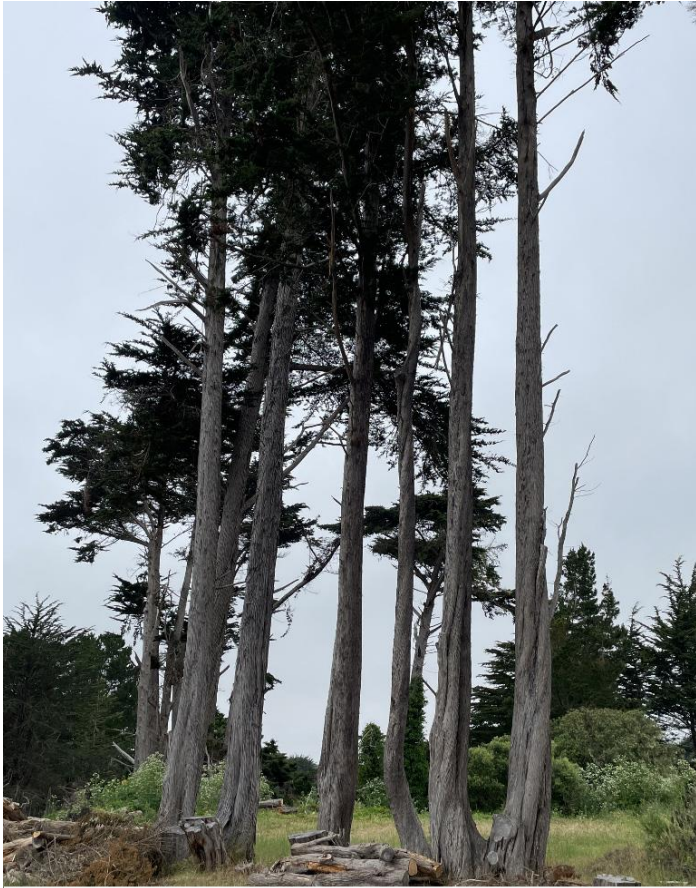
**Crowded planting = Lion's Tailing & Excessive Height**

Like many Monterey pine, Monterey cypress and blue gum wind rows or boundary plantings, these trees were planted too close to one another, causing them to interfere with each other's root systems as well as providing very limited growing space for canopy spread (See Figures 2, 3 & 4). Consequently, there has been severe competition for light and growing space resulting in excessive height growth and unbalanced canopies (See Figures 3 & 4). The canopies have been "lion's tailed" by competition and lower limb failures. This created tall lever arms exerting force on the inadequate root systems and resulted in long trunk and branch wave lengths under wind loads. The remaining trees are now at maximum height for the species, 85 feet. (See Figure 3)

Figure 3 - Competition for growing space has led to excessive height growth, lion's tailing and lever force on the compromised root systems.

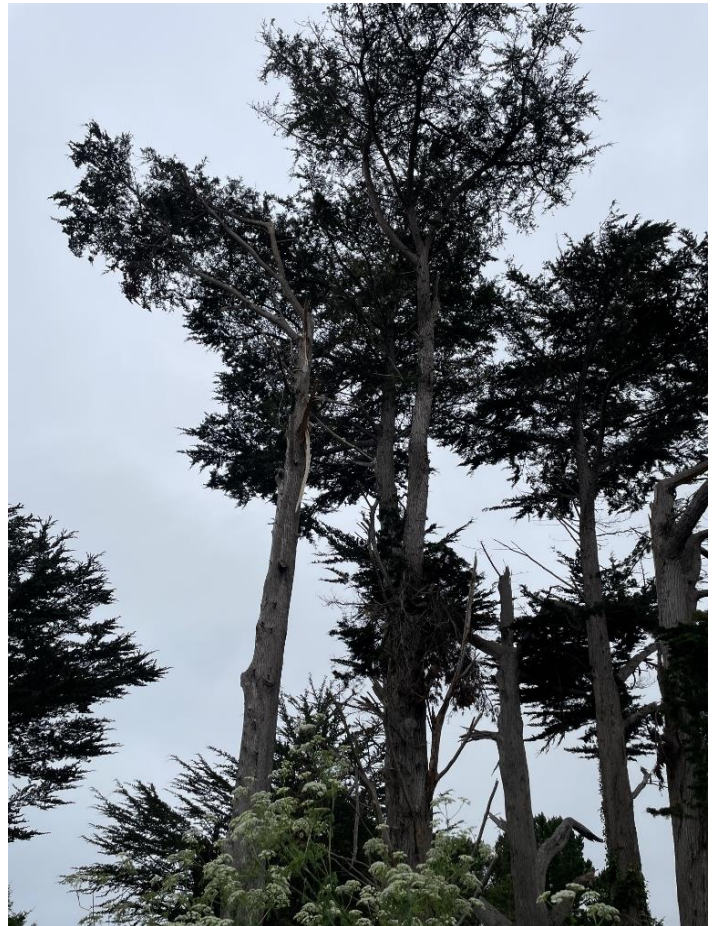
Figure 4 - Lack of adequate growing space has asymmetric canopies with over-extended limbs and in many cases lion's tailed branches.

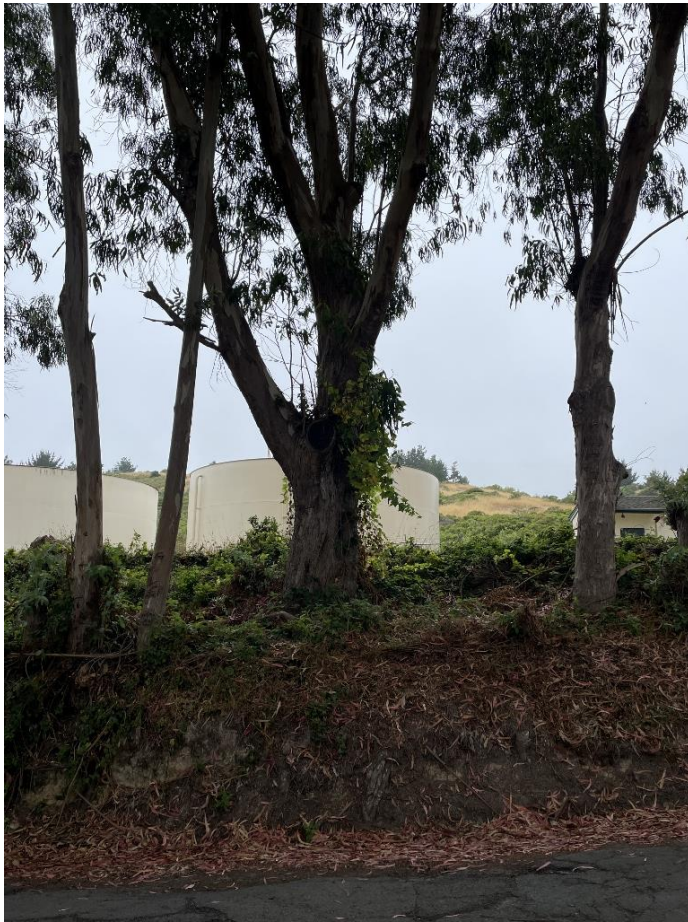
The Blue Gum Eucalyptus windrow along the 290 Mesa Road tank farm was planted too densely. The high density caused some trees to be dominant over less vigorous trees that became suppressed. (See Figure 5) Crowding also caused inadequate canopy growing space, which deformed the canopies and individual branches. (See Figure 6) The east-west orientation of the windrow and a second windrow across the road also contribute to the poor form and vigor of the trees.

Figure 5– Suppressed trees left, dominant tree center, deformed tree right.

The health and stability of the windrow can be improved by removing subordinate/suppressed trees and safety pruning the trees recommended for retention.

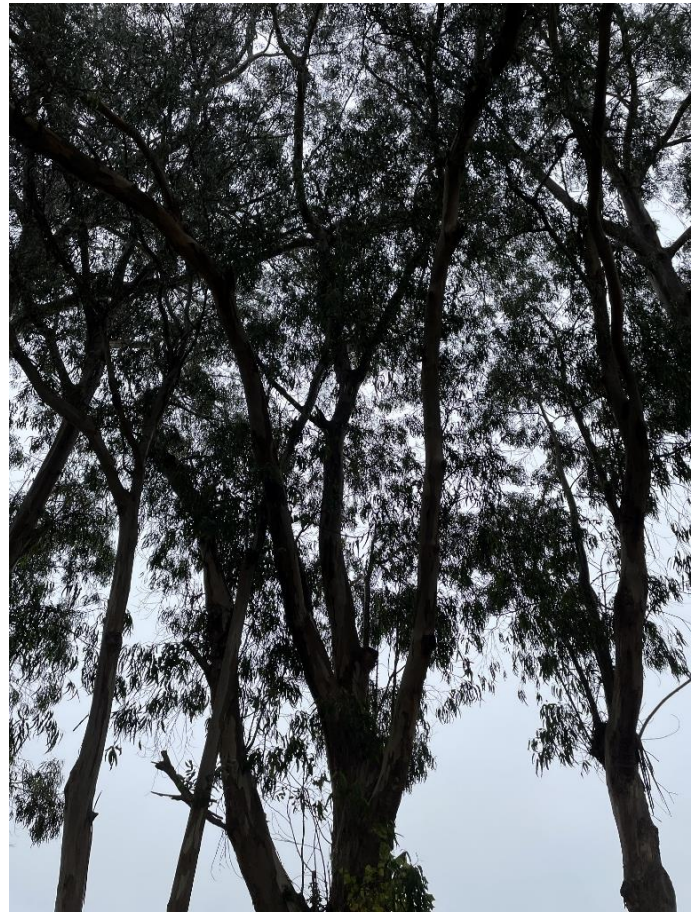
Figure 6- Crowding resulted in crossing branches and asymmetric canopies.

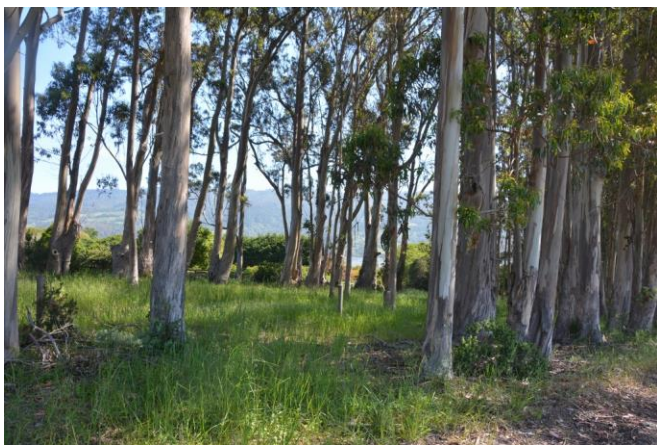
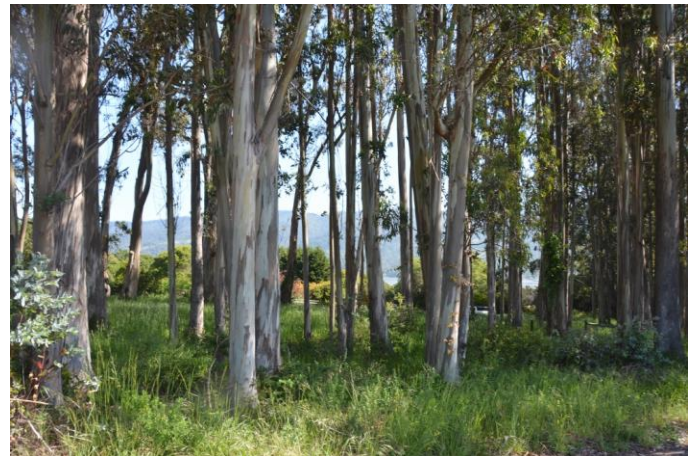
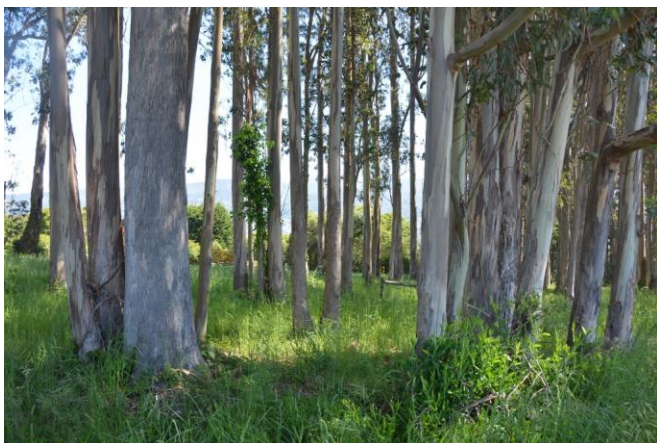
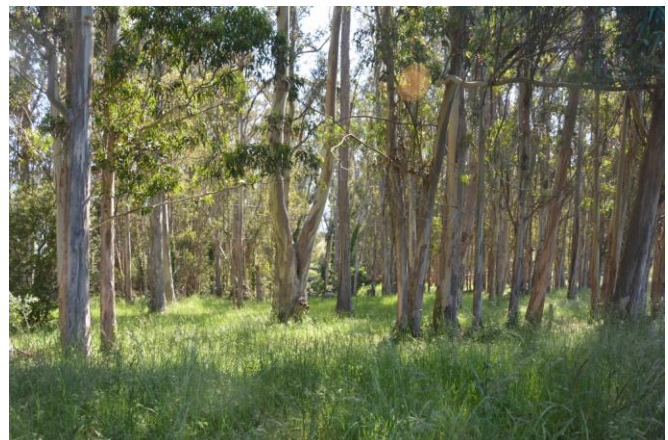
Figure 9 - Grove Fuels in May, 2023 – Comparing grove fuels to Wright and Vihnanek Fuel load photo series.

► **Regarding the potential for severe wildfire behavior Mr. Julin acknowledges that high fire hazards are due to “leaves, bark and branches that collect in the understory.” UFA recommends ongoing understory clearing.**

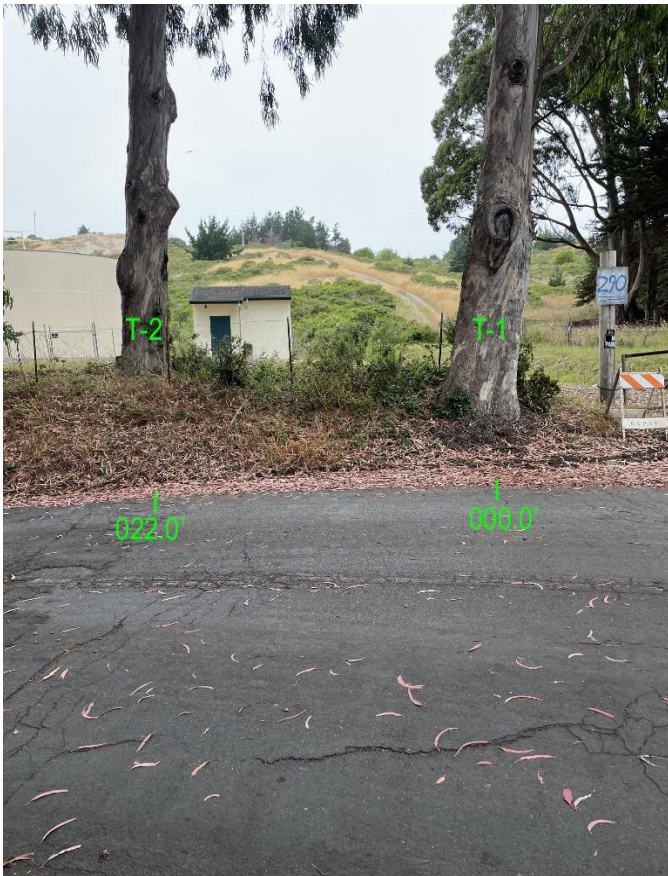
Transect: 000.0' T-1 is the east most tree in the windrow, closest to the gate to the tank area.  
 Condition: T-1 is a dominant tree. It has two over-extended limbs to the south (S) & southeast (SE)  
 Recommendation: Shorten these tow limb with reduction cuts. See APPENDIX A Photos 1 & 2

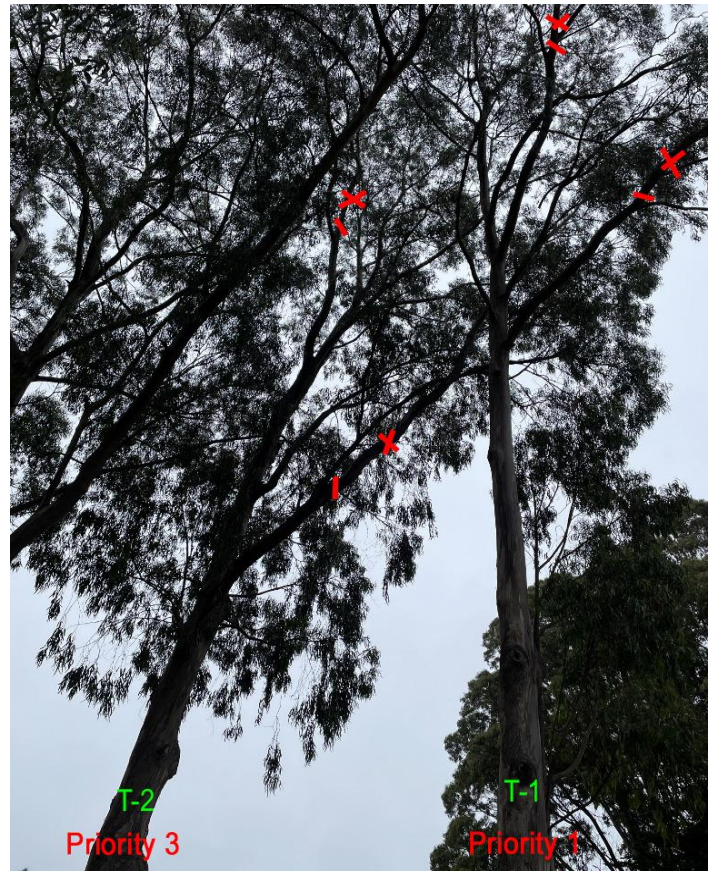
Transect: 022.0' T-2 is less crowded than many of the trees in the windrow, but the canopy is overtopped  
 Condition: T-2 is in the intermediate crown class. Crowded canopy. Two over-extended branches.  
 Recommendation: Shorten two over extended limbs with reduction cuts. See APPENDIX A Photo 2

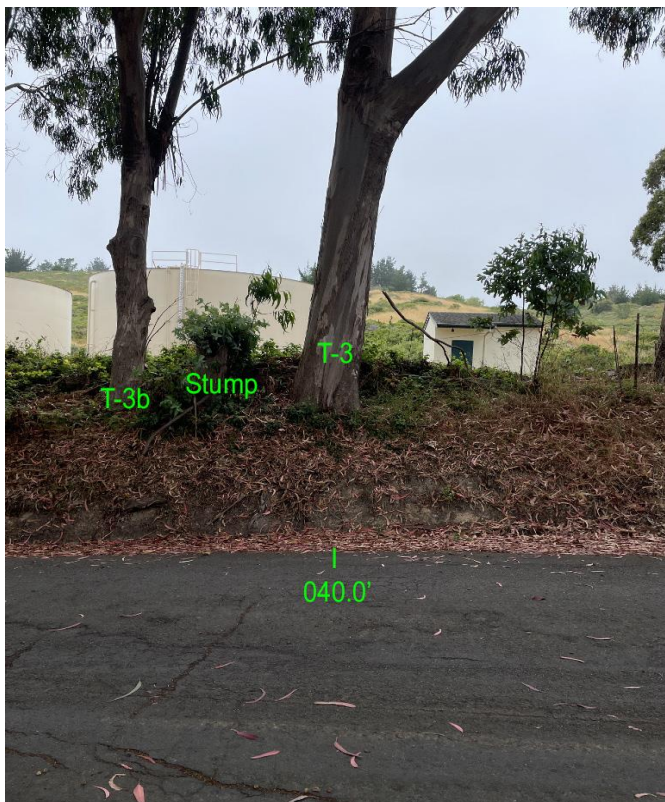
Transect: 048.5' T-3b is severely crowded by T-3 & T-4. See APPENDIX A Photo 3  
 Condition: T-3b is suppressed and malformed. It has two leaders with a weak acute angle crotch  
 Recommendation: The subordinate leader could be removed or it could be removed, benefiting T-3 & T-4

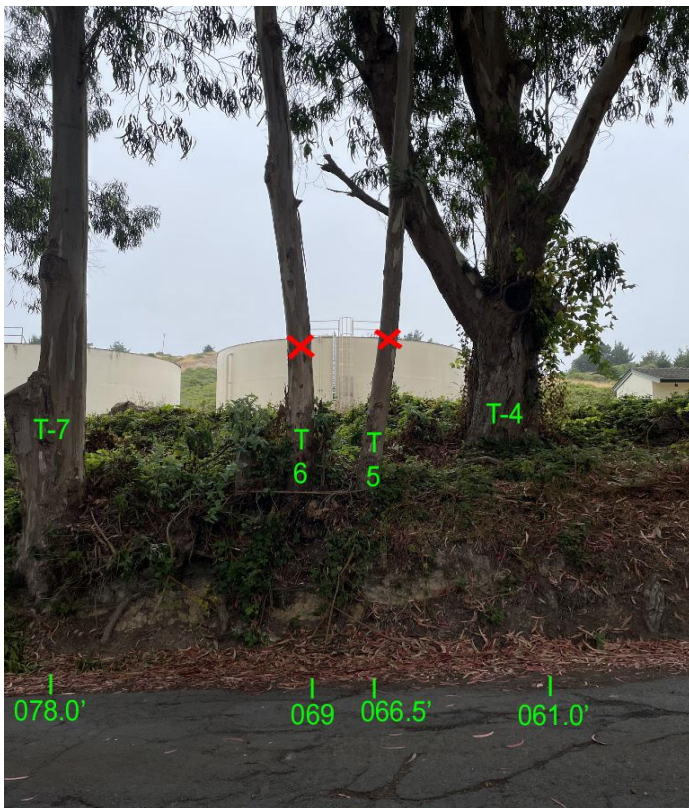
Transect: 061.0' T-4 is a dominant tree that suppresses T-3b, T-5 and T-6. APPENDIX A, Photo 5  
 Condition: T-4 has an asymmetric canopy to the south and has 3 over extended limbs to the S.  
 Recommendation: Reduce the asymmetry with reduction cuts on the three over-extended limbs. Photo 6.

Transect: 066.5' T-5 is severely suppressed by T-4. See APPENDIX A, Photo 5  
 Condition: T-5 is suppressed and over-extended with poor taper. Photo 6  
 Recommendation: Remove and well cover stump with black plastic topped by black geotextile to kill..

Transect: 069.0' T-6 is severely suppressed by T-4. See APPENDIX A, Photo 5  
 Condition: T-6 is suppressed and over-extended with poor taper. Photo 6  
 Recommendation: Remove and well cover stump with black plastic topped by black geotextile to kill..

Transect: 078.0' T-7 has a Dominant Canopy height over T-5 & T-6. See APPENDIX A, Photo 5  
 Condition: T-7 has a relatively small canopy behind T-8  
 Recommendation: No Action necessary.

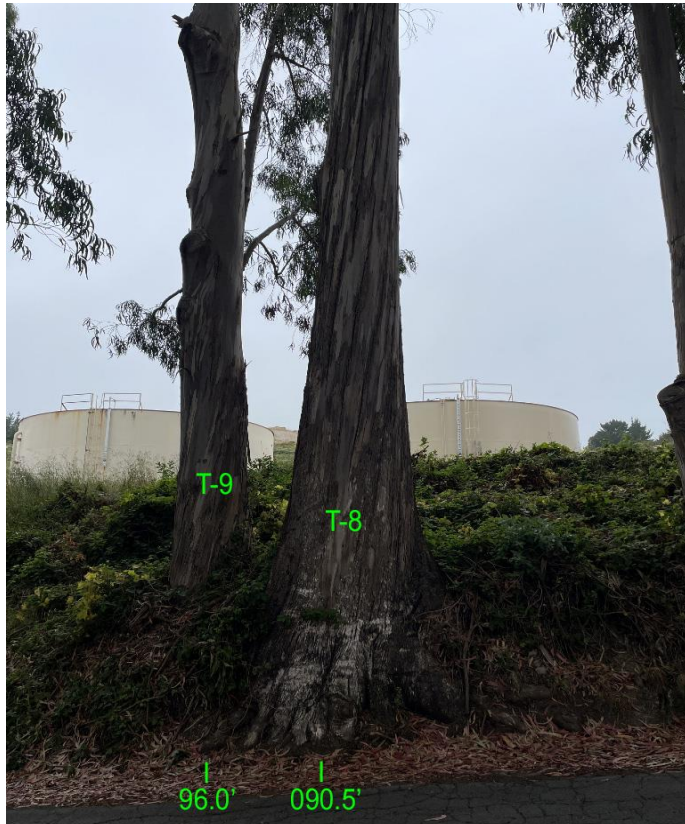
Transect: 090.5' T-8 is a dominant tree. It forces T-9 to the north and the T-9 canopy to the west. Photo 7  
 Condition: T-8 is rooted at the base of the cut bank and has cracked the pavement. Its canopy is asymmetric to the south over the road. It has 4 over-extended limbs over the road.  
 Recommendation: Remove one limb with poor taper and reduce three as shown in Photo 8.

Transect: 096.0' T-9 is rooted close to and somewhat behind T-8. APPENDIX A, Photo 7.  
 Condition: T-9 has been extensively pruned in the past. Its canopy is asymmetric to the west.  
 Recommendation: Reduce one SW extending limb See Photo 8.

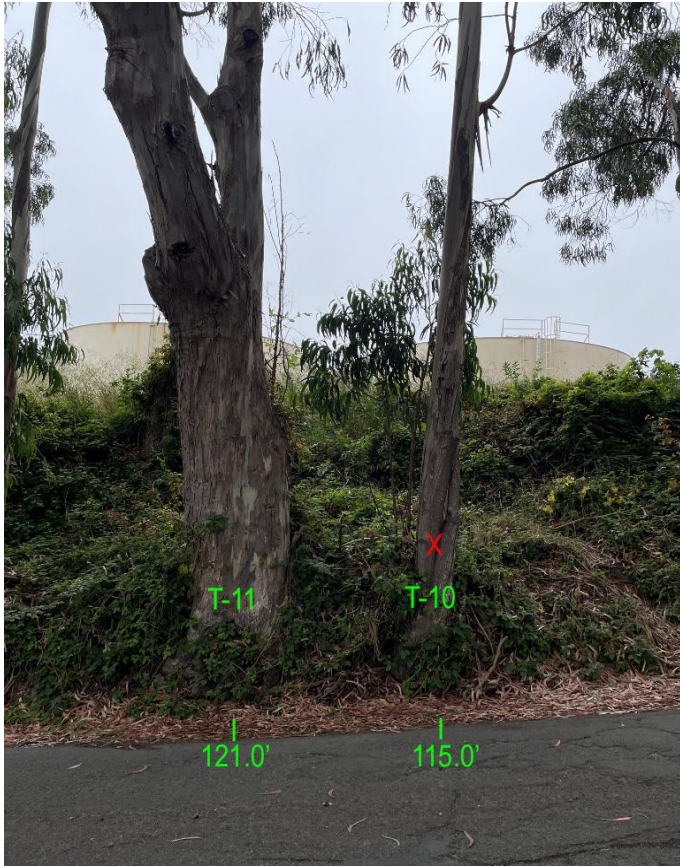
Transect: 115.0' T-10 is rooted within a few feet of T-11 and is in the suppressed crown class. Photo 9.  
 Condition: It is subordinated/suppressed by T-11 and has a small canopy to the north of T-10.  
 Recommendation: Remove and well cover stump with black plastic topped by black geotextile to kill.

Transect: 121.0' T-11 is in the dominant crown class.  
 Condition: T-11 has four over-extended limbs with poor taper. See APPENDIX A, Photo 9  
 Recommendation: Remove one over-extending limb to the south and reduce one limb. Photo 10

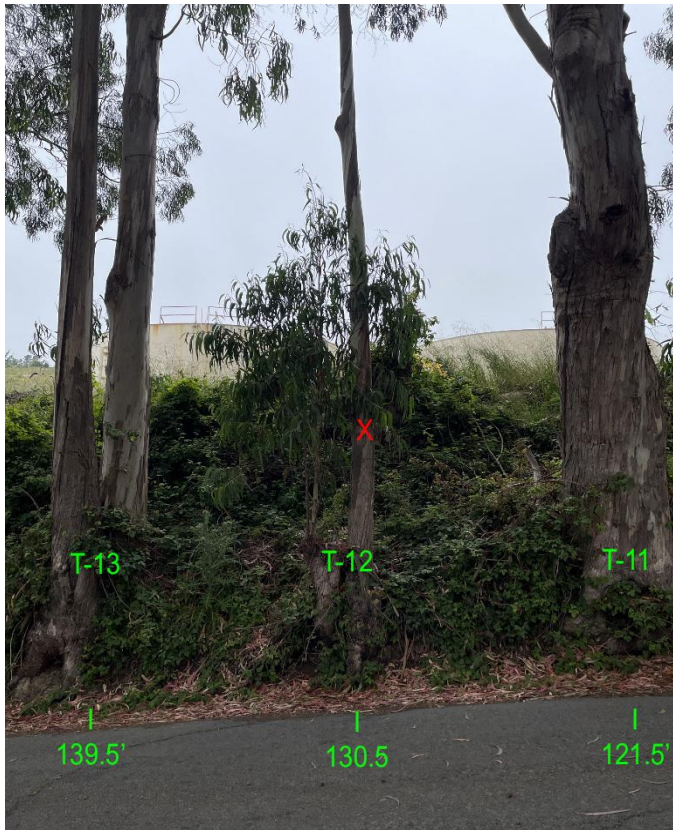
Transect: 130.5' T-12 is highly suppressed between T-11 and T-13 See APPENDIX A, Photo 11  
 Condition: T-12 is a highly suppressed stump sprout (second growth) Photo 11.  
 Recommendation: Remove and well cover stump with black plastic topped by black geotextile to kill.

Transect: 139.5' T-13 is a codominant two stem tree. See APPENDIX A, Photo 11  
 Condition: It has one south over-extended branch with poor taper. See Photo 12  
 Recommendation: Reduce over-extended branch. Photo 12

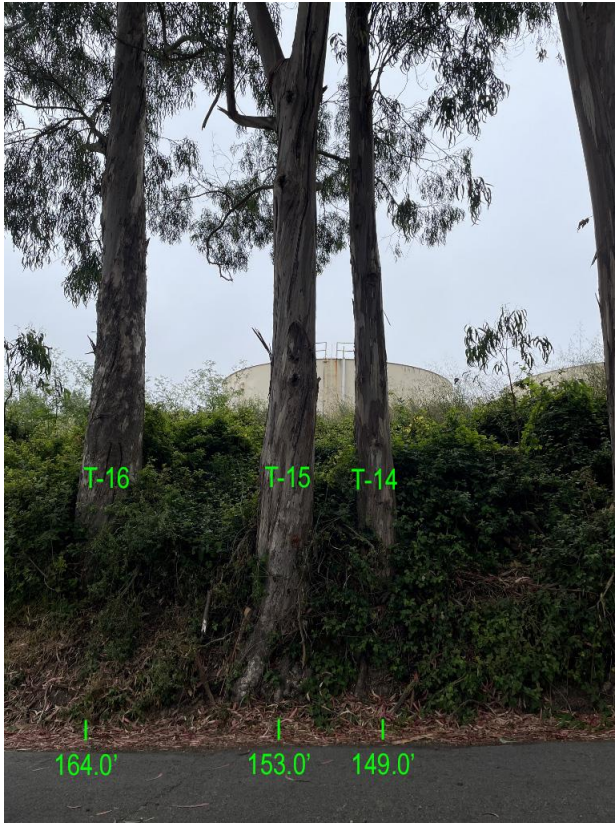
Transect: 149.0' T-14 is rooted close to T-15 and slightly up slope. See APPENDIX A, Photo 13  
 Condition: It is forced to the north by the more dominant Trees 13, 15 & 16. See Photo 14.

Transect: 153.0' T-15 is rooted down the cut bank. See APPENDIX A, Photo 13  
 Condition: It has one SW over-extending limb. See Photo 14.  
 Recommendation: Reduce the over-extended limb as shown in Photo 14.

Transect: 164.0' T-16 is upslope and NW of the base of T-15 See APPENDIX A, Photo 13  
 Condition: It has one over-extended limb to the south.  
 Recommendation: Remove over-extended limb as shown in Photo 14.

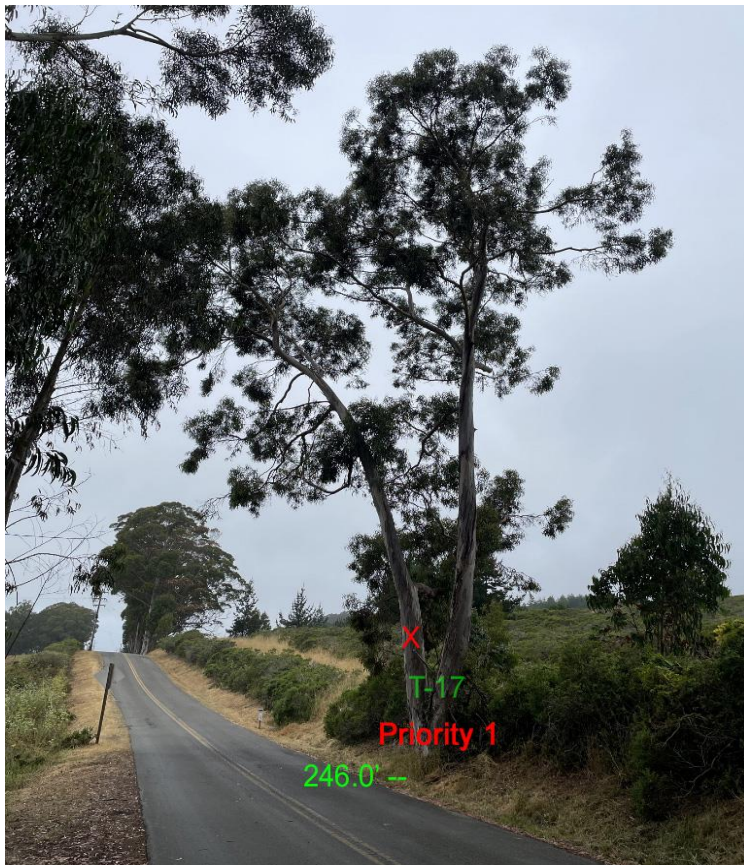
Transect: 246.0' T-17 stands alone 80 west of T-16 See APPENDIX A, Photo 15  
 Condition: T-17 has two trunks, one of which is heavily bowed to the SW. See Photo 15.  
 Recommendation: Remove SW bowed trunk.
