TECHNICAL MEMORANDUM (DRAFT)

Re: **Coastal Bluff Evaluation and Alternatives Analysis – Update
Surfer’s Overlook on Terrace Avenue
Bolinas, California
Gannett Fleming Project No. 075063**

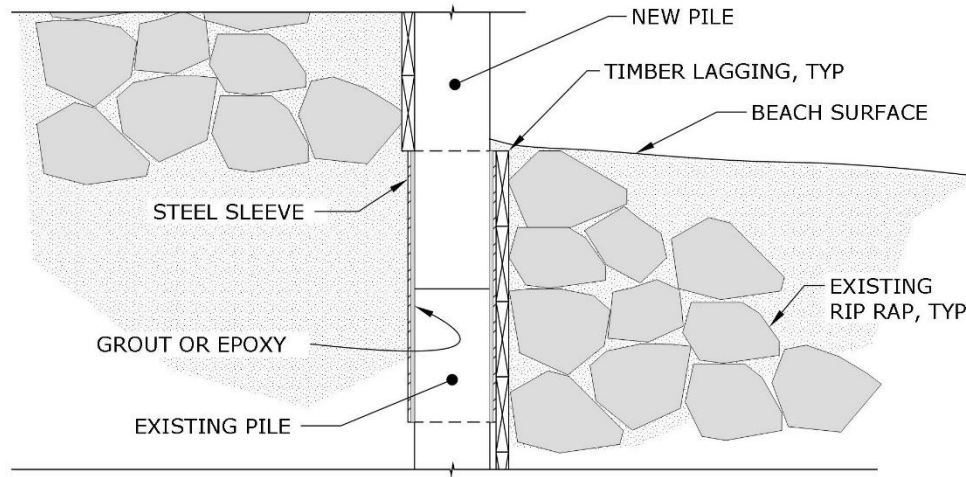
Figure 1: Conceptual detail depicting a below-grade splice of a sea wall pile.

As an alternative to full replacement, it is our opinion that more economical in-kind repair may be possible. If the pile deterioration has not progressed too far below grade, we feel that it may be feasible to splice new pile sections atop the embedded portions of the piles using a steel (or similar) “sleeve,” filled with grout or epoxy, to join the two sections (see Figure 1). With this approach, we anticipate that the lagging would be stabilized by hand-placed rakers (i.e., “kickers”) braced in front of the wall while the deteriorated pile top was removed and replaced with a new pile section, and could be removed once the splice was cured/secured.

In order to investigate the feasibility of this approach, the depth to sound wood in candidate piles would need to be determined by exhuming the upper embedment of candidate piles and inspecting each pile, possibly by driving a small probe into the pile or collecting a small core of wood. These inspections could be performed largely with hand tools, although a mini excavator might be necessary to remove some rip rap blocks from the face of the pile. If sound wood were found below existing grade that was reasonably accessible without extensive excavation, stockpiling, etc., we feel that this method of repair could be considered for rehabilitation of the wall.

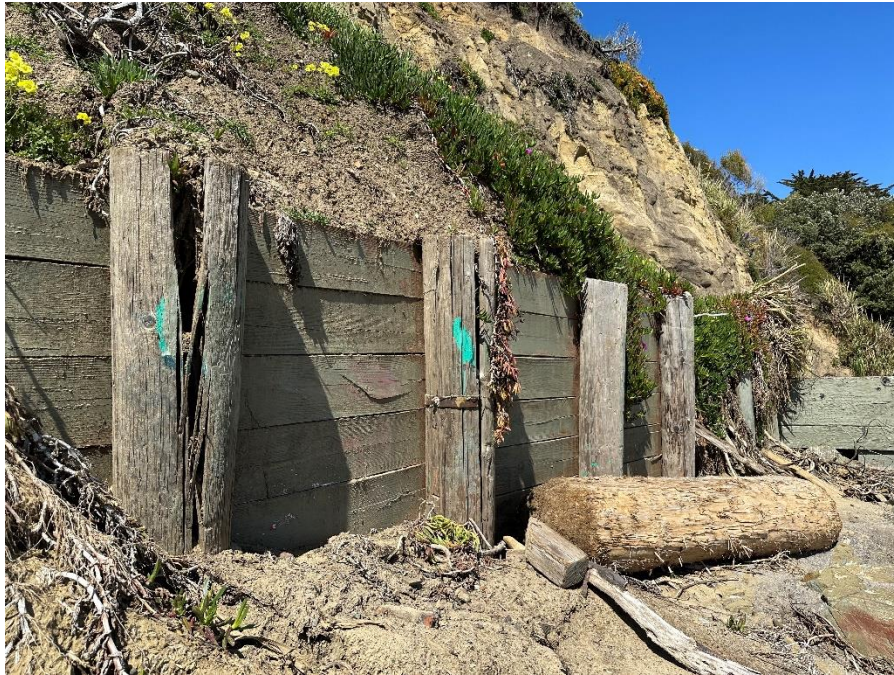
The sea wall conditions observed in 2023 represent a significant deterioration relative to our observations in 2010, with multiple piles exhibiting severe splitting and out-of-plumb orientations (see Photos 1-3).

Similarly, a significant number of the lagging boards behind the piles exhibit severe bowing or are completely ruptured (see Photos 4 & 5). Little is visible in the way of fasteners/hardware on the wall, except that in a few locations, steel bands appear to have been placed around some piles, in what is assumed to have been an attempt to resist splitting of the piles; however, in these cases the bands appear to have failed.

Photo 1: Severely split/failing sea wall piles. Note broken steel band at mid-height.
Photo: IMG_3296.jpg Date: 4/13/23

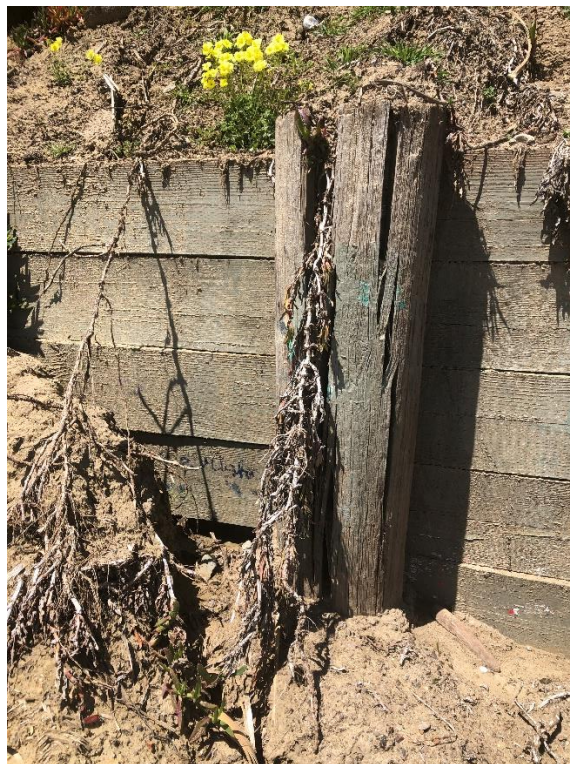
Photo 2: Debris and vegetation accumulation within void of split pile. Note missing bottom lagging at lower left. Photo: IMG_3297.jpg Date: 4/13/23

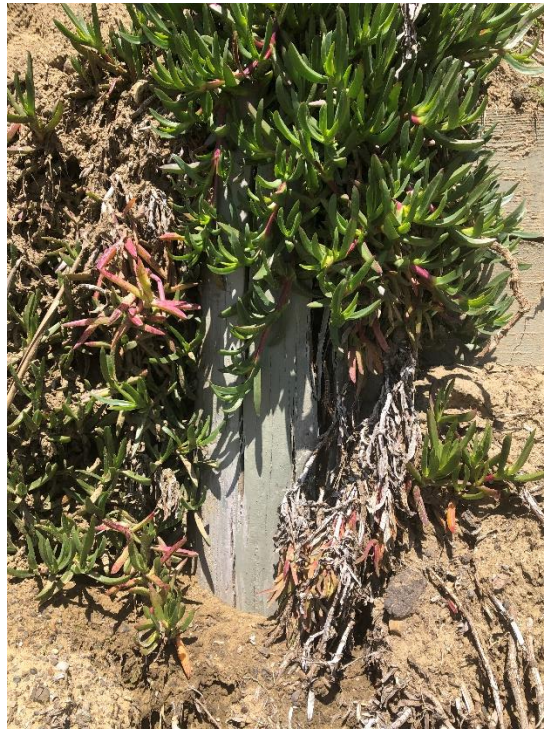
Photo 3: Vegetation growing from within void of split pile. Note sloughed slope debris around pile.
Photo: IMG_3298.jpg Date: 4/13/23

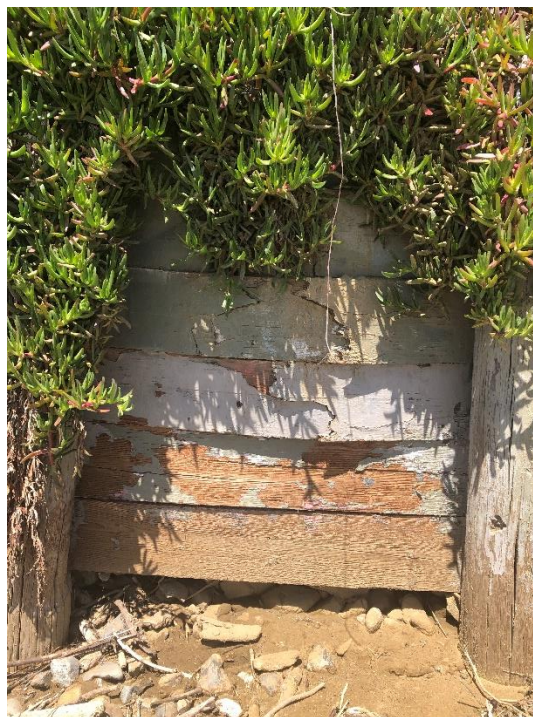
Photo 4: Severely bowing/failing timber lagging. Photo: IMG_3309.jpg Date: 4/13/23

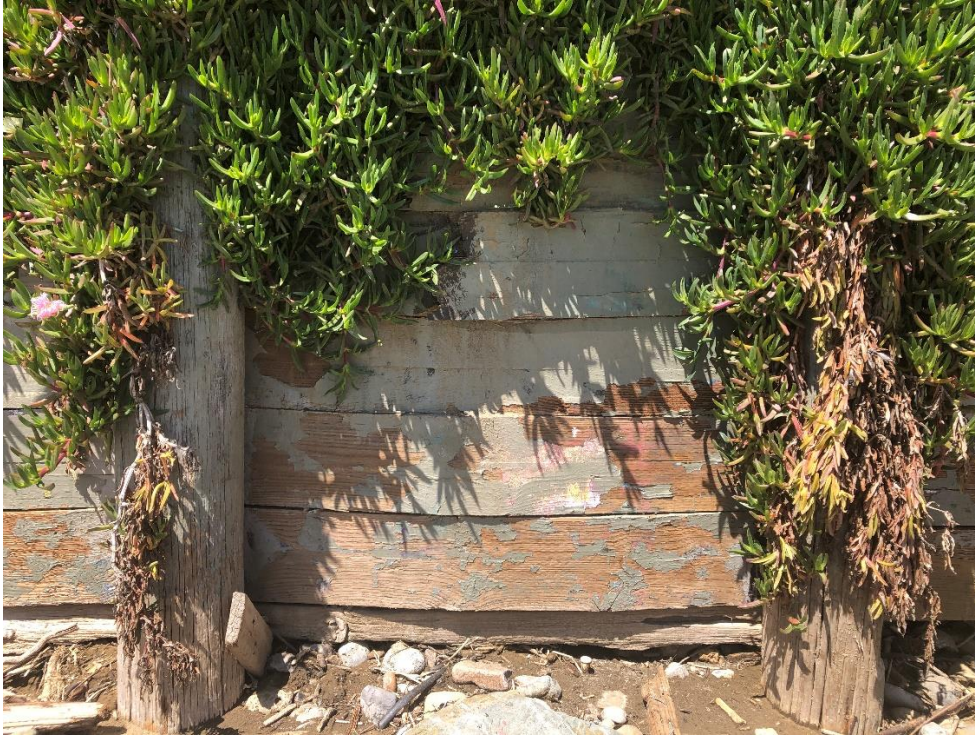
Photo 5: Severely bowing/failing timber lagging. Photo: IMG_3310.jpg Date: 4/13/23

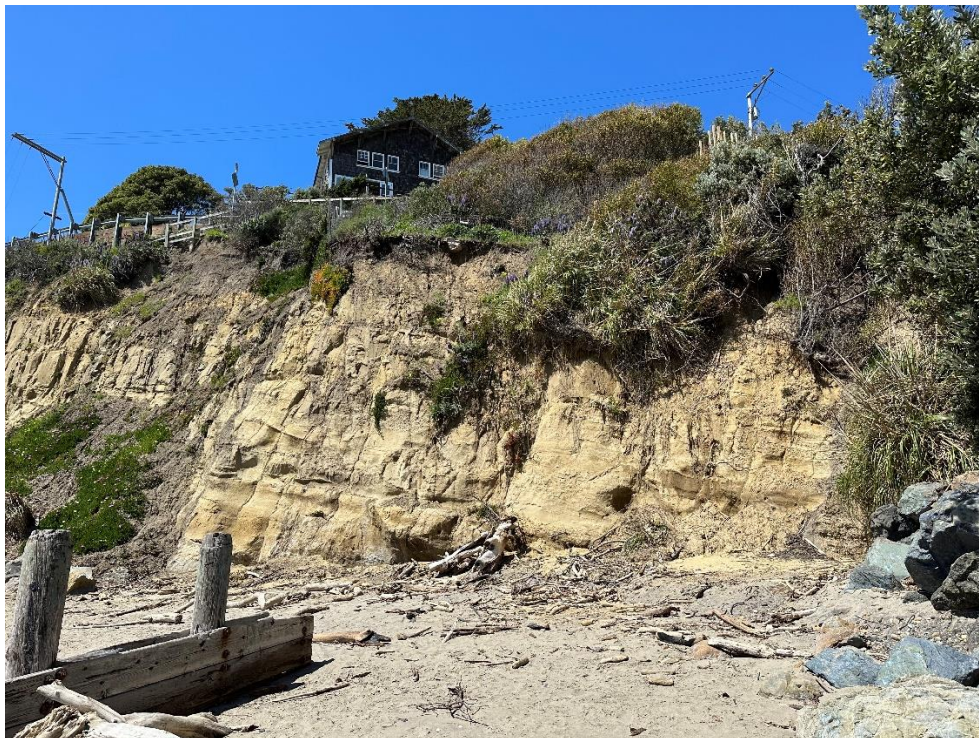
The approximately 65 feet of bluff between the east end of the sea wall and the residence at 100 Brighton Avenue is currently unprotected, with no buttresses or structures immediately in front of the bluff face. A timber bulkhead and groins had existed in this area at one time, but the bulkhead failed in the early 1980s, leading to the loss of a residence behind it (locally known as the Frenetta residence) in the early 1990s. Remnants of the groins, comprising deteriorating driven timber piles and lagging locally project above the beach by two to three feet.

Photo 6: Unprotected bluff face adjacent to 100 Brighton Avenue. Photo: IMG_0382.jpg Date: 4/13/23

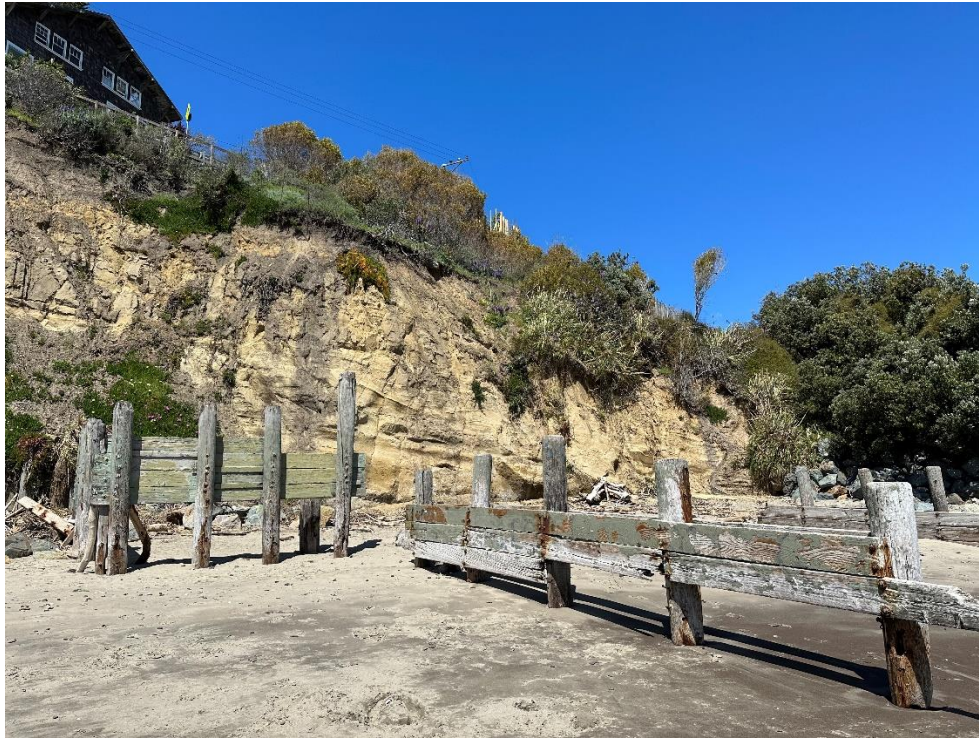
This slower-than-anticipated retreat at the unprotected toe of the bluff may be attributable to several factors. First, while the remnants of the timber groin that once fronted the Frenetta residence are in a state of advanced disrepair, they do still pose some impediment to wave attack on the bluff, both by deflecting/slowing wave runup, and intercepting some waveborne debris that can exacerbate the undercutting effects of wave attack (see Photo 7). Second, the continued presence of the concrete groin at the mouth of Bolinas Lagoon likely contributes to more sand retention at Surfer’s Overlook, which can increase wave runup distances and help dissipate wave energy. Also, it should be borne in mind that bluff retreat rates are based on long term trends, and a period of time on the order of a decade in which bluff retreat was less than the long-term average is not especially unusual.

Photo 7: Remnants of timber groins to the east of the sea wall. Photo: IMG_0376.jpg Date: 4/13/23

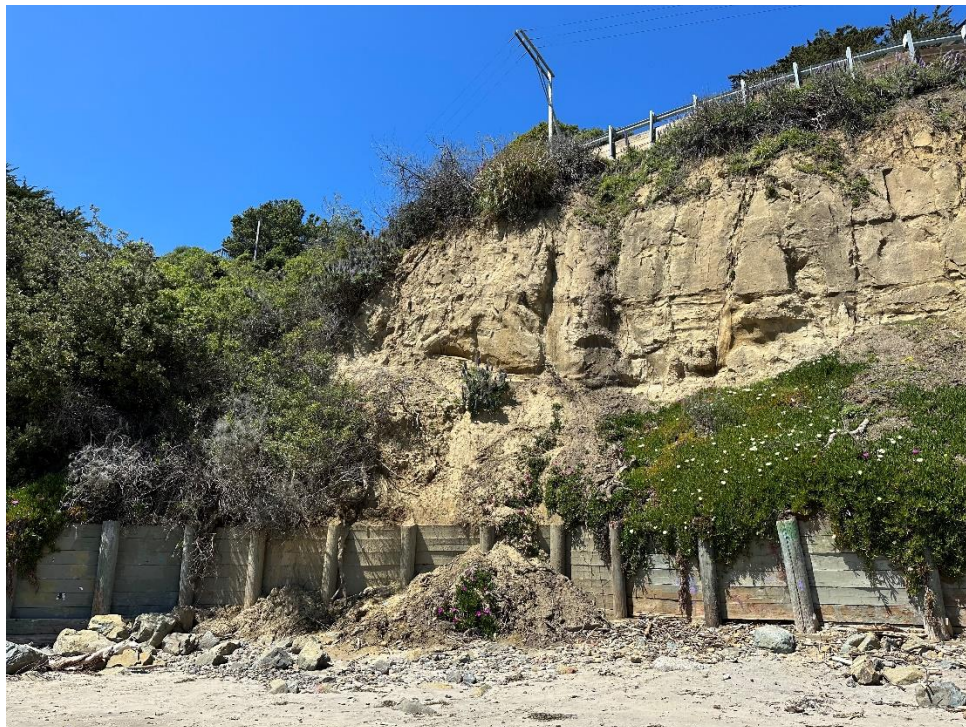
In contrast to the lower bluff, the upper portion of the bluff, comprising deeply-weathered Merced Formation materials, organic soils, and artificial fill, has experienced more significant erosion and retreat. This is evidenced by significant piles of sloughed debris that have accumulated on and in front of the sea wall (see Photos 8 & 9), as well as evidence of continued soil loss on the upper slope itself (see Photo 10).

Photo 8: Sloughed material from upper bluff. Photo: IMG_0370.jpg Date: 4/13/23

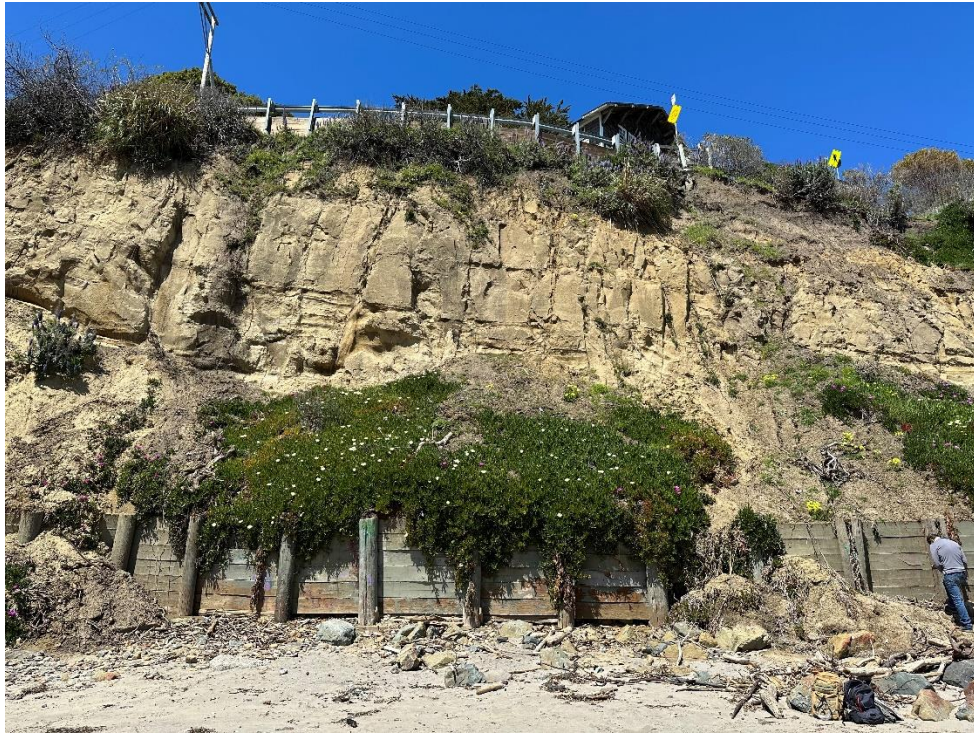
Photo 9: Sloughed material from upper bluff. Photo: IMG_0371.jpg Date: 4/13/23

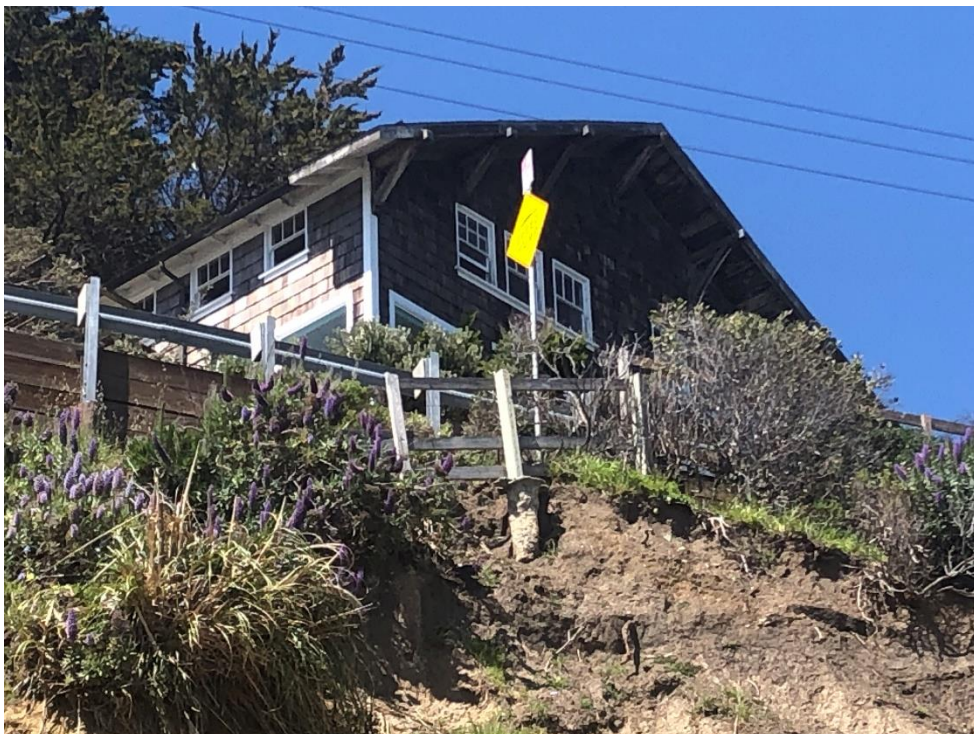
Photo 10: Undermined fence post on the upper bluff. Photo: IMG_0371.jpg Date: 4/13/23
