Bolinas Community Public Utility District

WHARF ROAD LIFT STATION STUDY

November 9, 2023

Assessment of Vogelsang Pump Failures

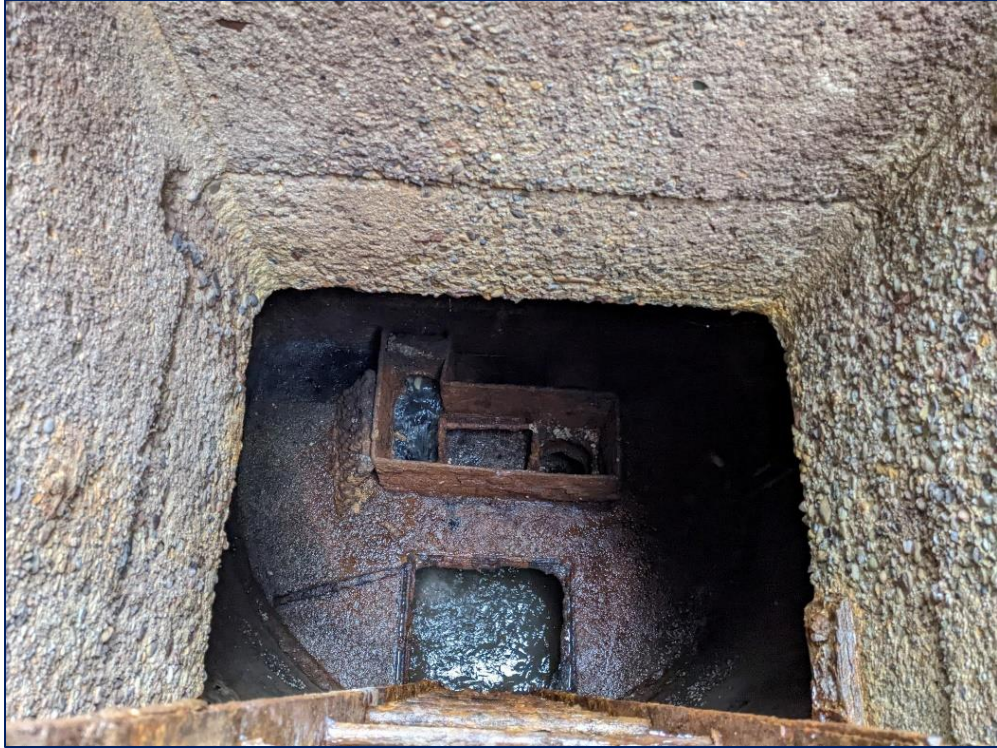
District maintenance crews have observed beach sand within the collection system that enters the pumping system. The sand can act as an abrasive on the rubber rotary lobe. The existing lower wet well does not trap the sand by settling and instead, directs the sand directly to the rotary pump's inlet pipe through the bottom concrete channel.

The hydrogen sulfides formed in decomposing wastewater has an aggressiveness which over time attacks the interior surface of the concrete wet well. This is observable in the upper wet well chamber and grinder deck, by loss of the smooth cement paste surface of the concrete (see photo on the next page).

Existing Concrete Wet Well

- Sawcut and enlarge grinder deck openings above lower wet well.
- Modify wet well by turning lower portion into sand/rock pocket to prevent sand from entering pumps.

- Sandblast and coat wet well with a modern, protective, sewage resistant coating.
- Rehabilitate the existing Wharf Road gravity sewer by pipebursting to prevent sand from entering the pumping system.

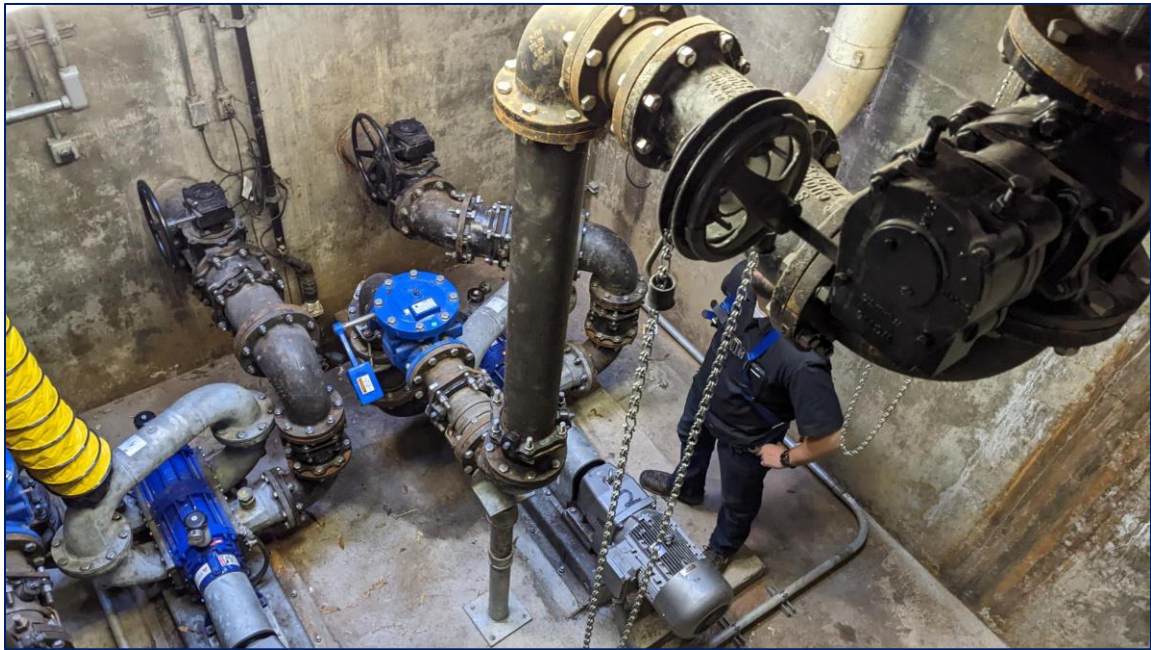
Based on the 1973 KCA plan set for the Wastewater Treatment and Disposal System, the dry well concrete structure walls and ceiling are cast in place, 18 inch thick, 3000 psi concrete with two mats of steel reinforcement bar (mostly No. 8). The below grade concrete structure is not currently painted or coated, which is not necessary for its current use. The unpainted surface allows for an easy surface inspection of the concrete walls and ceiling. From this inspection it is clear that the concrete is in good shape with no serious cracking or water intrusion (see photo on the next page). Based on these observations and plan review, it appears the structure should provide many more years of service.

Existing Dry Well With Sewage Pumps

- Convert dry well/pump room to submersible pump station wet well (see discussion below).

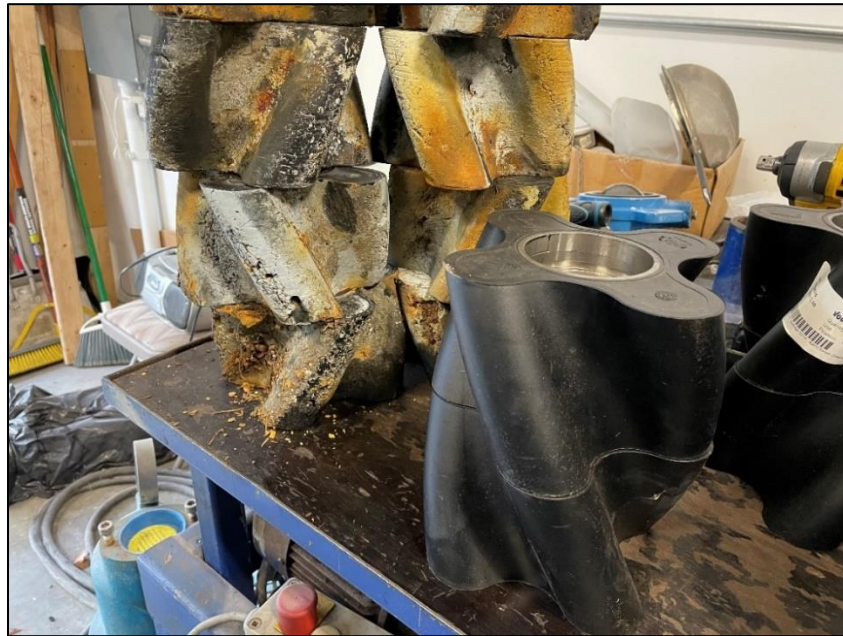
A major impetus of this study is to evaluate the recent past operational damage to the rotary lobe of the Vogelsang Pumps. Based on staff observation and discussions with the repair shop, the rubber coated rotary lobes of the pumps were severely damaged by 2020. The regional distributor of the Vogelsang pump, and the repair mechanic, believe the damage was due to fibrous rags in the sewage (commonly the cleaning cloth marketed as “Swiffer”). However, the Vogelsang Engineering staff have not officially commented on the cause of the damage. All sewage utilities are faced with the complications of transporting this debris in the sewage, which commonly causes clogs in valves and pumps, and is laborious to remove. But, in most sewage pumping installations the rags may clog the pumps but do not seriously damage the pumps. The pump can be “deragged” and is placed back into operation.

Damaged Vogelsang Rotary Lobes Compared to New Rotary Lobes

Another source of damage to the rubber coated Vogelsang rotary lobes, could be the presence of beach sand in the wastewater. District maintenance crew members have detected sand in the collection system which serves Wharf Road and have removed it by vacuuming periodically. Sand would have a regular abrasive affect on the rotating parts and piping. The photo above, taken during a recent pump repair by Vogelsang, compares the damaged rotary lobe on the lefthand side to a brand-new rotary lobe on the righthand side and appears to validate that the damage is from something abrasive.

- Install a sand and grit trap in the influent manhole located in the street in front of the lift station and upstream of the wet well.

- Elect to install a permanent sand and grit trap in the wet well, or
- Elect to rehabilitate the entire pump station to submersible Flygt pumps. Modern Flygt pumps would not require rag removal in all but extreme conditions (see attached Sketch 2).

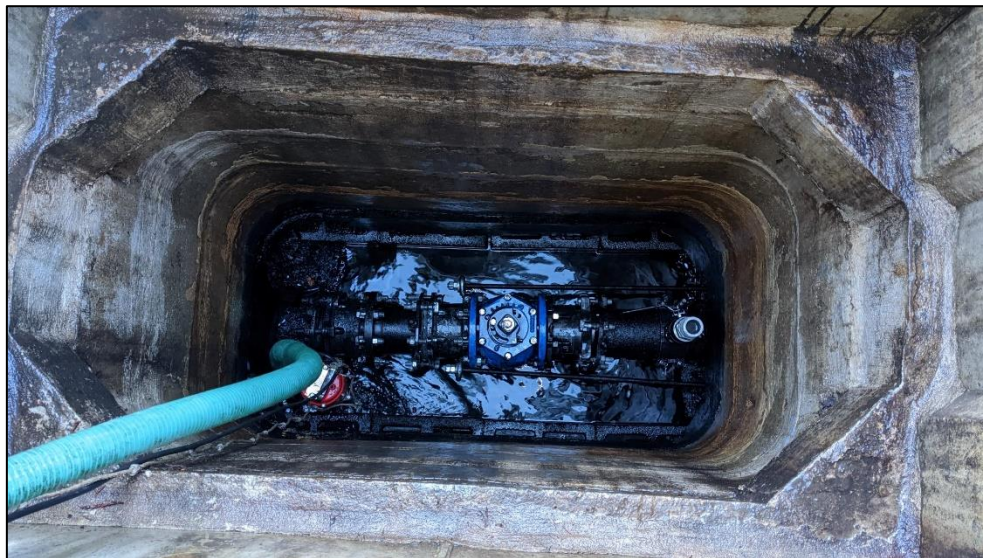
check valves and a redundant check valve was installed in a below grade vault on the buried ductile iron sewage force main in the street in front of the pump station (see photo below). Due to the high head pumping, this check valve must take the brunt of the pressure water hammer when the pumps shut down; somewhat relieving the check valves in the pump room. Because of this, the check valve in the street vault failed in 2022 and was subsequently replaced with a more appropriate model.

Lift Station Force Main in Wharf Road

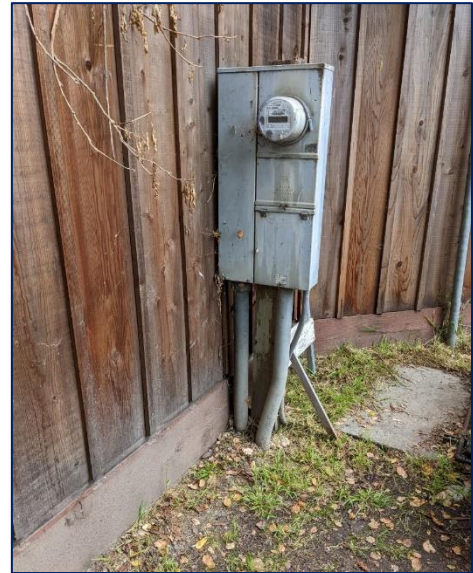
Electrical service from PG&E is via underground conduit and cable, 120/240VAC, 3 phase, 4 wire. The existing service is from open delta transformers on adjacent overhead pole. The Metering Panel is NEMA 3R painted steel, stanchion mounted, with surface rust but in working condition. The existing main breaker is 225 amp, 3 pole, and was replaced in July 2014. There is sufficient working clearance in front of the Metering Panel.

Existing Lift Station PG&E Meter

- Stanchion has deteriorated and needs to be replaced.
- Duct seal conduit to MCC.

- Provide arc flash label with calculations on panel, per NEC Article 110.24.
- Replace Metering Panel with main disconnect as existing panel is nearing end of useful life.

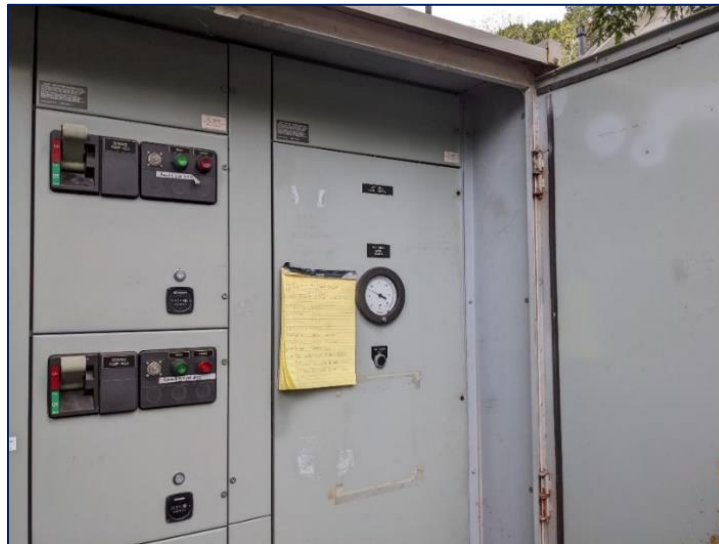
Control Panel. The MCC is freestanding on a concrete pad, non-walk-in type, NEMA 3R painted steel enclosure, and manufactured by CMC in 1990. The MCC contains an automatic transfer switch, two full voltage non-reversing pump starters, a 9KVA 3 phase transformer, 120/208 Panelboard with 50-amp main breaker, and an integral pump control panel. The pump control panel contains the wet well level bubbler system for level monitoring, hardwired control relays for starting and stopping pumps in auto mode based on wet well level, as well as interlocking pumps for duty/standby operation, and a pneumatic level gauge.

Existing Lift Station Motor Control Center

- Adjust electronic overload trips to “automatic” reset, typical for each pump.
- Set Pump 1 full load amps setting on overload relay to 75. Currently set at 70.
- Replace lightbulbs for Running and Ready pilot lights.
- Duct seal all conduits routed underground.
- Replace existing 100-amp motor circuit protector (MCP) type breakers with 150-amp MCP at both pump starters.
- Add 120 VAC strip heater in bottom of ATS section of MCC.
- Provide flexible moisture curing polyurethane sealant all around perimeter of MCC, at least the front and sides to minimum water tracking in MCC. Sealant to be similar to Vulkem #116.
- Provide as-built Single Line Diagram and Pump Control Schematics within MCC.
- Add Power Monitoring Fail relay on load side of ATS and wire contact to Autodialer. Relay to monitor low voltage, phase loss, and phase reversal. Relay to be similar to Time Mark #258B.

- Add “Hand-Off-Dry Well” hand switch for pump control at MCC cubicles, typical for each pump. “Dry well” position would allow for hand switch at pump in dry well to have control.

- Provide arc flash label on exterior door front, per NEC Article 110.16.
- Add surge protection device on load side of ATS. Surge device to be similar to Eaton SPD, rated for 240 VAC, 3 phase and 250kA.
- Replace bubbler and pneumatic controls with submersible level transducer and duplex pump controller. Controller to be similar to MPE #SC100.
- Replace MCC as existing is at end of useful life. Locate new MCC on slab on grade that is 4” above grade.
- Add programmable logic controller (PLC) with operator interface terminal (OIT) for pump control, wet well setpoint adjustment, alarming, trending, etc.

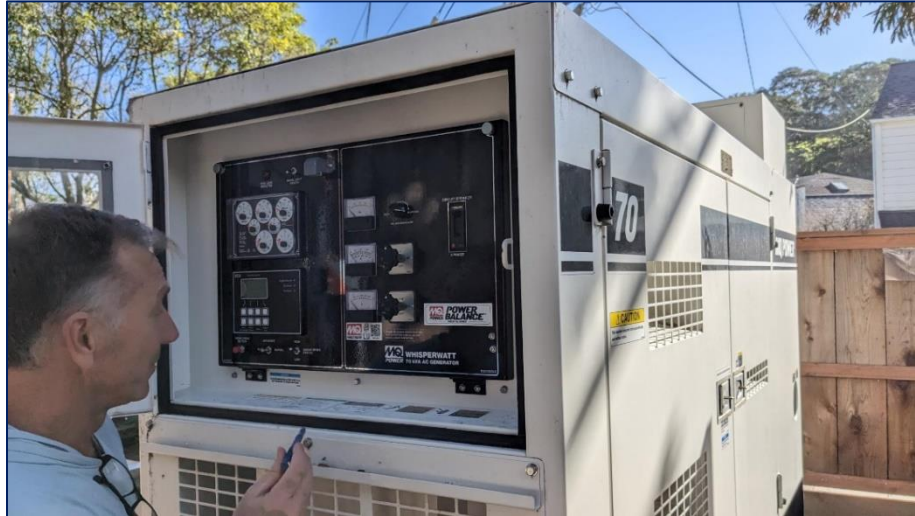
The portable generator is in great condition. The generator is Dyno MQ Power Whisperwatt #DCA-70SSIU4F, 70 kW, 3 phase, with 200-amp main breaker. Configured for 120/240 VAC and rated for 168 amps. Generator is wired to MCC automatic transfer switch and sized to operate one pump plus miscellaneous station loads.

Existing Lift Station Portable Generator

- Provide additional onsite fuel storage (may be possible to flush and reuse existing aboveground diesel tank already onsite).

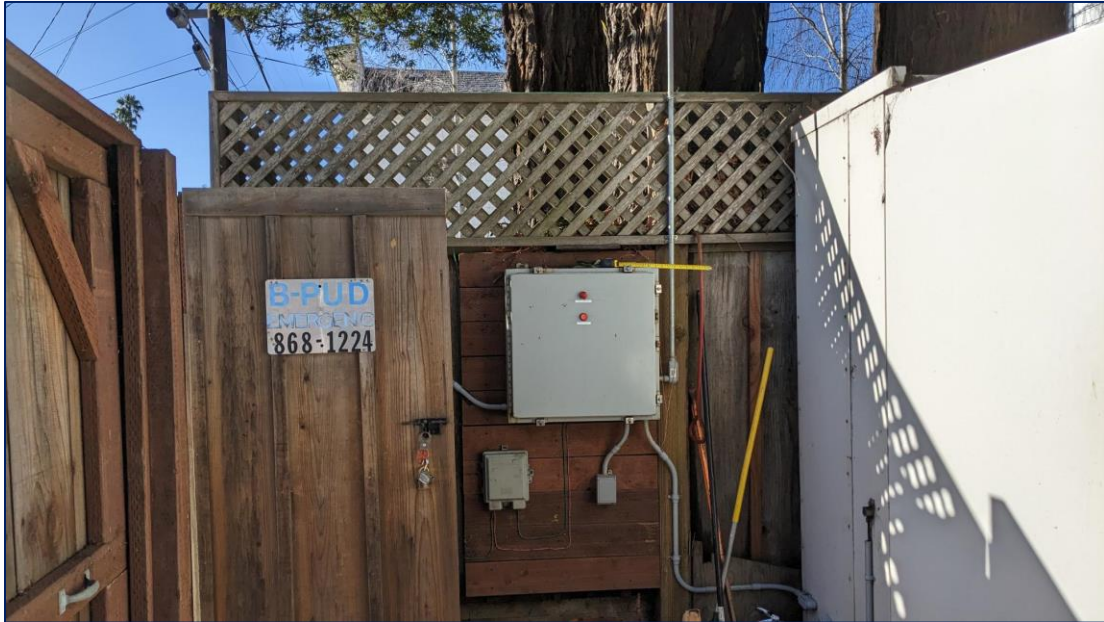
- 3.3 Autodialer Panel: The autodialer panel is wall mounted, NEMA 3R painted steel enclosure. Autodialer is hardwired to telephone utility and includes red light for alarm status. Only alarm is high level alarm. The enclosure had some standing water at bottom of panel.

Existing Lift Station Autodialer Panel

- Drill 3/8" to 1/2" hole in bottom of enclosure to drain any water.
- Duct seal all conduits routed underground.
- Add the following alarms to existing autodialer: AC Power Monitoring Fail alarm.

- Replace autodialer with cellular (AT&T) option. Disconnect and cancel hardwired telephone service.
- Add the following alarms to new autodialer: Pump 1 Fault, Pump 2 Fault, Power Fail, ATS in Emergency, Generator General Alarm (General alarm can be any of: Not in Auto, Gen Fault, or Low Fuel), Dry Well Pump Room Flood.

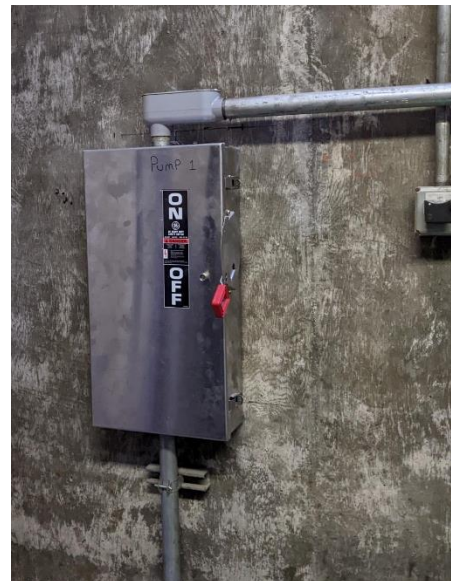
- 3.4 Dry Well & Wet Well: The dry well pump room is below grade and has a limit switch activated exhaust fan and limit switch activated lights. The dry well pump room is clean and has sufficient working clearances. NFPA 820 classifies the dry well pump room as a hazardous area; Class 1 Division 2. Therefore, the electrical equipment (disconnect switches, light fixtures) needs to be explosion proof. The

alternative is to continuously ventilate the dry well room with minimum 6 air changes per hour, then it is “unclassified area”, and the existing electrical equipment is adequate. The District elected to do this and the fan now continuously ventilates the dry well.

*Existing Dry Well Pump Disconnect
(Not Explosion Proof)*

- Fix lights in dry well, limit switch may be faulty.
- Confirm fan is providing 6 air changes per hour, and leave running all the time. Otherwise, replace lights and disconnect switches with explosion proof type and add seal off fittings on electrical conduits leaving the dry well pump room.

- Add float switch for flood alarm in dry well pump room and tie into autodialer.
- Replace wet well bubbler system with submersible level transducer. Submersible level transducer to be similar to Blue Ribbon #BC001 Birdcage.
- Provide float switches (Off, Lead, High) in wet well for back up pump controls. Float switches to be similar to Flygt #ENM-10.
