BUILDING INSPECTION REPORT

101 Mesa Road, Bolinas, CA

Inspection Date:
Monday, June 10, 2024

Prepared For:
Bolinas Community Public Utilities District

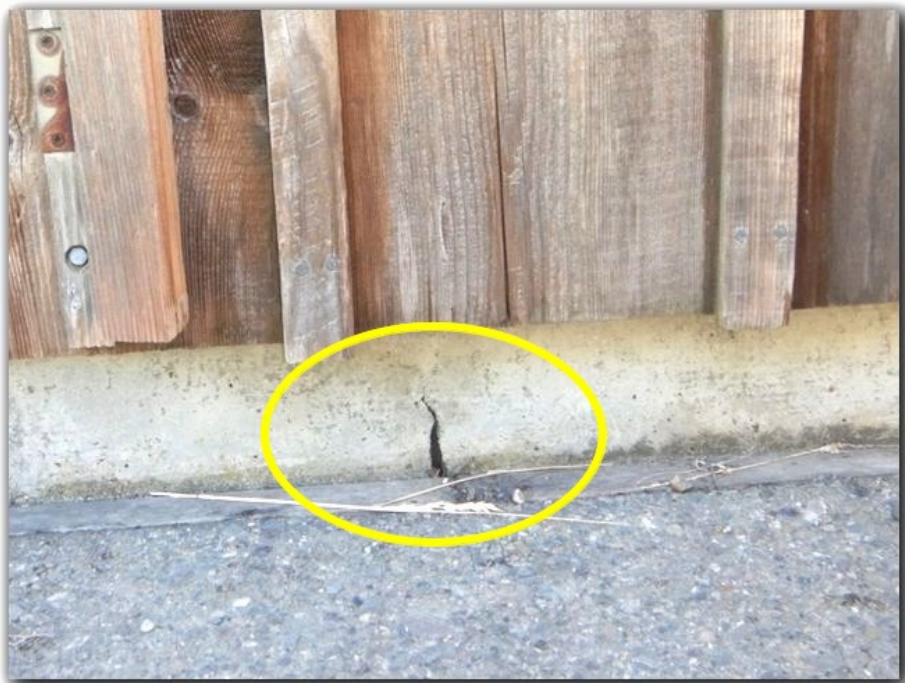
2. We observed a crack in the foundation at the front exterior raised edge (See image below). The crack should be monitored. If the crack should expand or lengthen it would be wise to seek the advice of an engineer to determine what, if any, corrective repairs would be necessary.

We observed a crack in the foundation at the front exterior raised edge (See image below). The crack should be monitored. If the crack should expand or lengthen it would be wise to seek the advice of an engineer to determine what, if any, corrective repairs would be necessary.

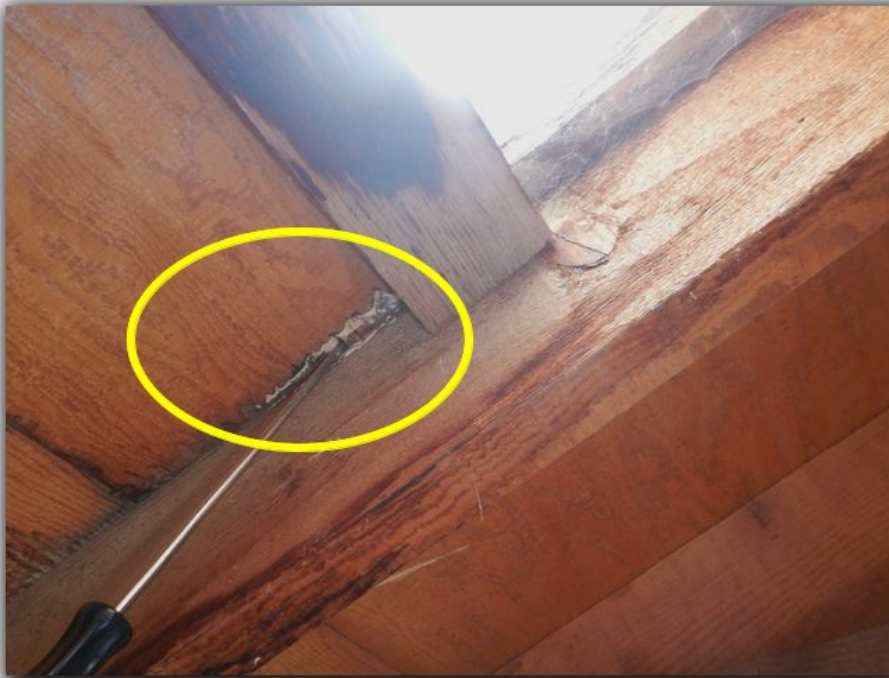
3. Roof sheathing below a skylight shows moisture related damage (See image below). We recommend the damaged sheathing replaced.
4. This inspection is not for the purpose of identifying the presence of rodents or bats in or around the building. However, we were advised prior to our site inspection that the laboratory structure had a substantial bat infestation and that prior attempts at remediation were attempted. Based upon the level of staining and remaining bat guano throughout the large storage room, the infestation remains. Further, rodent excrement was observed throughout the building. A pest control exterminator that specializes in rodent and bat removal, exclusion, cleaning and sanitizing should be retained. Long term rodent and bat infestations damage a building and can be a health threat to the occupants.

We noted moisture stains on the roof sheathing and framing below and adjacent to the skylights suggesting chronic leakage. It is possible the stains are historic and the roof no longer leaks, however we cannot be sure as it was not raining during the inspection. During future rain events we recommend the roof structure monitored for additional staining and leakage. If additional staining or leaks are observed we would recommend a qualified roofing contractor be retained to make corrective repairs as needed to prevent future leaks.

Roof sheathing below a skylight shows moisture related damage (See image below). We recommend the damaged sheathing replaced.

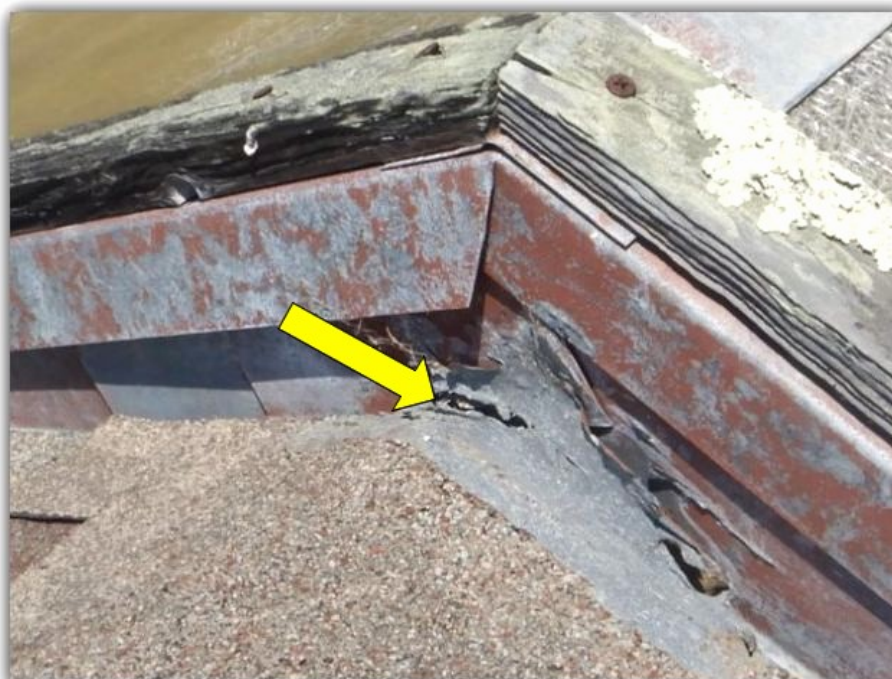
Roof connections at the ridge and adjacent to the skylights have been caulked in the past (See image below of one example). The caulking is worn and cracked and could be a reason for the water staining and damage observed below the skylights. We recommend replication of the caulking to prevent future leaks.

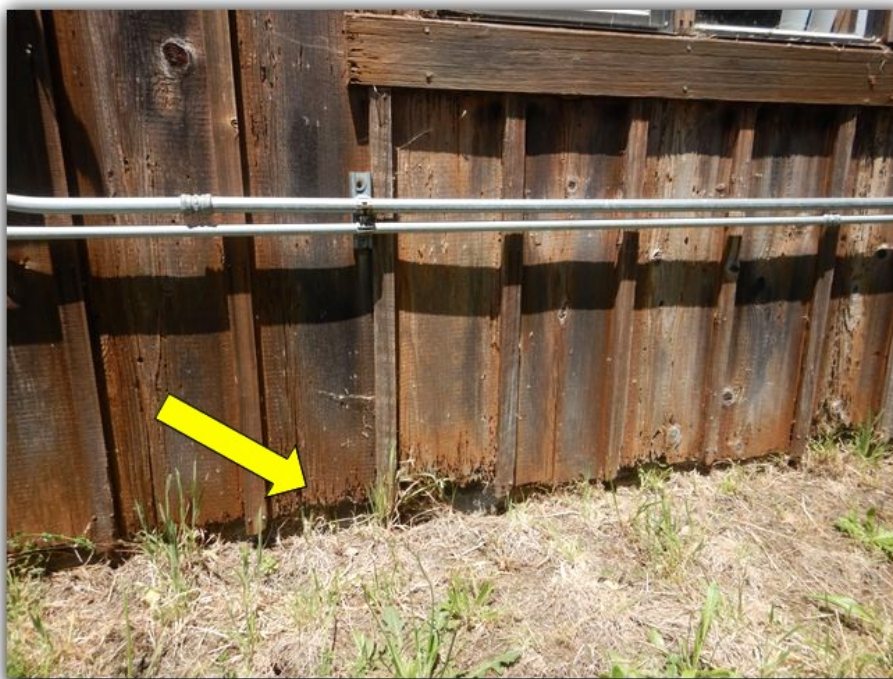
9. The bottom of the wood siding at the rear of the building showed moisture related damage (See image below of examples). We recommend all damaged siding replaced. Painting or staining the siding after the damaged siding is replaced should be considered to help protect the siding from the damaging effects of weather and ultra violet sun light.

The bottom of the wood siding at the rear of the building showed moisture related damage (See image below of examples). We recommend all damaged siding replaced. Painting or staining the siding after the damaged siding is replaced should be considered to help protect the siding from the damaging effects of weather and ultra violet sun light.

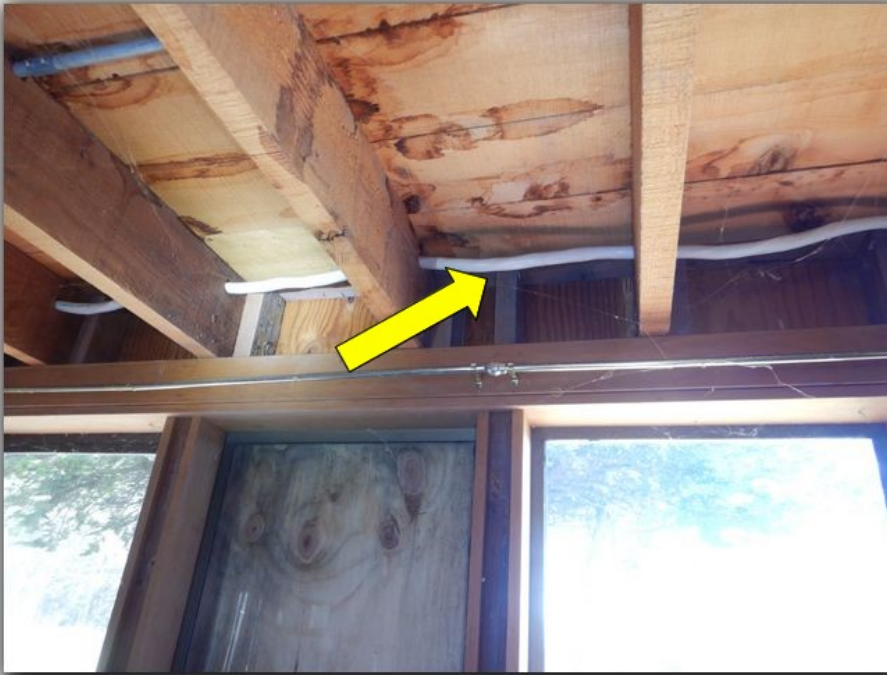
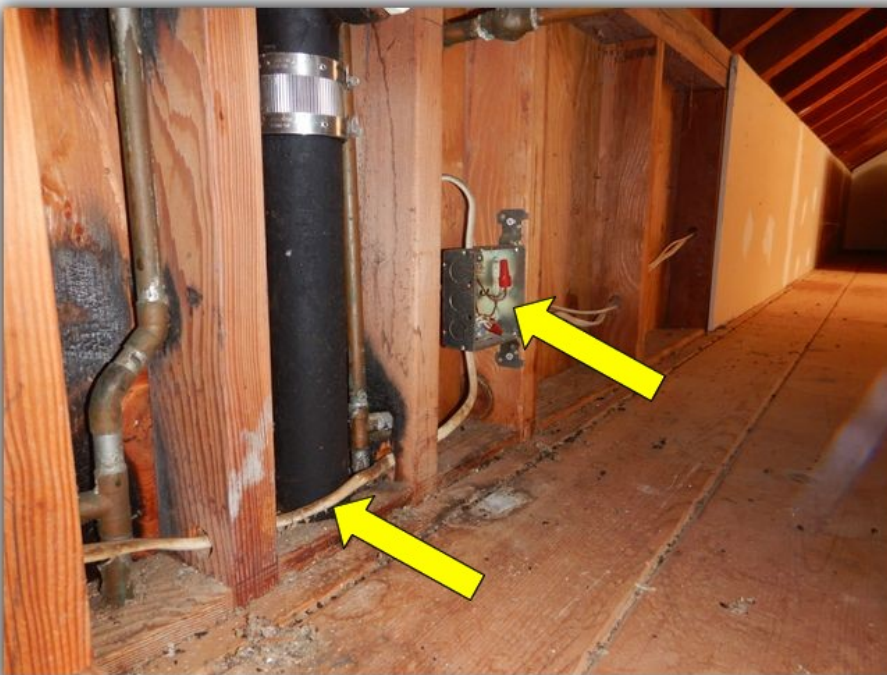
An electrical junction box upstairs was without a protective cover plate (See second image below). We recommend a junction box cover be installed to protect the wire connections and contain fire.

Wiring was exposed inside the building in a few locations (See images below of some examples). We recommend all exposed wiring protected in accordance with current standards.

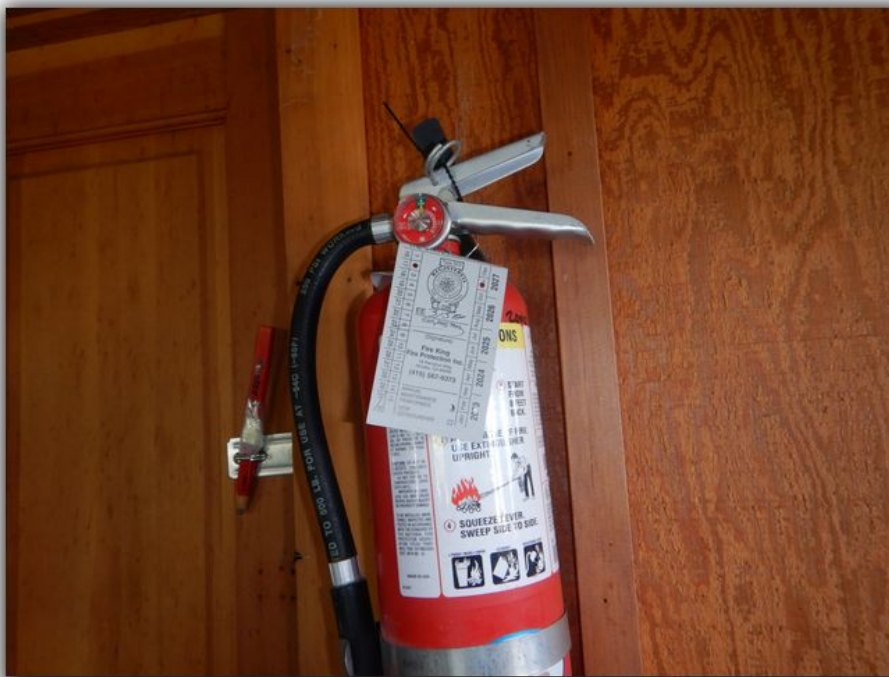
We observed two fire extinguishers installed in the building. The fire extinguishers inspection tags were current, but will require inspection in November of this year.
