Butler Commercial Building Inspection Inc.
Commercial & Residential Inspection
Established 1995

BUILDING INSPECTION REPORT

270 Elm Street, Bolinas, CA

Report Number:
20240610-01

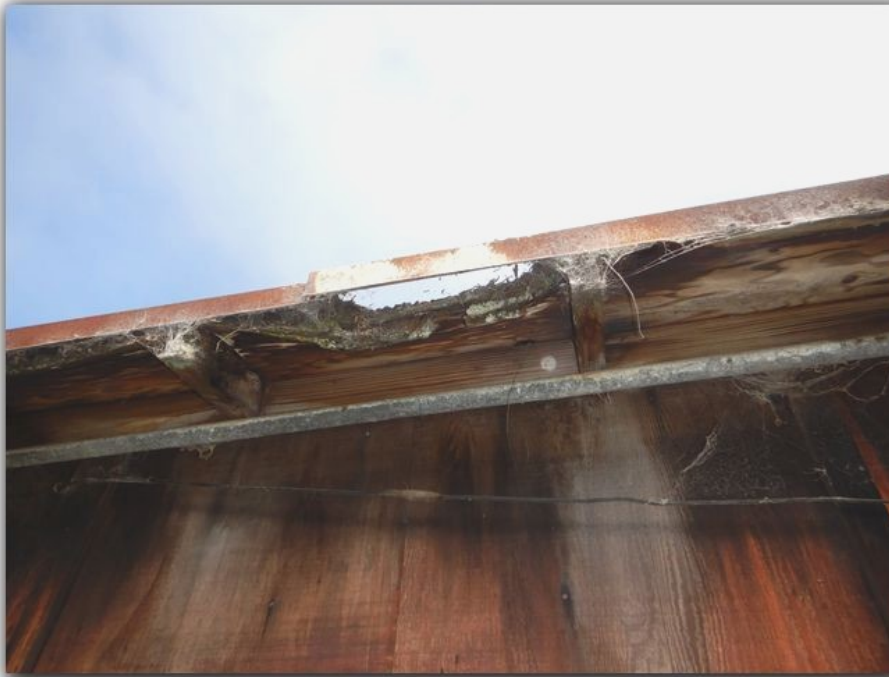
10. The front building has a built-up, gravel protected roof surface. The protective gravel is largely missing and the roof surface is deteriorated and well past its expected service life (See image below for an example). If the building will be repaired, rather than razed, the roof surface and deteriorated sheathing will need to be replaced.

The front building has a built-up, gravel protected roof surface. The protective gravel is largely missing and the roof surface is deteriorated and well past its expected service life (See image below for an example). If the building will be repaired, rather than razed, the roof surface and deteriorated sheathing will need to be replaced.

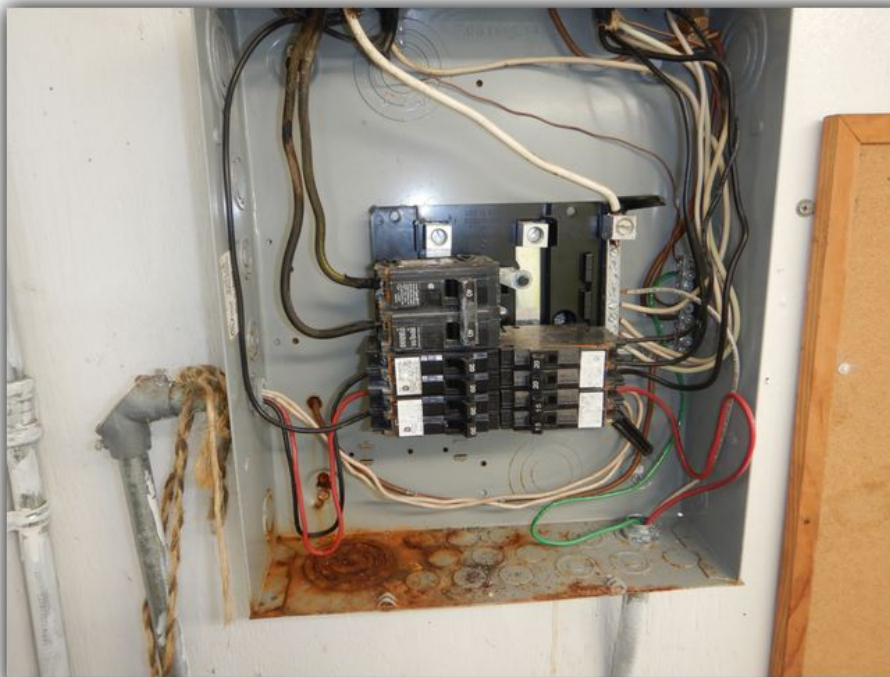
14. Moisture has entered the sub panel causing corrosion (See image below). Corrosion of hardware inside an electrical can be hazardous. For improved safety and reliability, we recommend the panel replaced when the service mast and overhead service conductors are replaced.

Moisture has entered the sub panel causing corrosion (See image below). Corrosion of hardware inside an electrical can be hazardous. For improved safety and reliability, we recommend the panel replaced when the service mast and overhead service conductors are replaced.

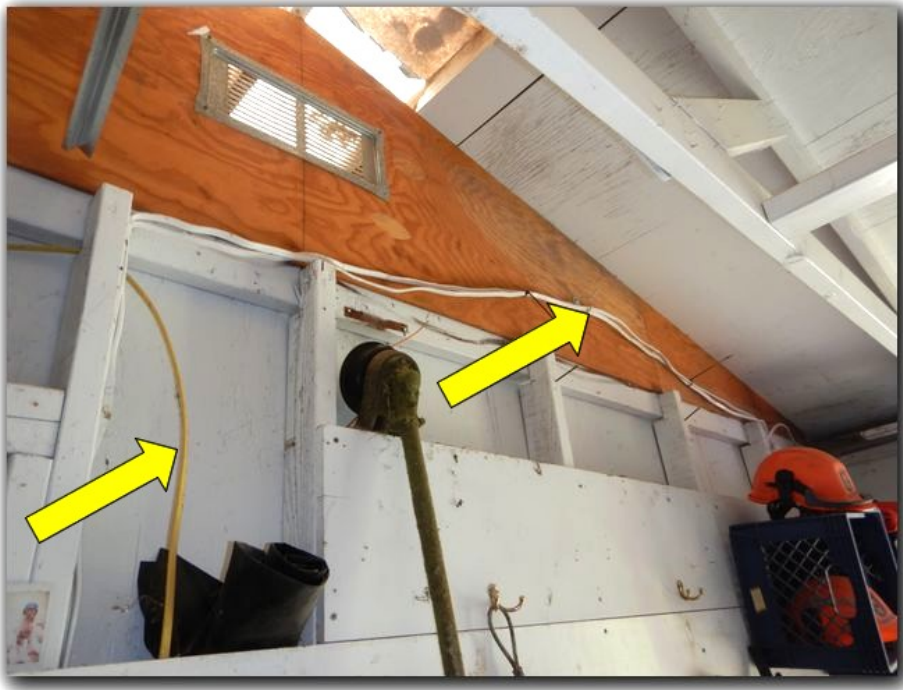
Exposed, loose and unprotected exterior wiring was observed inside the buildings (See image below of examples). We recommend all exposed wiring protected to prevent damage and improve safety.

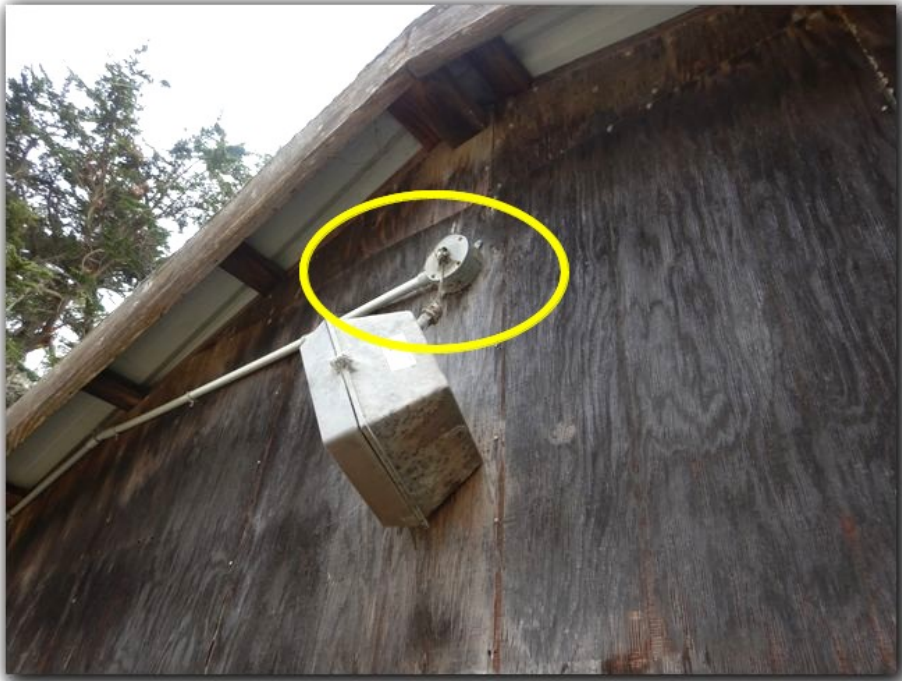
An exterior light fixture at the rear storage shed is supported by its wiring (See image below). This is a safety hazard that should be corrected.

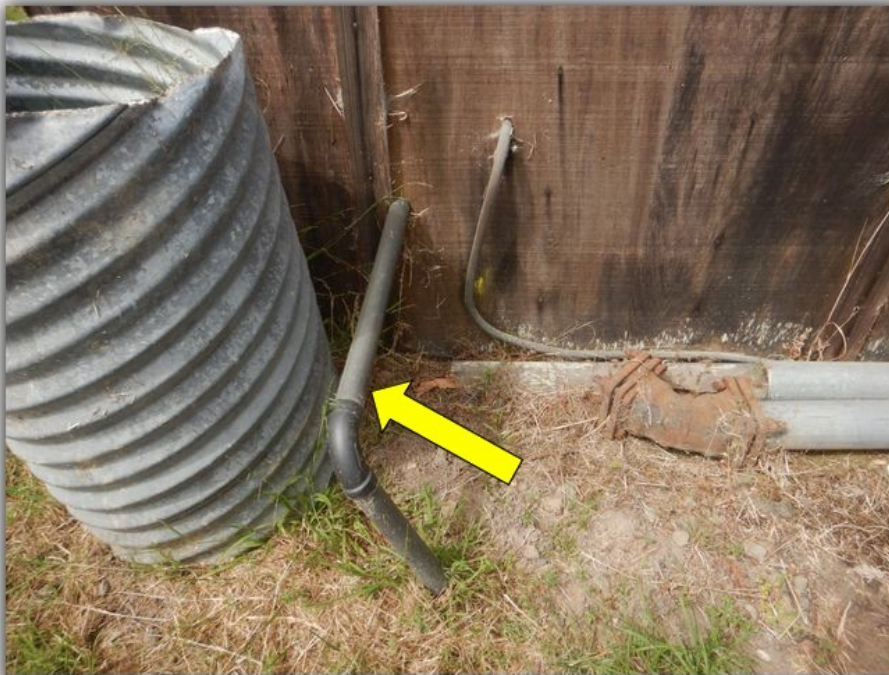
16. The sink in the shop building drains into the soil at the right side exterior of the shop (See image below). This is a potential health hazard. We recommend connecting the drain to a sanitary sewer or septic system in a manner acceptable to the local building department.

The sink in the shop building drains into the soil at the right side exterior of the shop (See image below). This is a potential health hazard. We recommend connecting the drain to a sanitary sewer or septic system in a manner acceptable to the local building department.

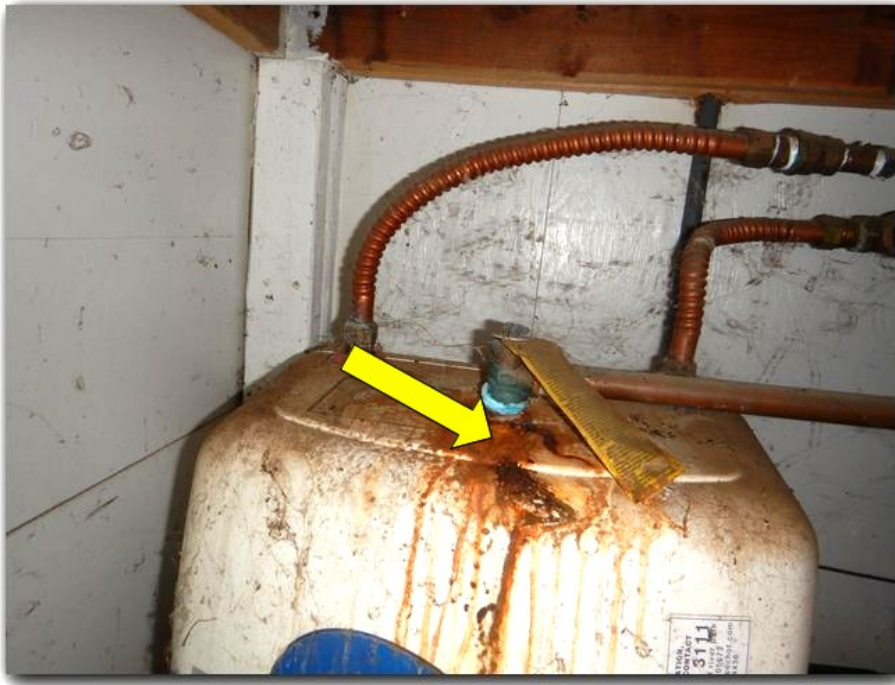
17. An electric water heater was installed under the counter top and sink in the shop building and was leaking (See image below). The water heater should be removed. If heated water will be needed in the shop building a new water heater should be installed.

An electric water heater was installed under the counter top and sink in the shop building and was

leaking (See image below). The water heater should be removed. If heated water will be needed in the shop building a new water heater should be installed.

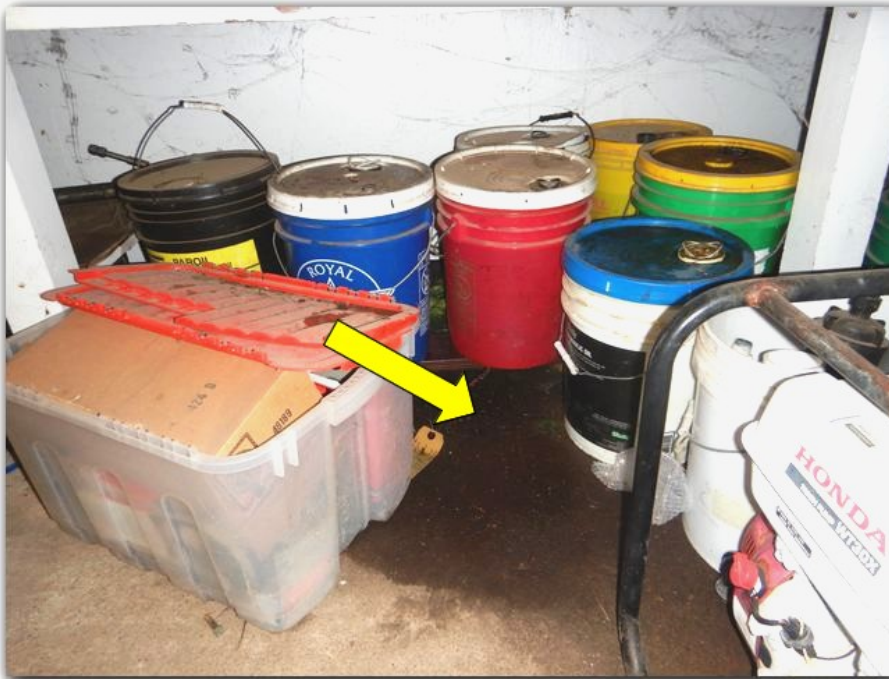
19. Inside the shop building we observed at least one leaking container that may contain a substance that could have an adverse environmental impact (See image below). We recommend all leaking containers removed and the interior surfaces of the buildings cleaned of all potentially hazardous materials.

Inside the shop building we observed at least one leaking container that may contain a substance that could have an adverse environmental impact (See image below). We recommend all leaking containers removed and the interior surfaces of the buildings cleaned of all potentially hazardous materials.
