The Bolinas Eucalyptus Project Inventory: Zone 5

**A REPORT ON THE INVENTORY OF BOLINAS PUBLIC UTILITY DISTRICT AND
ADJOINING TREES IN ZONE 5**

BY TOM GAMAN, REGISTERED PROFESSIONAL FORESTER #1776

MARCH 2023

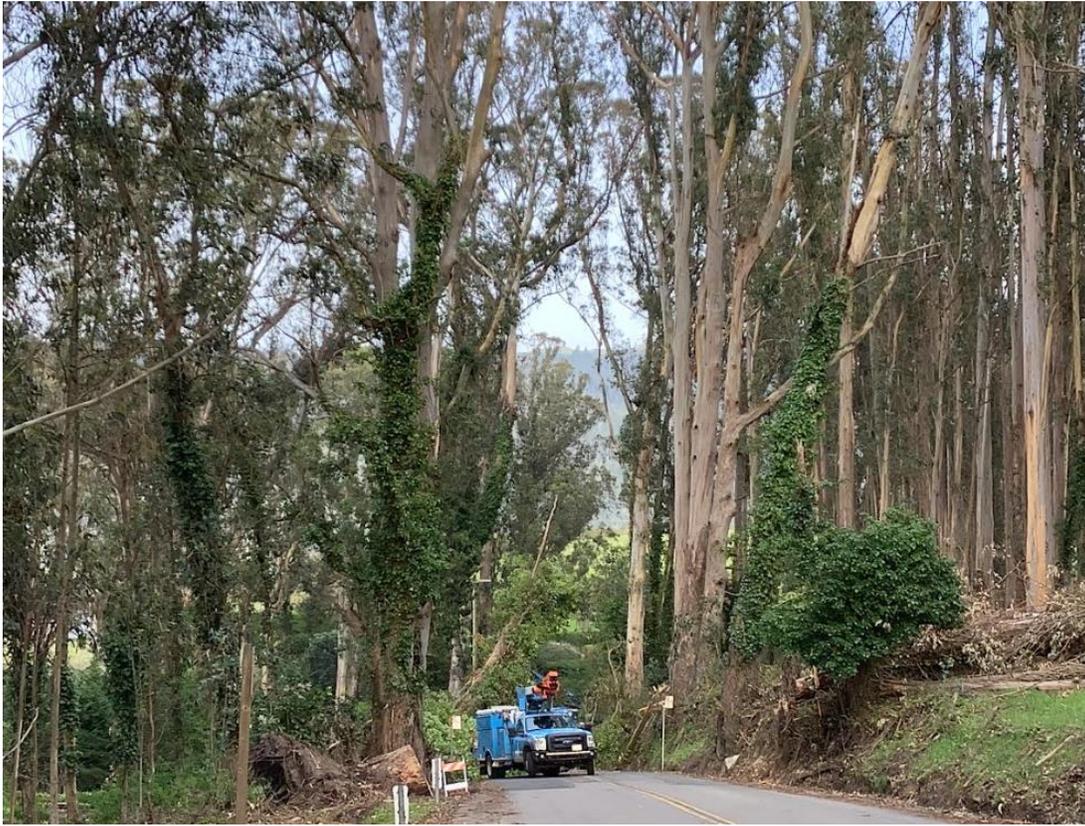
Figure 1 Zone 5 PG&E crews repair destruction caused by falling trees along Mesa Road

crews worked day and night (Figure 1). Fortunately, no vehicles were traveling the road as the trees fell. Others were not so lucky. On March 22 falling trees killed 3 persons in separate Bay Area incidents during a “bomb cyclone” event.

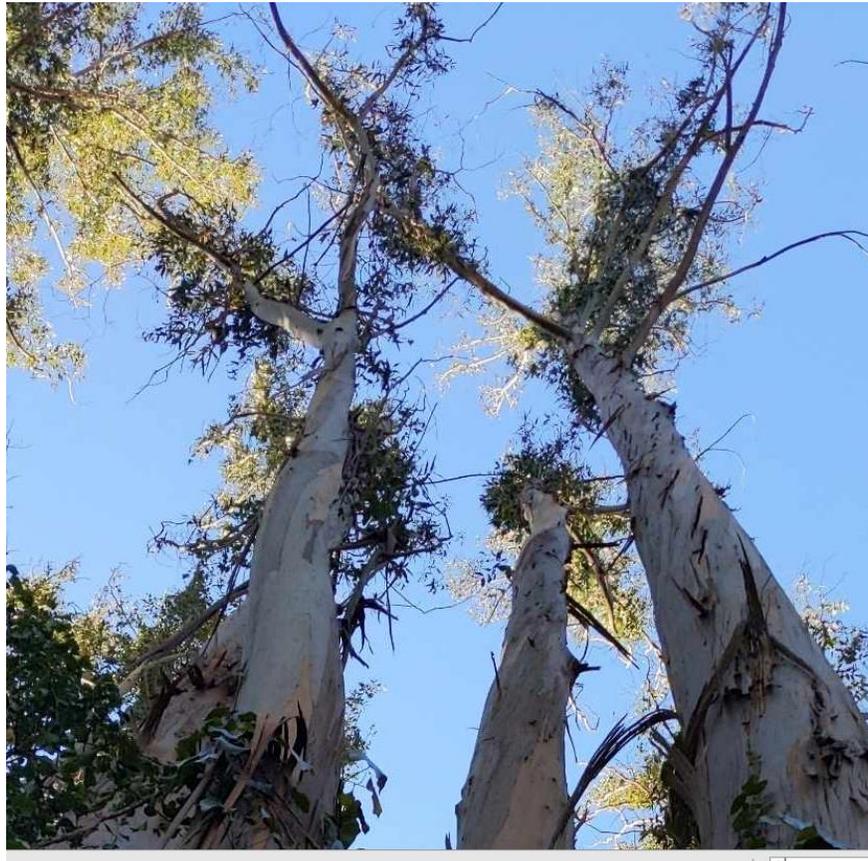
Live Crown Ratio. Live Crown ratio is the percentage of the total tree height which supports green live branching. The value is commonly used in assessing forest health and in modeling predicted future forest conditions. In natural stands in the Sierra and Coast ranges of California healthy trees normally exhibit a live crown ratio of 40% or more. In this stand the average live crown ratio is 24% reflecting intense competition among unhealthy tree crowns struggling for access to sunlight. Dead branches are interspersed with live branching.

Figure 8 Typical view of Zone 5 sparse Eucalyptus crown looking upwards

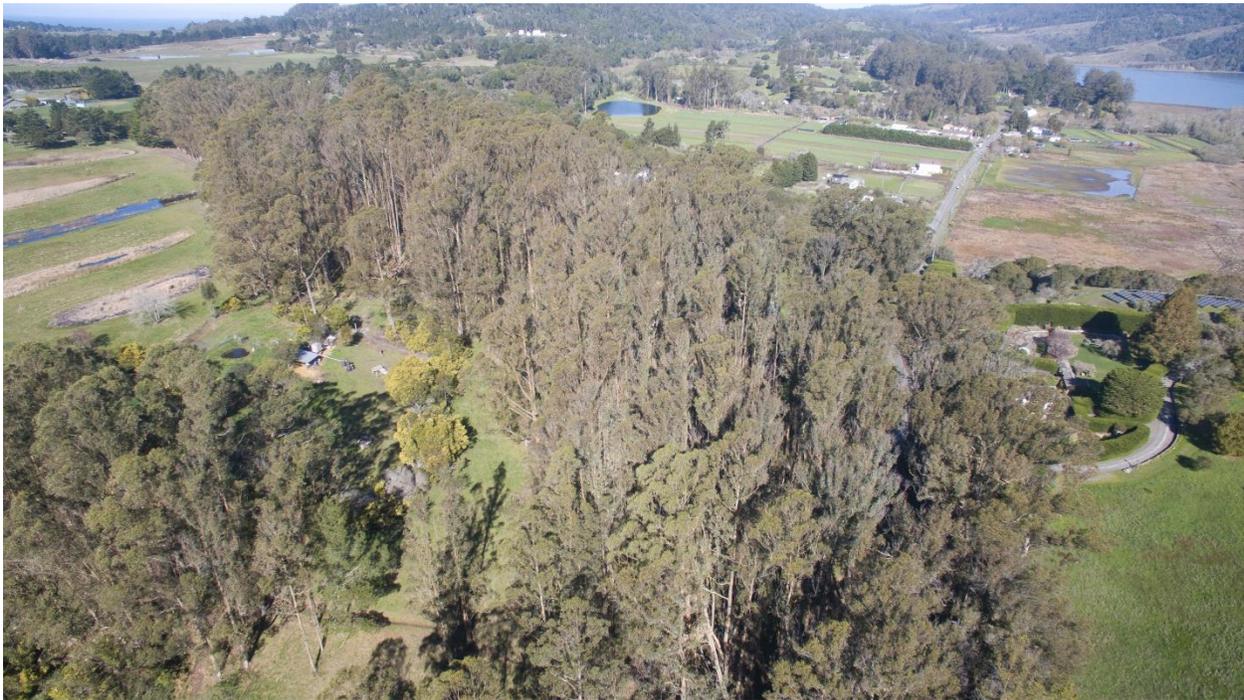
To further investigate the canopy and crown condition of the trees aerial drone imagery (flown March 1, 2023) vertical aerial photography and video demonstrates the crowded condition, branch mortality, and sparse foliage of the trees. The high-resolution photos and video are viewable online at the link in the footnote on page 7. Note the crowded stem density, sparse crowns and dead branches.

Canopy Closure. An important metric in forest stand assessment is canopy closure. This inventory does include a crown diameter estimate for each large measure tree. When all the trees' crown areas are compiled the large ("measure") tree canopy closure on the 11.9 acres is 55%. Placing a grid over Zone 5 and counting squares reveals a canopy density of 90%. The crowns are mostly non overlapping so this measurement indicates that 700+ trees less than 19.5" in diameter collectively share 35% of the crown space. As such the available canopy area represents insufficient crown availability for the codominant trees in the lower diameter classes. Throughout the inventory it was clear that most such smaller tree crowns are very sparse and most of those trees are severely stressed as a result.

Figure 9 Looking west toward sparse tree tops and crowded canopies at Zone 5. Aerial imagery March 2023.

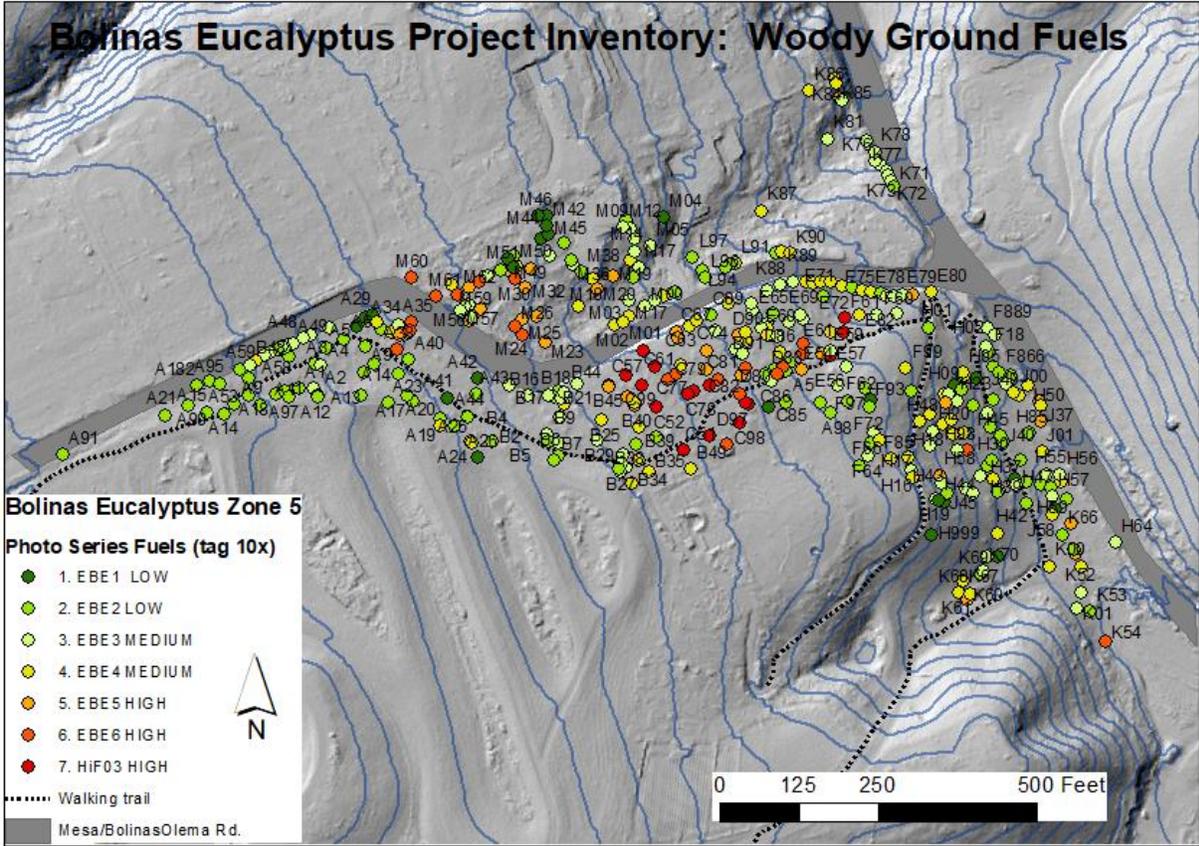
In an ideal world where the fuels reported by Wright and Vihnanek correspond perfectly with the conditions viewed in Zone 5 at Bolinas, the forest floor at present would be supporting 11 tons of woody debris per acre, but of course this is just an estimate. The fact remains, however, that the woody fuels on the forest floor vary dramatically over the area encompassed by Zone 5 as shown in the map below. Cognizant of the fire hazard, BPUD did some work in the grove in 2011 and the understory fuels were thinned out. Each year BPUD mows the area under the trees to maintain understory fuels at levels as low as possible. The map below shows the accumulation of fuels to be widely distributed (from low to high) throughout the grove.

Figure 11 Woody ground fuels (Low in green and High in red)

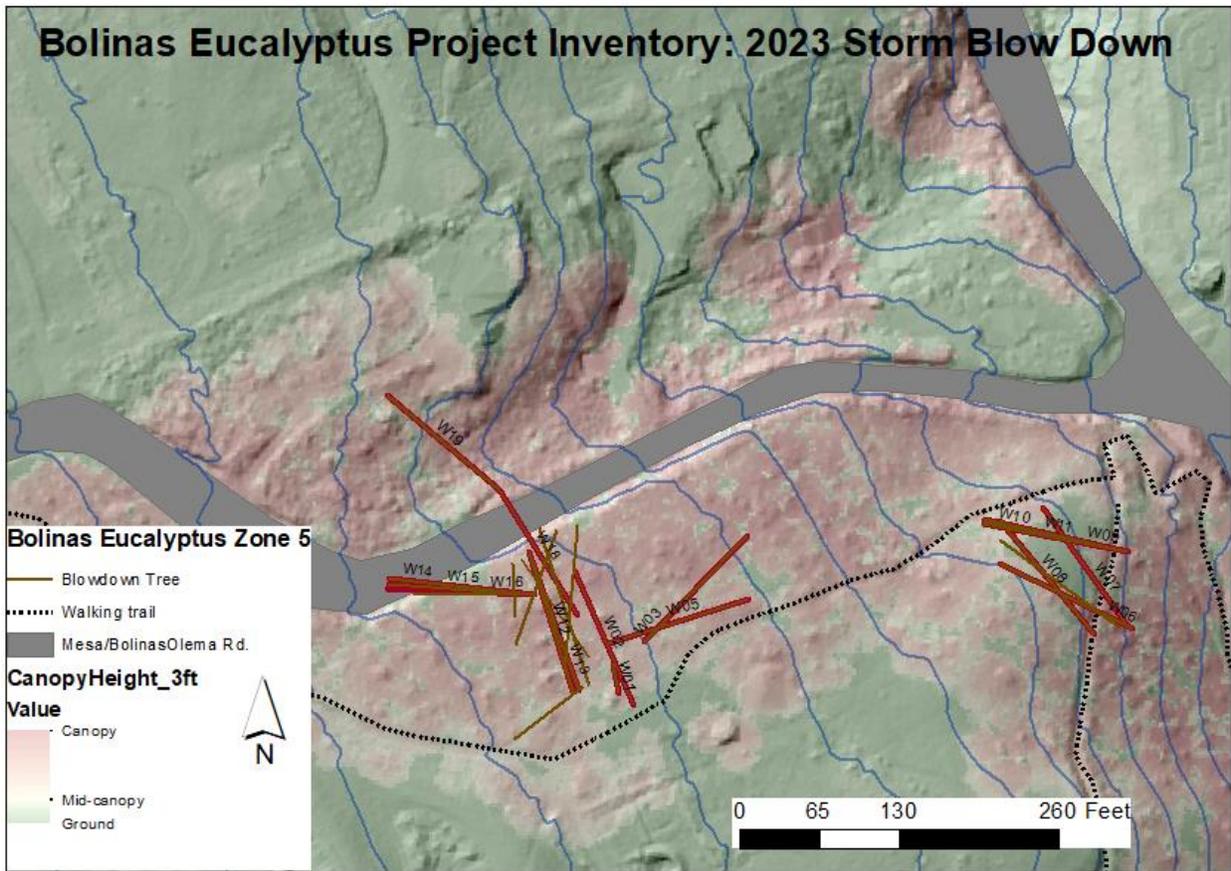
During the January 2023 storm series 24 trees within the grove blew down over several nights. These trees were 14” to 63” in diameter and each had been over 100’ tall. Half of the blown down trees were over 20” in diameter and 5 of them were 30” and larger. Several smaller but tall trees were hit by falling trees. They broke and they fell. A small number of other trees are “leaners”, supported by their neighbors, and they could fall at any time. Aside from the damage to the stand of trees the impacts of the storm included major injuries to 2 persons in a passing vehicle. The forester reviewed the damage to the stand and measured each fallen tree’s diameter, GPS location and direction of fall. Most windfall trees were lying on the ground with azimuth of west to northwest. The exceptions were the very large 63” blue gum that fell across the road, and collateral damage of fallen trees struck by adjacent blown down trees. The elimination of 24 trees created new gaps in the canopy which render residual trees increasingly vulnerable to ongoing blow down. Though most trees that fall are blown down by the south or northerly winds during saturated soils conditions, it does not seem possible to predict which trees will fall next, or in which direction.

Figure 12 Trees blown down in the January 2023 winds

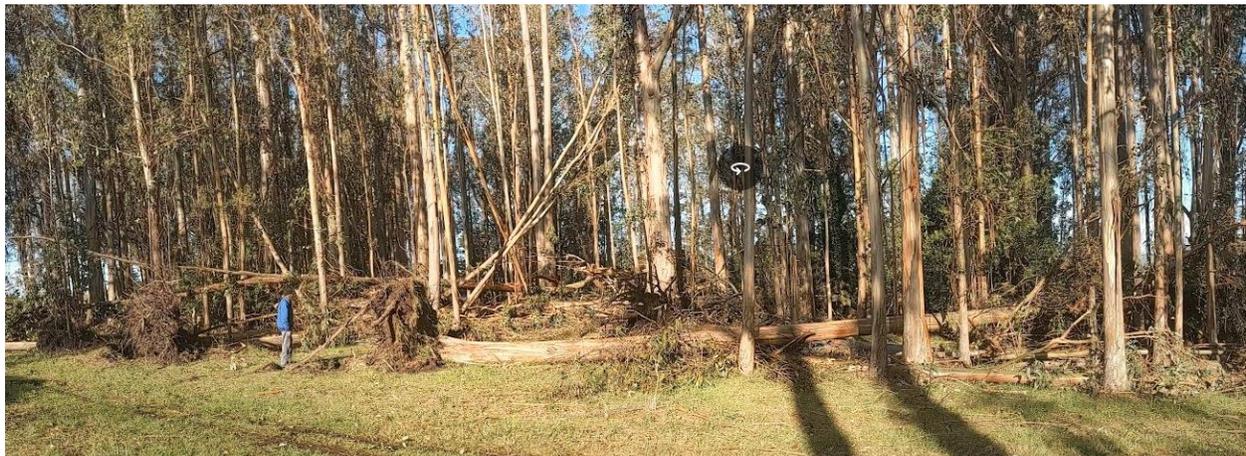
Figure 13 Some January 2023 wind thrown blown down trees

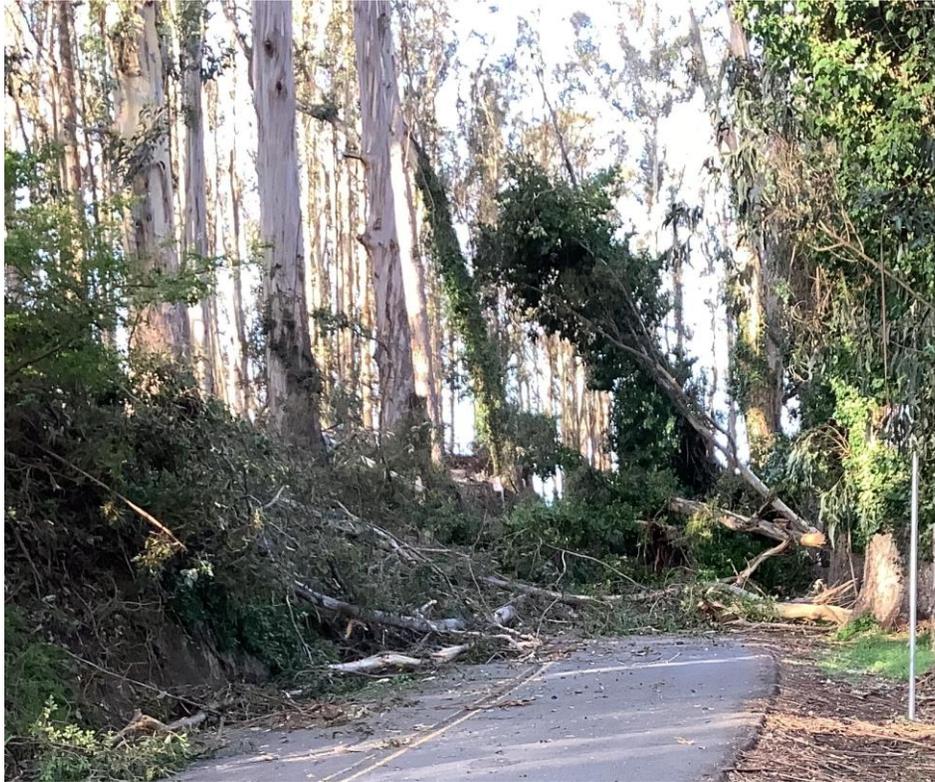
On March 3, 2023, a month after the January storms another tree, nearby the 63" tree that had fallen earlier, failed during calm clear conditions. Its collapse caused 2 of its neighboring trees also to fall. Those trees and large broken branches descended onto Mesa Road, destroying a power pole and wires, extinguishing electricity service to the local area for some time. PG&E

Figure 14 Two large trees fell across Mesa Road on March 3, 2023

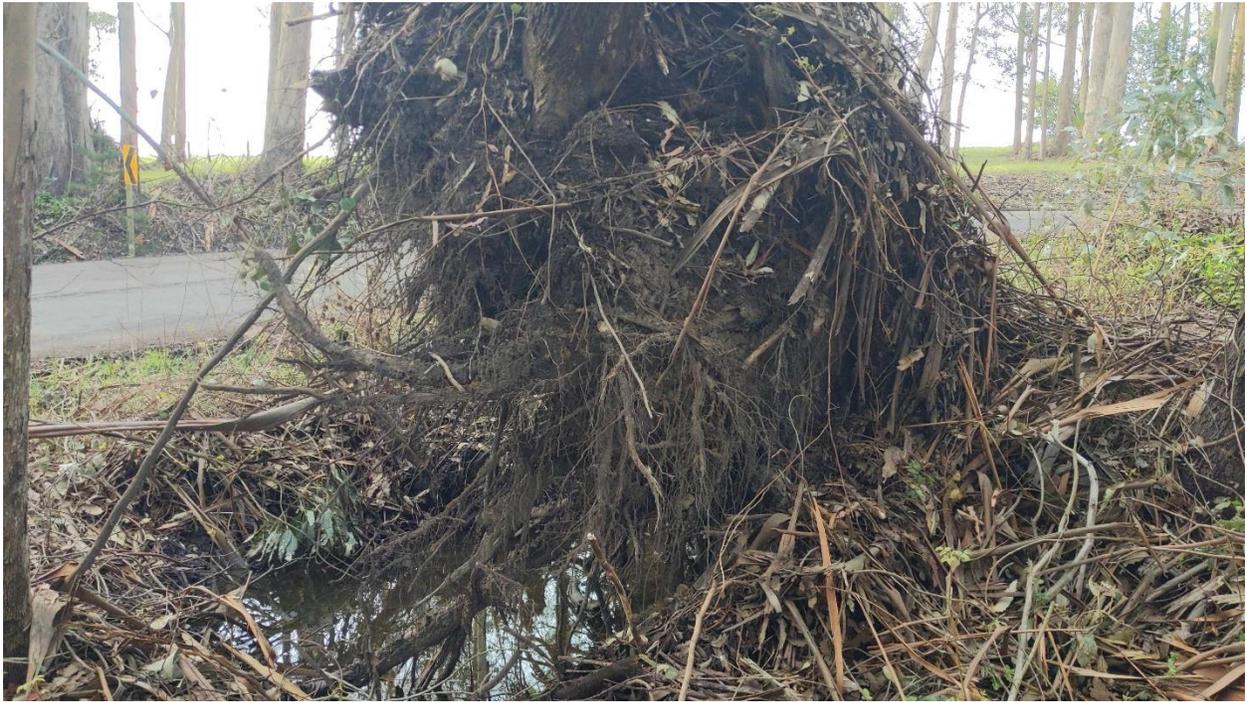
The photo below shows the ground saturation that occurred shortly after a tree along Mesa Road blew down. The root balls had been consistently anchored each with a large number of 1-2” diameter roots. In Figure 15 the water table had risen to the point that the large tree structure was not supportable given the wet soil conditions, but earlier in the same week, other trees had blown down without a high level of root ball saturation. The trees at Zone 5 today are up to 3 times the height of the native oak woodland trees that most likely occupied the site in pre-European times. This suggests that the soils in the area have not evolved with large, and tall trees that are vulnerable to the high gusts of southerly winds characteristic of Pacific coastal winter storms.

Figure 15 Root ball alongside Mesa Road

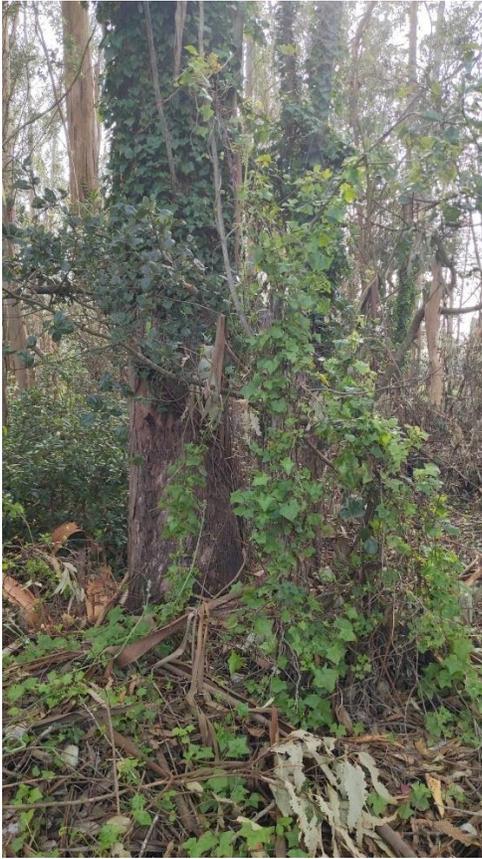
Figure 17 Vines of English ivy and Cape ivy climbing trees on a private parcel

There is extensive vine cover of English ivy and Cape Ivy spreading mostly on the northerly parcels. Suffice it to say that the allelopathic nature of Eucalyptus stands effectively eliminates native flora and instead results in fire- and windthrow-prone monocultures that attract hardy invasives such as broom, English Ivy, cape Ivy, and Acacias. Such conditions are common around the Bay Area and they create artificial exotic vegetative conditions that beg for the restoration of oak woodland biodiversity that supports the broad array of native flora and fauna.
