## Bolinas Community Public Utility District & Bolinas Fire Protection District

### **Hazard Tree Mitigation Report**

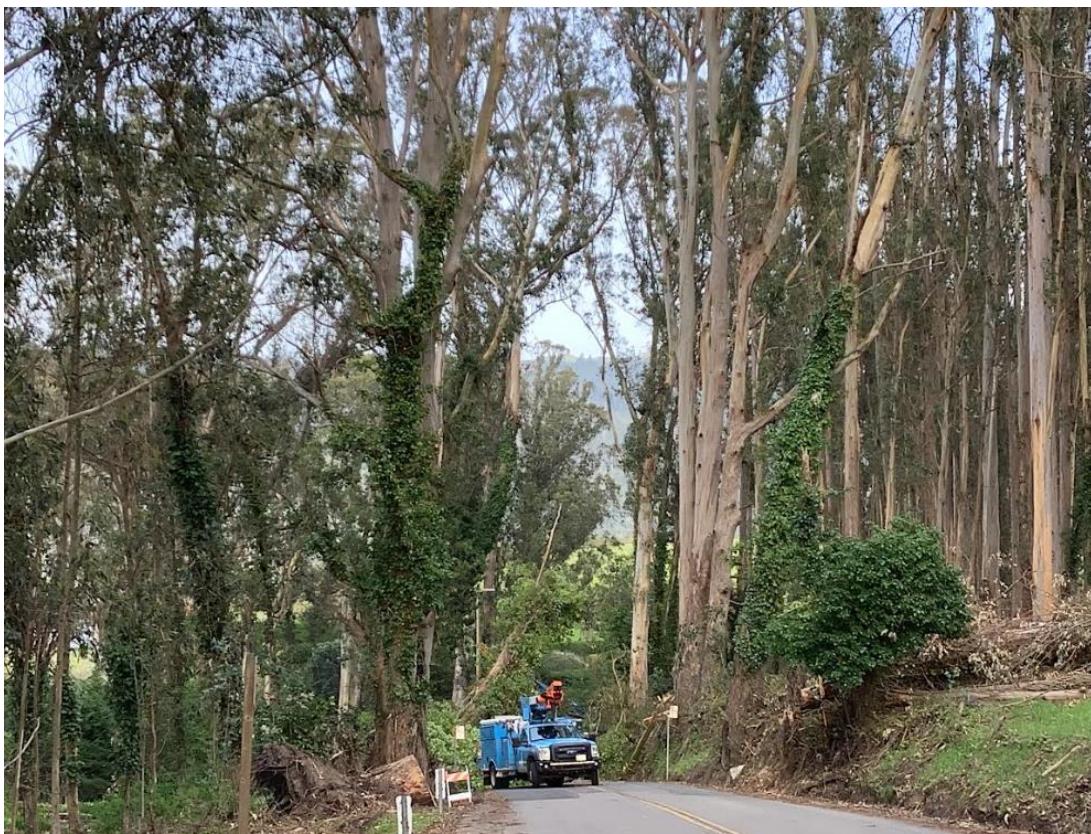
*Figure 1 Zone 5 PG&E crews repair destruction caused by falling trees along Mesa Road*

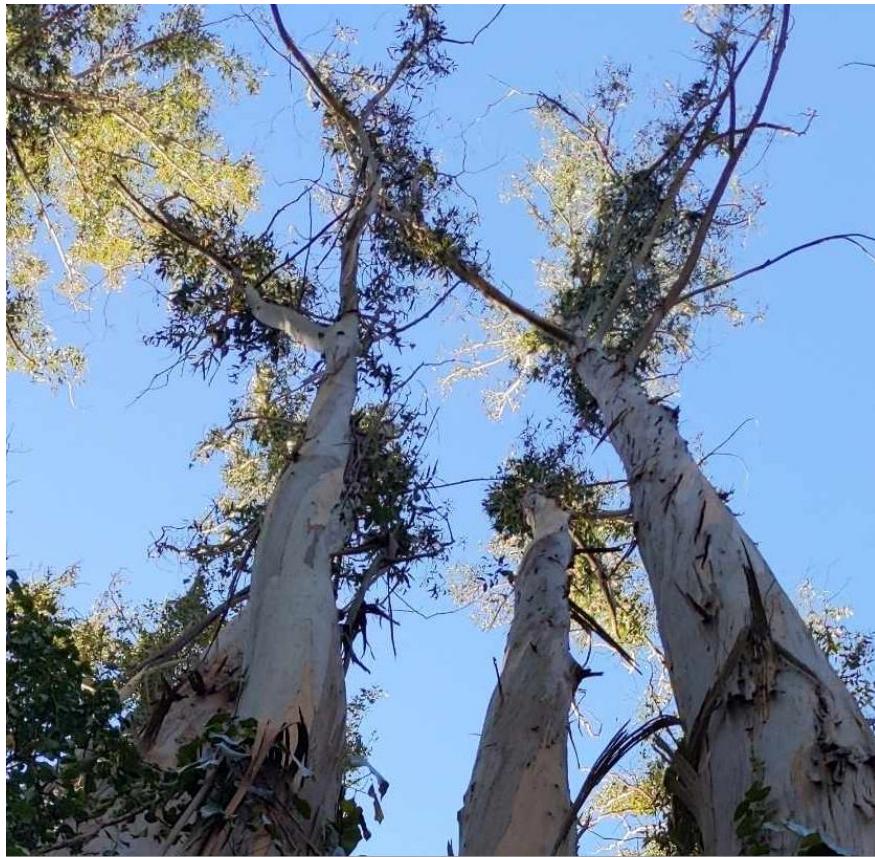
*Figure 8 Typical view of Zone 5 sparse Eucalyptus crown looking upwards*

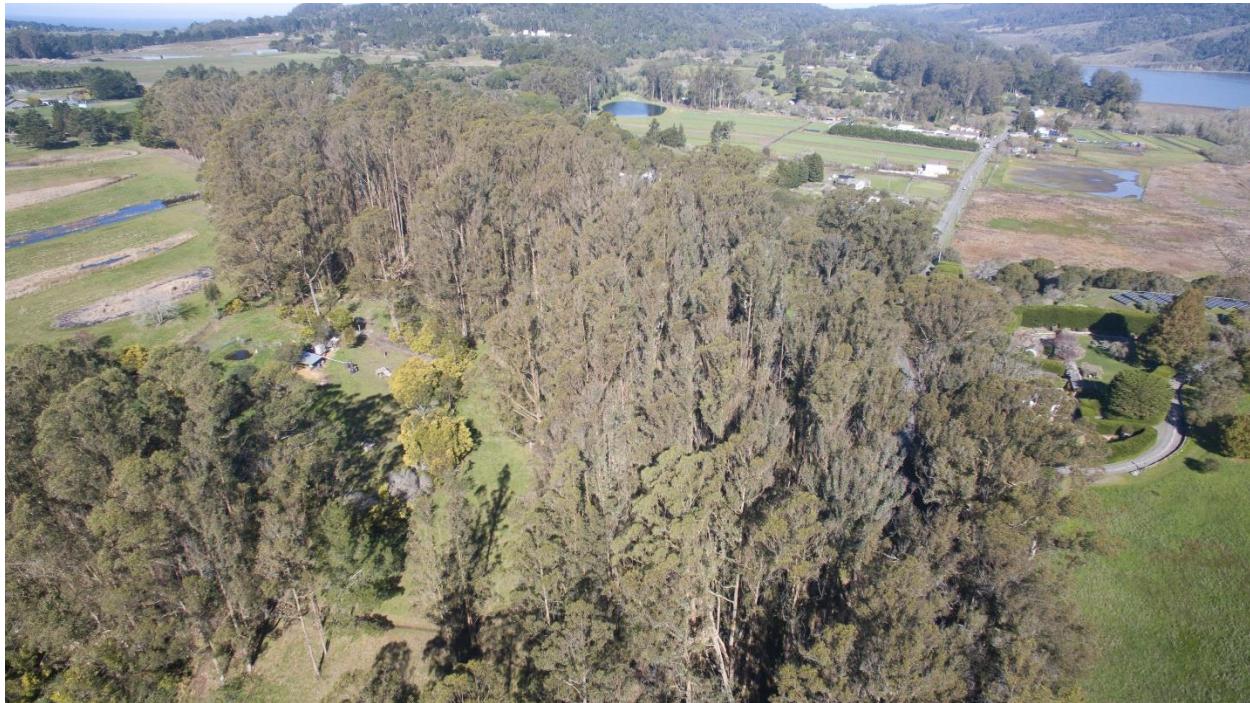
Figure 9 Looking west toward sparse tree tops and crowded canopies at Zone 5. Aerial imagery March 2023.

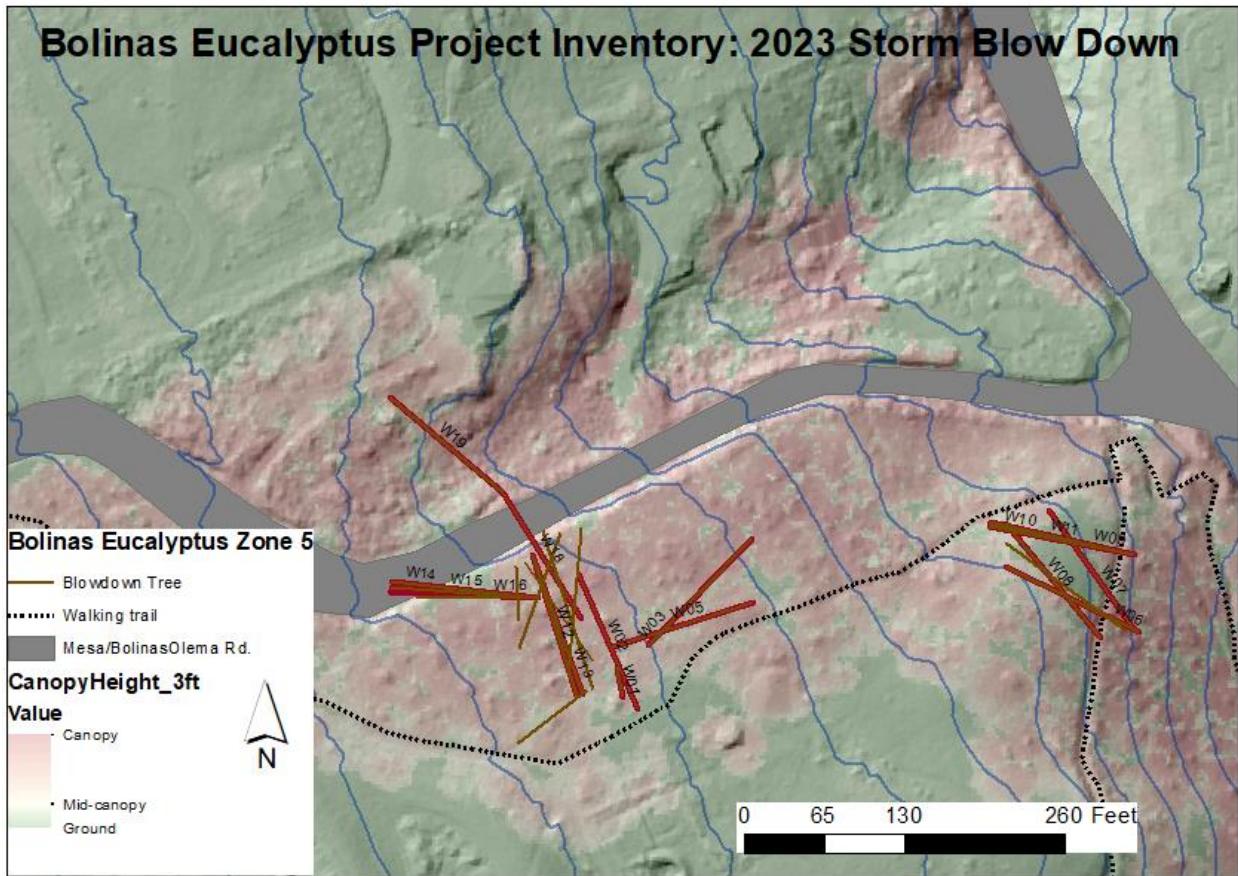
During the January 2023 storm series 24 trees within the grove blew down over several nights. These trees were 14" to 63" in diameter and each had been over 100' tall. Half of the blown down trees were over 20" in diameter and 5 of them were 30" and larger. Several smaller but tall trees were hit by falling trees. They broke and they fell. A small number of other trees are "leaners", supported by their neighbors, and they could fall at any time. Aside from the damage to the stand of trees the impacts of the storm included major injuries to 2 persons in a passing vehicle. The forester reviewed the damage to the stand and measured each fallen tree's diameter, GPS location and direction of fall. Most windfall trees were lying on the ground with azimuth of west to northwest. The exceptions were the very large 63" blue gum that fell across the road, and collateral damage of fallen trees struck by adjacent blown down trees. The elimination of 24 trees created new gaps in the canopy which render residual trees increasingly vulnerable to ongoing blow down. Though most trees that fall are blown down by the south or northerly winds during saturated soils conditions, it does not seem possible to predict which trees will fall next, or in which direction.

Figure 12 Trees blown down in the January 2023 winds

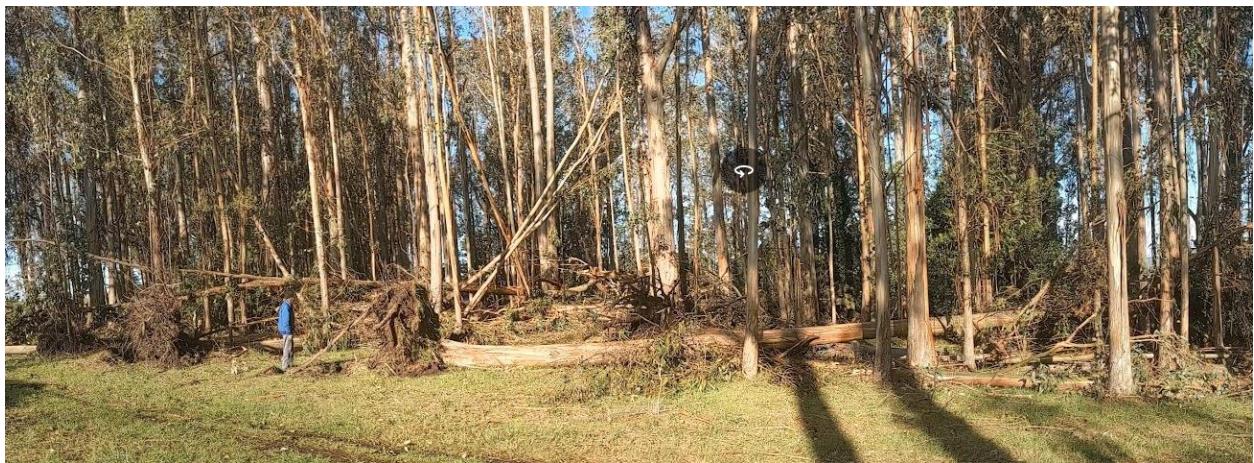
Figure 13 Some January 2023 wind thrown blown down trees

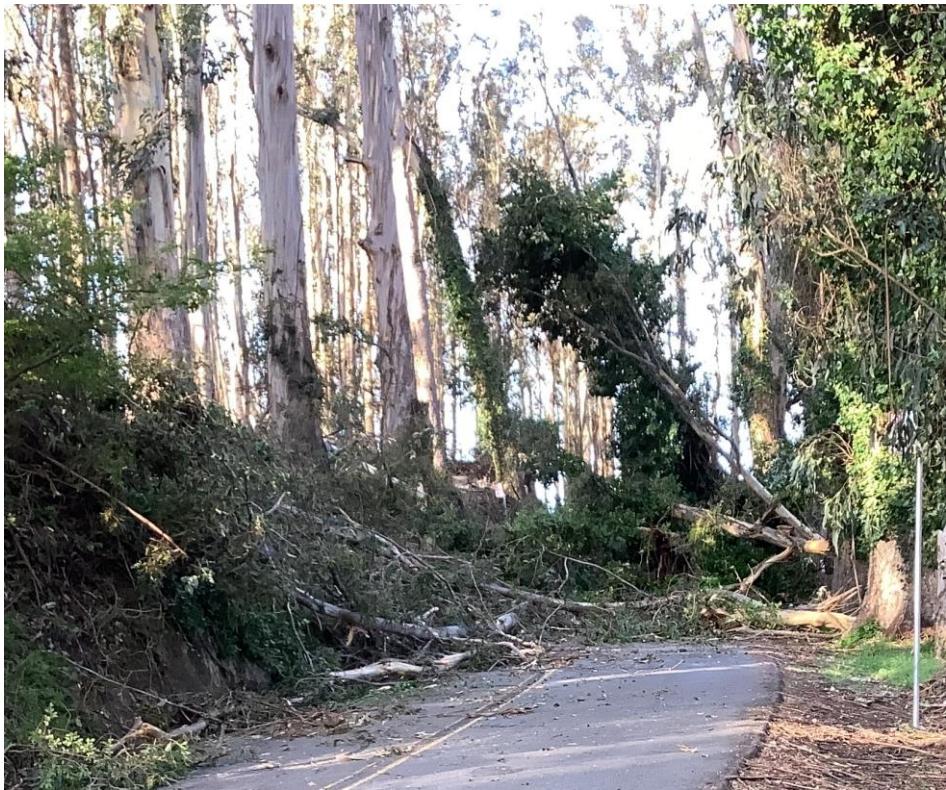
*Figure 14 Two large trees fell across Mesa Road on March 3, 2023*

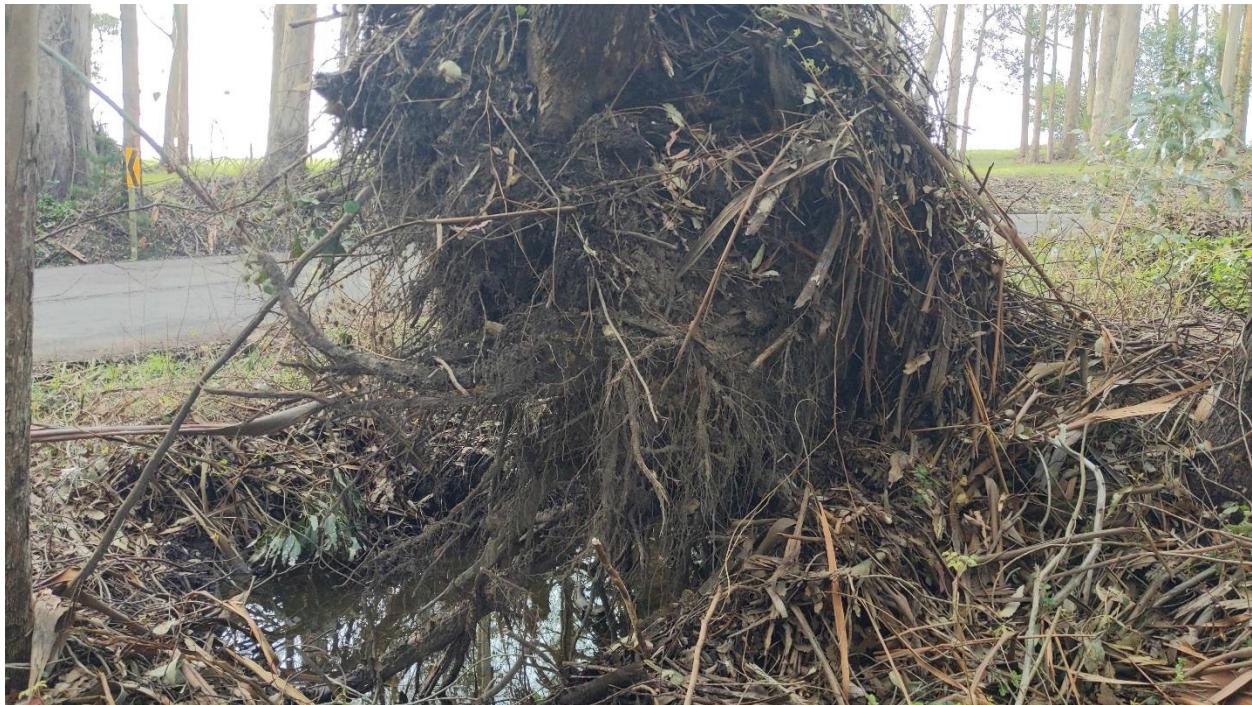
The photo below shows the ground saturation that occurred shortly after a tree along Mesa Road blew down. The root balls had been consistently anchored each with a large number of 1-2" diameter roots. In Figure 15 the water table had risen to the point that the large tree structure was not supportable given the wet soil conditions, but earlier in the same week, other trees had blown down without a high level of root ball saturation. The trees at Zone 5 today are up to 3 times the height of the native oak woodland trees that most likely occupied the site in pre-European times. This suggests that the soils in the area have not evolved with large, and tall trees that are vulnerable to the high gusts of southerly winds characteristic of Pacific coastal winter storms.

Figure 15 Root ball alongside Mesa Road

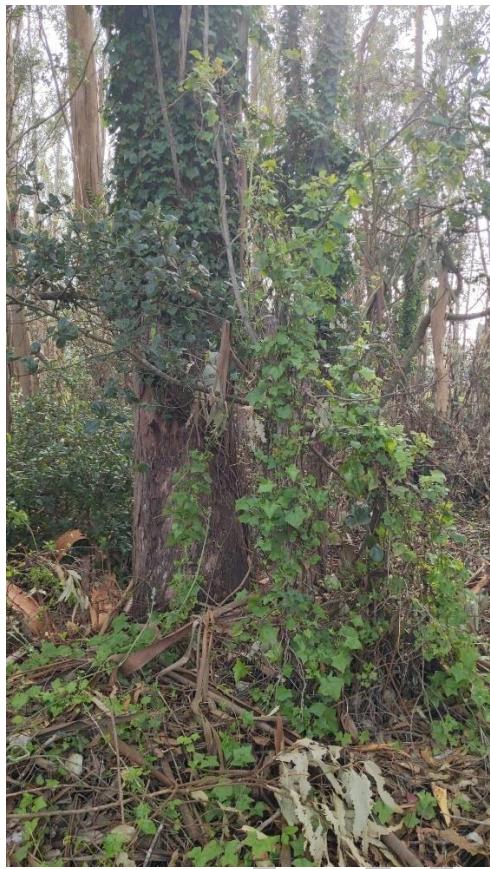
Figure 17 Vines of English ivy and Cape ivy climbing trees on a private parcel

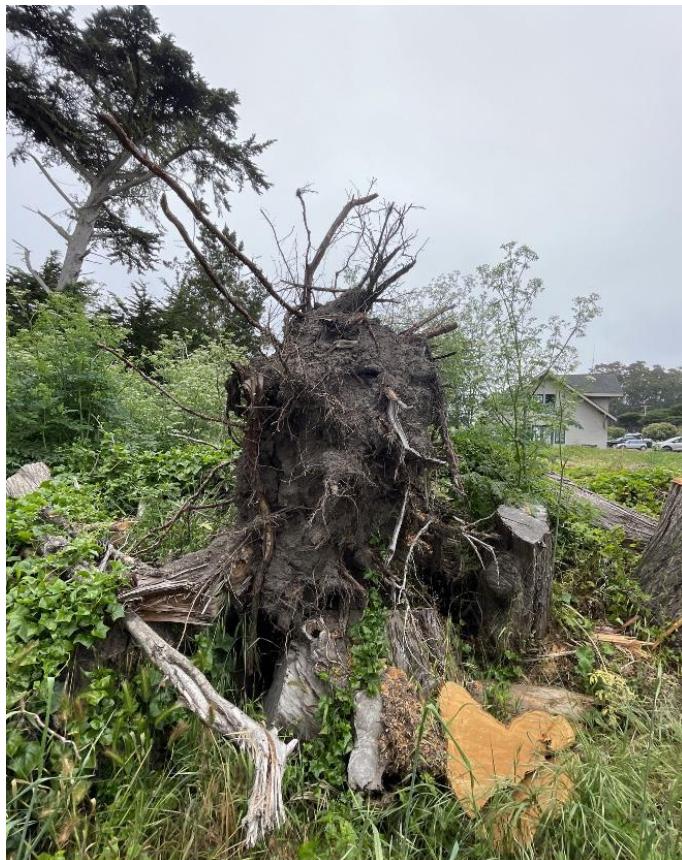
**Crowding = Deformed Root System**

Figure 1 – The crowded planting of the cypress border planting allowed little room for root growth.

**Recommendation:** Directional fell the entire windrow into the field. Remove and chip branches for fire prevention. If the border planting is replaced consult a consulting arborist about species selection and spacing.

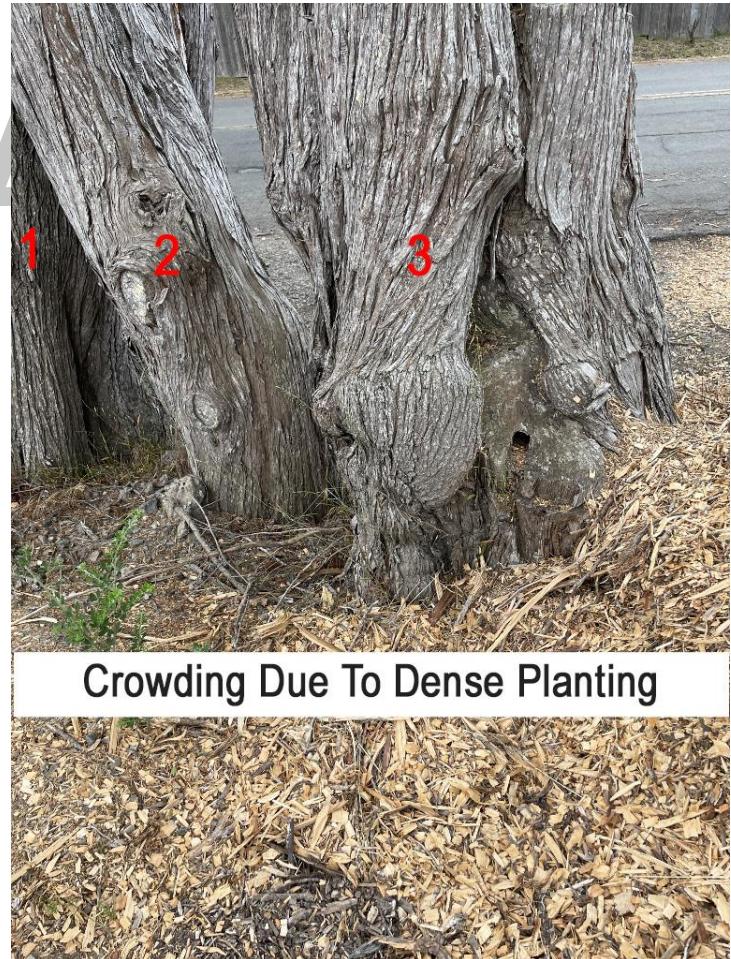
Figure 2 – The crowding of the trees has led to abnormal root and canopy development.

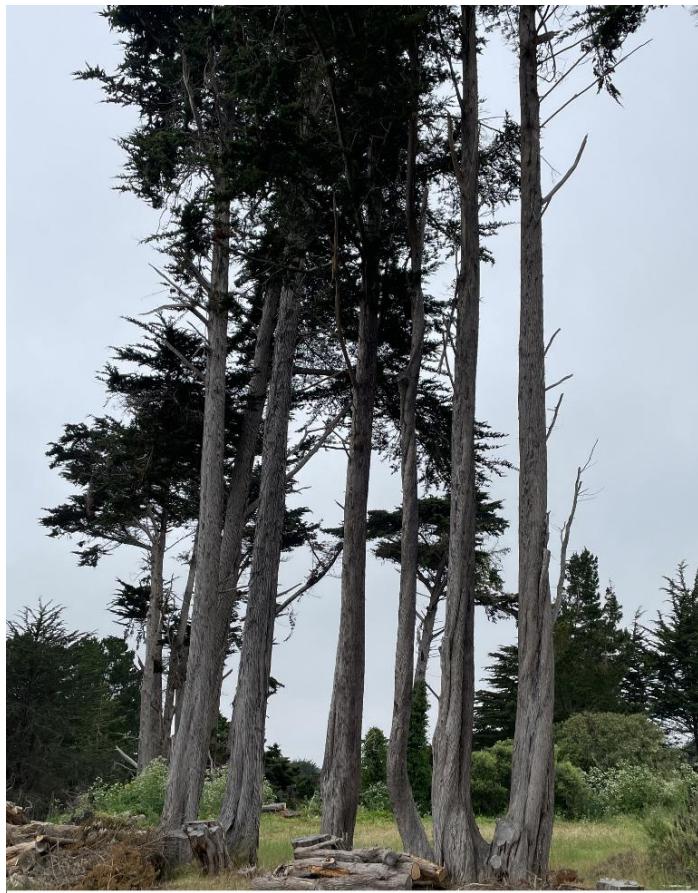
**Crowded planting = Lion's Tailing & Excessive Height**

Figure 3 - Competition for growing space has led to excessive height growth, lion's tailing and lever force on the compromised root systems.

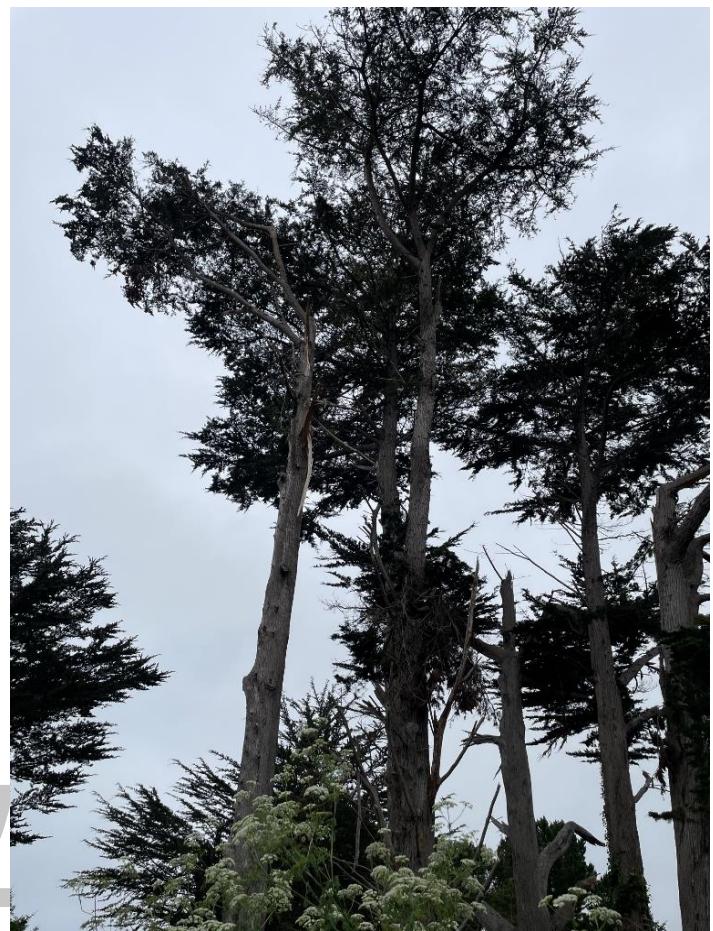
Figure 4 - Lack of adequate growing space has asymmetric canopies with over-extended limbs and in many cases lion's tailed branches.

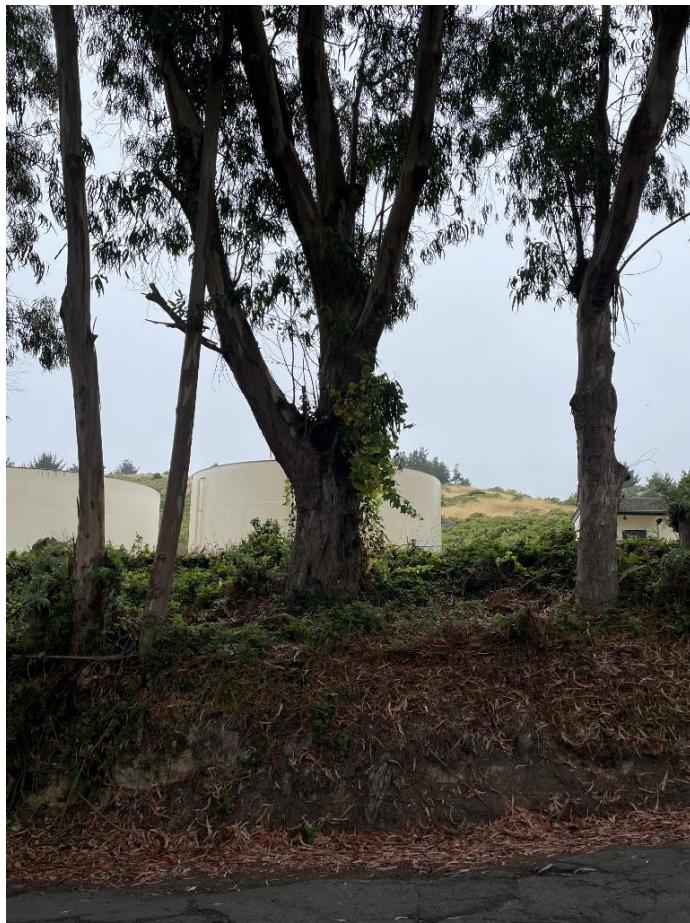
Figure 5– Suppressed trees left, dominant tree center, deformed tree right.

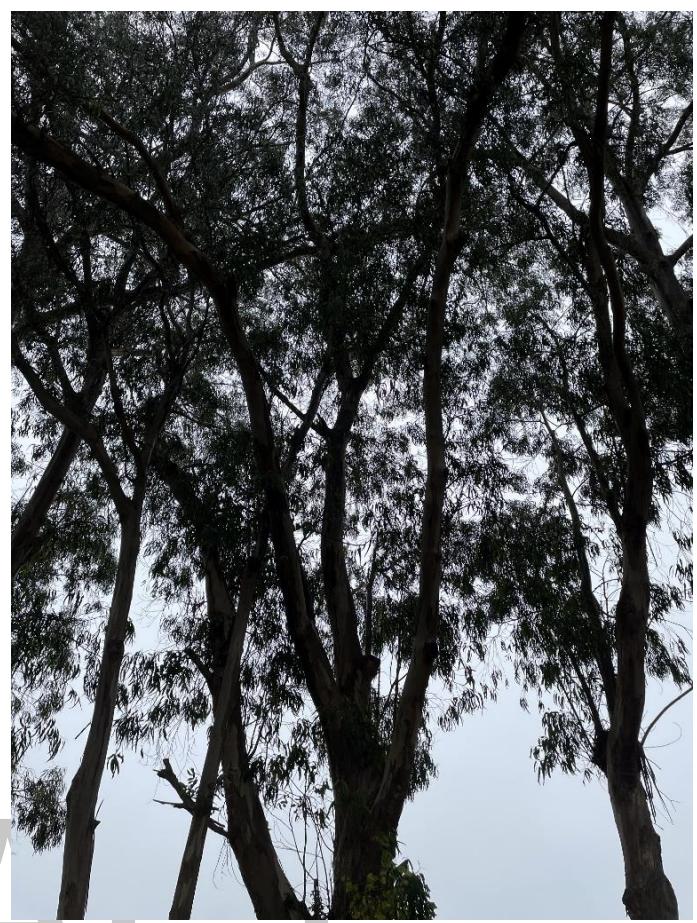
Figure 6- Crowding resulted in crossing branches and asymmetric canopies.
