## ARBORIST REPORT

### **Assessment of 14 Eucalyptus Stands Locations, Attributes, Fire Hazards, Treatments & Priorities Bolinás, California**

*Prepared for:*  
**Wildfire Safe Bolinas**

**March 18, 2021**

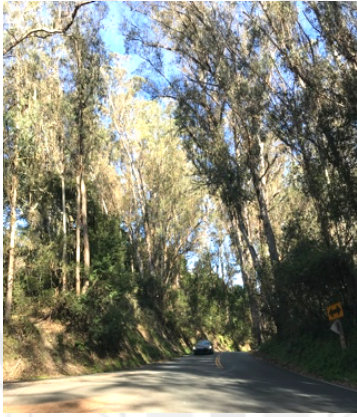
No.	Location	Size (ac.)	Photo	Notes
1	HWY 1, Horseshoe Hill Road	11

Dense stand of large roadside eucalypts that have spread both uphill and downhill across a drainage. Native trees include California bay, coast live oak and Douglas-fir. The understory is dense with heavy fuel loading. Above-ground electrical distribution wires with transformer are present. Located at confluence of 2 primary evacuation routes for Bolinas.
2	Paradise Valley Road	2

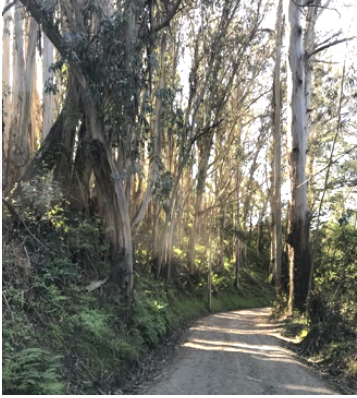
Dense stand of small to large eucalypts on both sides of the road with coast live oak, California bay, and Douglas-fir intermixed. The understory is dense with heavy fuel loading. A drainage parallels the road downslope to the northwest. Above-ground communication wires pass above the road and electrical wires skirt the western stand boundary. Sole evacuation route for Paradise Valley.

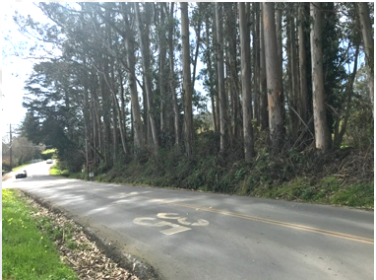
No.	Location	Size (ac.)	Photo	Notes
3	Horseshoe Hill Road, Lauff Ranch Road, Olema-Bolinas Road	1

<p>Dense roadside stand of moderate-size eucalypts intermixed with plum trees on the west side of the road. The understory is dense with heavy fuel loading. Above-ground electrical and communication wires pass by the stand across Horseshoe Hill Road. Located at the confluence of 2 primary evacuation routes for Bolinas.</p>
4	Star Route Farm	2

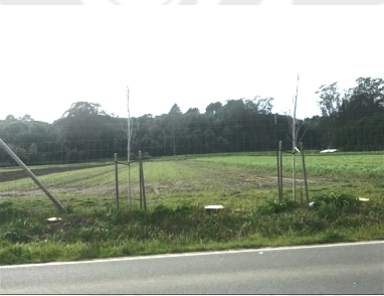
<p>Dispersed groves of large eucalypts growing on the eastern edge of a mixed evergreen forest and west of agricultural fields.</p>
5	Mesa, Olema Bolinas	12

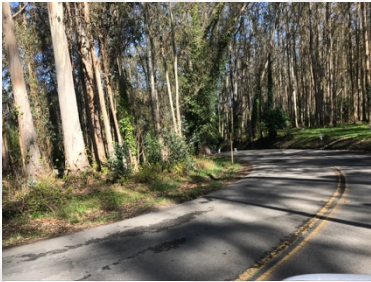
<p>Moderately dense stand including large roadside and smaller interior eucalypts. Treated understory south of Mesa Road and largely untreated understory north of the Mesa Road. Above-ground electrical and communication wires pass through the stand. Located at confluence of 2 primary evacuation routes for Bolinas.</p>

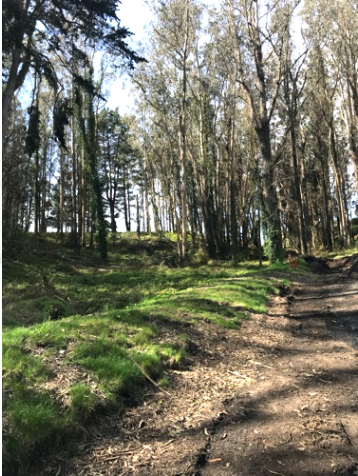
6	Bolinas-Stinson Resource Recovery Project Site	10

<p>Dense stand of small to moderate size eucalypts with canyon topography. Understory vegetation upslope of Resource Recovery building has been removed. Other areas have dense understory vegetation with heavy fuels and steep slopes.</p>

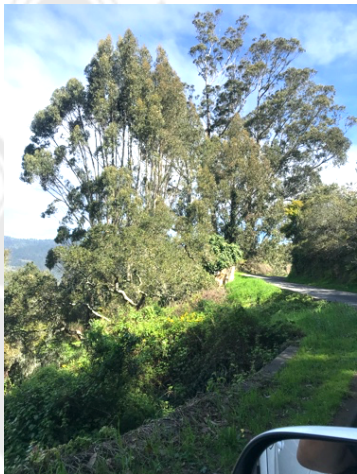
No.	Location	Size (ac.)	Photo	Notes
7	Altura Avenue	1

<p>Several groves of small to large eucalypts intermixed with Monterey pine on both sides of the steep one-way road. Unmanaged understories with heavy fuels. Ridge topography where high winds are common.</p>
8	Dogwood Road, Evergreen Road, Mesa Road	5

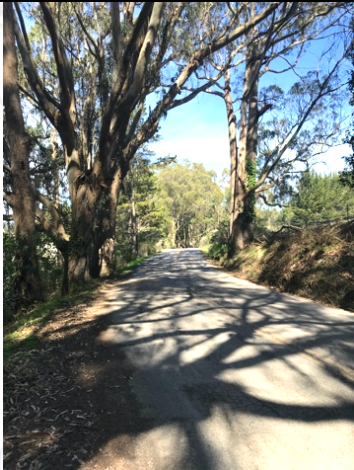
<p>Roadside eucalypts of small to large sizes intermixed with rows of Monterey cypresses and disbursed Monterey pines. Above-ground electrical and communication wires pass through the stand. Evacuation route for Mesa Road, Point Reyes Bird Observatory, and Palomarin Beach and Trailhead.</p>
9	Purple Gate Road	12

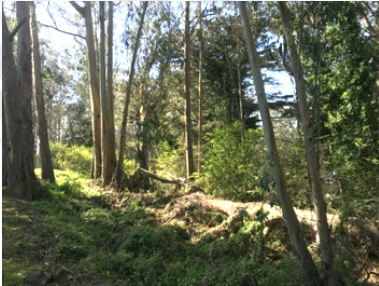
<p>Dense stand of small to large eucalypts intermixed with Monterey cypress and plum trees in a canyon topography setting. Mix of understory clearing intensity, but generally heavy ground fuels.</p>
10	Yucca Road, Ocean Parkway, Larch Road	4

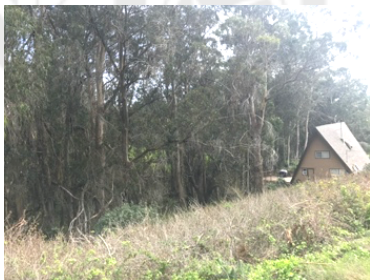
<p>Dense stand of medium to large eucalypts in a canyon topography setting. Heavy untreated ground fuels.</p>

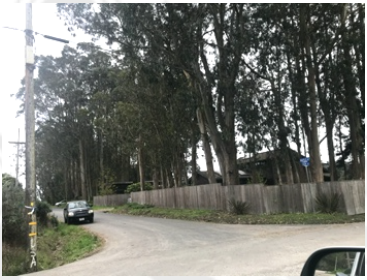
No.	Location	Size (ac.)	Photo	Notes
11	Elm Road, Maple Road, Cherry Drive	2

Dense stand of small to large eucalypts in level residential setting. Understory mostly unkempt with heavy fuels except for fenced yards where small trees have been removed and brush controlled.
12	Kale Road, Elm Road, Iris Road, Hawthorne Road	3

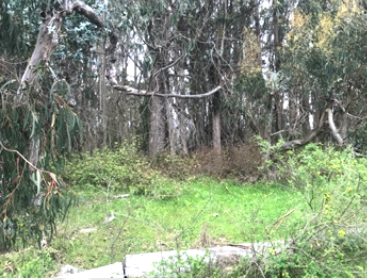
Dense stand of small to moderate size eucalypts intermixed with green wattle acacia and Monterey pine in a level residential setting. Untreated understory with heavy fuels.
13	Aspen Road, Elm Road	1

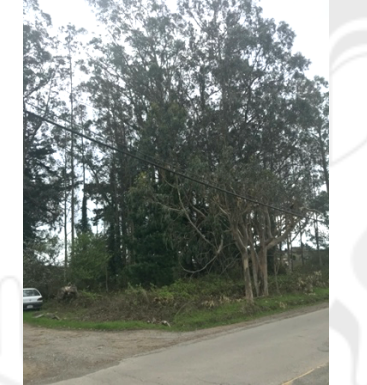
Dense stand of smaller eucalypts intermixed with Monterey pine in a level residential setting. Untreated understory with heavy fuels.
14	Terrace Avenue, Ocean Parkway, Marin Way	4

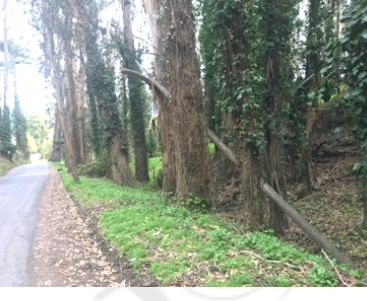
Dense stand of medium to large roadside eucalypts that have spread uphill on both sides of the road. The understory is dense with heavy fuel loading. Above-ground electrical distribution wires with transformer and communication wires are present. Terrace Avenue is a critical alternate evacuation route should Mesa Road be blocked or impassible due to fire.
