BCPUD PIPELINE

Winter 2019-20

BCPUD Projects Planned for 2020!

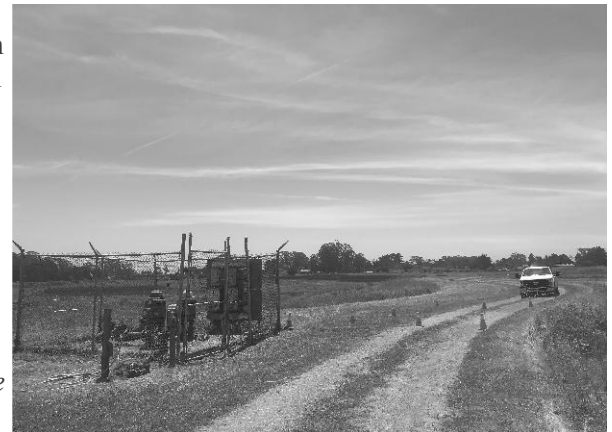
To dispose of the treated effluent from the final treatment pond, the district uses an irrigation pump station (*pictured to the right inside the chain link fencing*) to draw the effluent from the pond and distribute it out to the disposal fields via a network of sprinklers. The existing irrigation pump station is nearing the end of its useful life as it is nearly 50 years old. The two existing pumps in the station are 40-hp vertical turbine pumps extending 15-feet below the ground surface, drawing effluent from near the bottom of the final treatment pond through an 85-foot subsurface horizontal pipe to the station. The station is controlled by a nearby electrical control panel; this equipment is not enclosed or otherwise protected from the coastal marine environment. BCPUD operators have experienced significant maintenance issues with the pumps, which are located in underground casings and therefore constantly exposed to a highly corrosive wastewater environment. A crane is required to lift the pumps out of their casings for maintenance and repairs, which is excessively expensive given the BCPUD’s remote location and adds considerable to the expense of routine operation and maintenance.

The existing irrigation pump station is nearing the end of its useful life as it is nearly 50 years old. The two existing pumps in the station are 40-hp vertical turbine pumps extending 15-feet below the ground surface, drawing effluent from near the bottom of the final treatment pond through an 85-foot subsurface horizontal pipe to the station. The station is controlled by a nearby electrical control panel; this equipment is not enclosed or otherwise protected from the coastal marine environment. BCPUD operators have experienced significant maintenance issues with the pumps, which are located in underground casings and therefore constantly exposed to a highly corrosive wastewater environment. A crane is required to lift the pumps out of their casings for maintenance and repairs, which is excessively expensive given the BCPUD’s remote location and adds considerable to the expense of routine operation and maintenance.

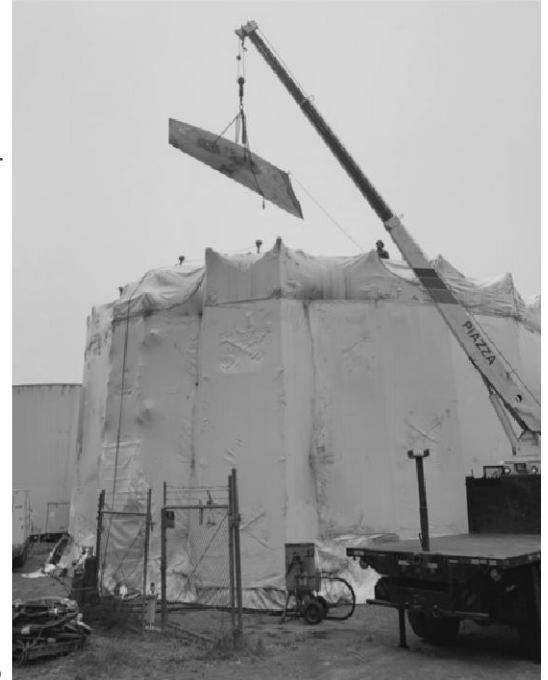
The district’s project to rehabilitate the “East Tank”, one of its two treated water storage tanks located on Mesa Road, is nearing completion following delays due to weather and due to significant unanticipated repairs that were needed to the roof of the tank as a result of extensive corrosion. Once the former coating was blasted off the tank interior at the outset of the project, it became clear that nearly 50% of the roof needed to be replaced. It required several months to engineer the roof repair component of the project, procure the needed materials, and install the new roof plates. (*See photo to the right of the roof repair underway.*). As of January 2020, the East Tank interior rehabilitation is fully complete and the tank is going back in service. However, there is work remaining on the exterior that can be done without containment, and we anticipate it will be completed once the rainy season is concluded, in the late Spring or early Summer 2020.
