***Eucalyptus and Monterey Cypress Tree Failure Analysis and Risk Assessment***

**Bolinas Community Public Utility District**  
270 Elm Road  
Bolinas, CA. 94924

## 270 ELM ROAD RISK ASSESSMENT

### **290 MESA ROAD EUCALYPTUS WINDROW**

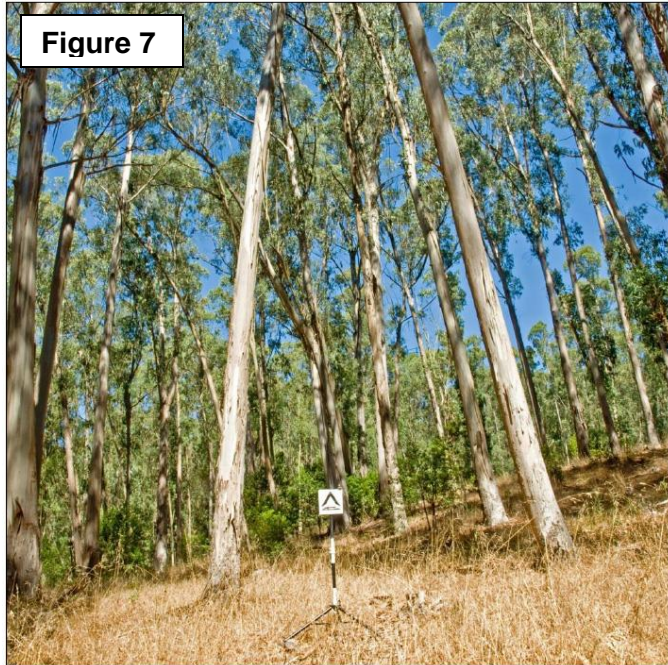
Figure 7

- **Turning his attention to fuels and fire behavior, he cites the role of Eucalyptus fuels as a contributing factor to the intense fire behavior in the 1991 Oakland/Berkeley “Tunnel Fire”. The initial fuels of the Tunnel Fire were brush, an unfinished structure, habited structures and Monterey pine forest. Fire modeling has ignored the role of houses (zero enthalpy), but residential structures have many times the enthalpy (combustion heat yield) of forest types, including Eucalyptus. This is not to say that Eucalyptus crowning fire did not play an important role in the Tunnel Fire, but canopy fire can be controlled with undergrowth management, especially where the trees have high canopies. The 2011 thinning and undergrowth management significantly reduced the possibility of canopy fire in the grove. After the 2011 fire management treatment most of the grove was comparable to a Wright and Vihnanek EBE 2 level. Measuring understory branch debris and grass fuels after a series of severe storms does not provide an accurate picture of long-term fuel loading and architecture. Ongoing undergrowth management is critical to reduce the probability of crowning fire to a low level of significance. My inspection of the grove indicates that most of the grove is still at a EBE 2 level (8.2 tons per acre) (See Figures 7, 8 & 9)**

EBE 02 EAST BAY EUCALYPTUS FOREST

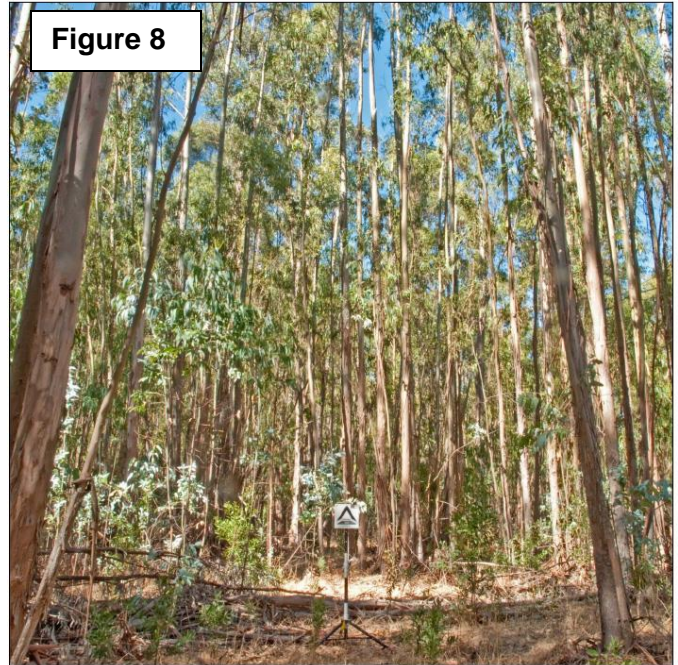
Figure 8

EBE 03 EAST BAY EUCALYPTUS FOREST
