## ARBORIST REPORT

### **Assessment of 14 Eucalyptus Stands Locations, Attributes, Fire Hazards, Treatments & Priorities Bolinás, California**

*Prepared for:*  
**Wildfire Safe Bolinas**

**March 18, 2021**

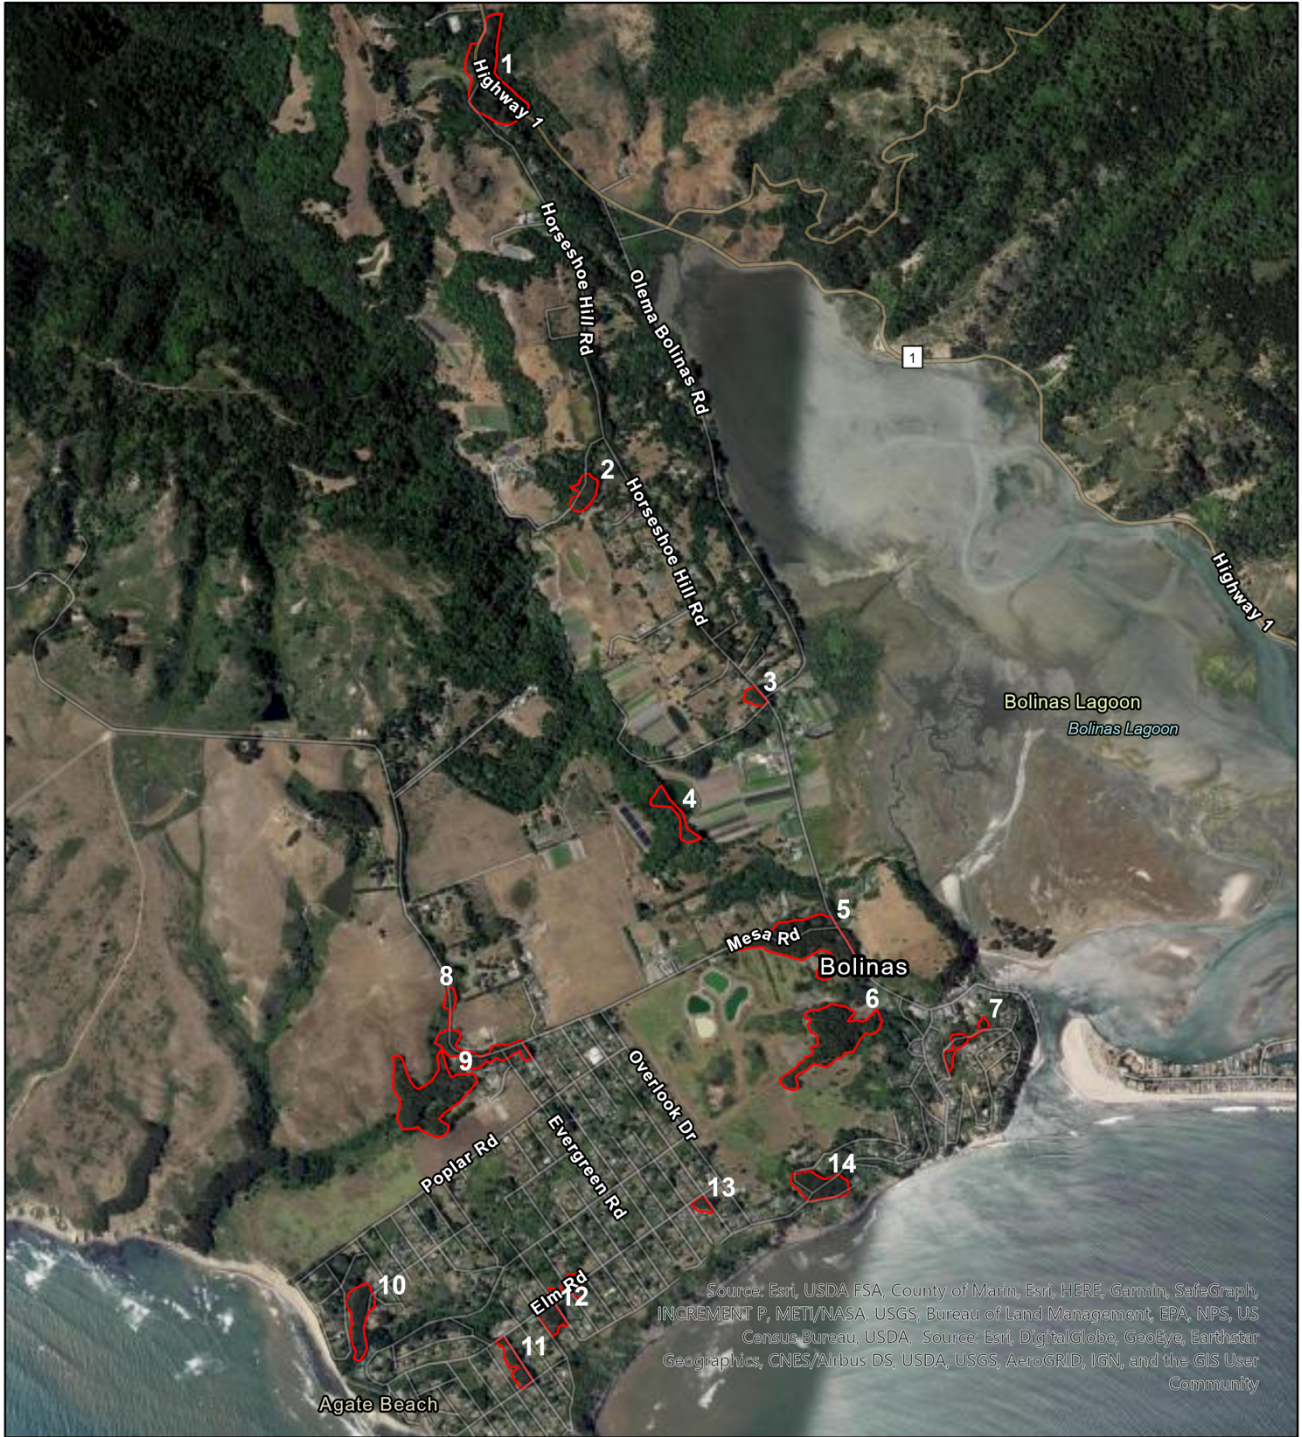
Dense stand of medium to large roadside eucalypts that have spread uphill on both sides of the road. The understory is dense with heavy fuel loading. Above-ground electrical distribution wires with transformer and communication wires are present. Terrace Avenue is a critical alternate evacuation route should Mesa Road be blocked or impassible due to fire.
