The Bolinas Eucalyptus Project Inventory: Zone 5

**A REPORT ON THE INVENTORY OF BOLINAS PUBLIC UTILITY DISTRICT AND
ADJOINING TREES IN ZONE 5**

BY TOM GAMAN, REGISTERED PROFESSIONAL FORESTER #1776

MARCH 2023

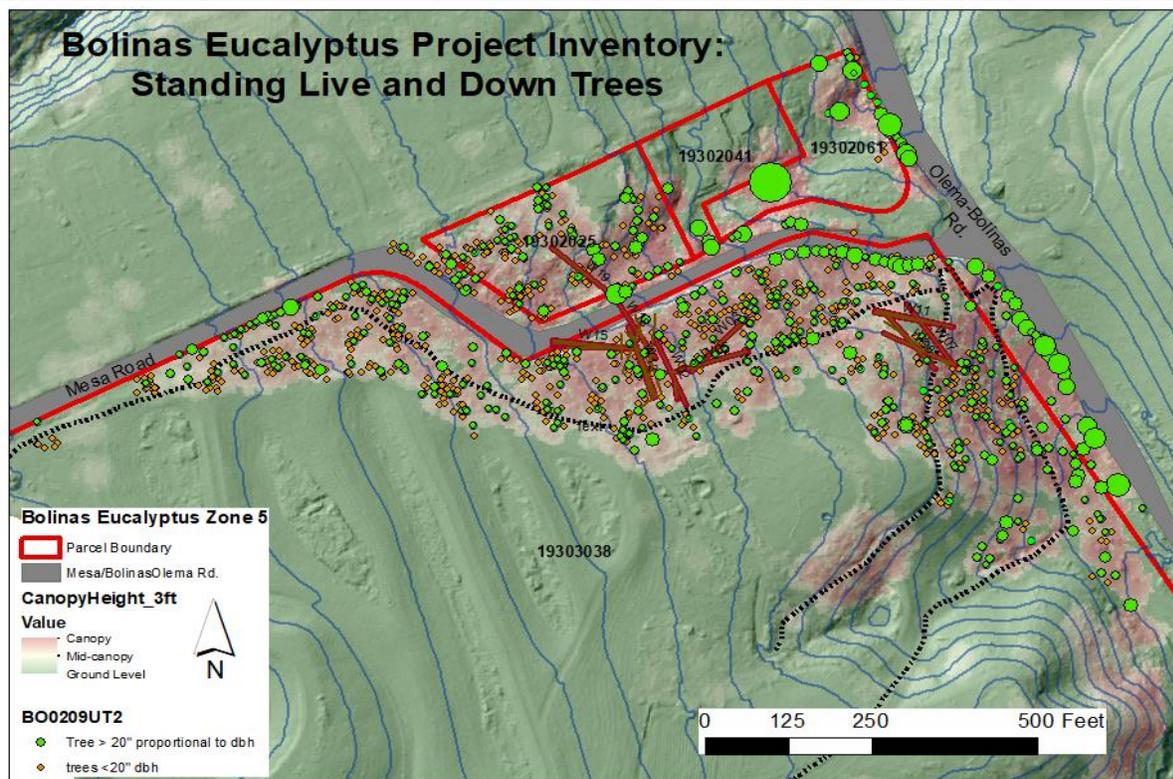
Figure 5 1139 trees. 11.9 acres. The size of each green dot represents relative tree diameter

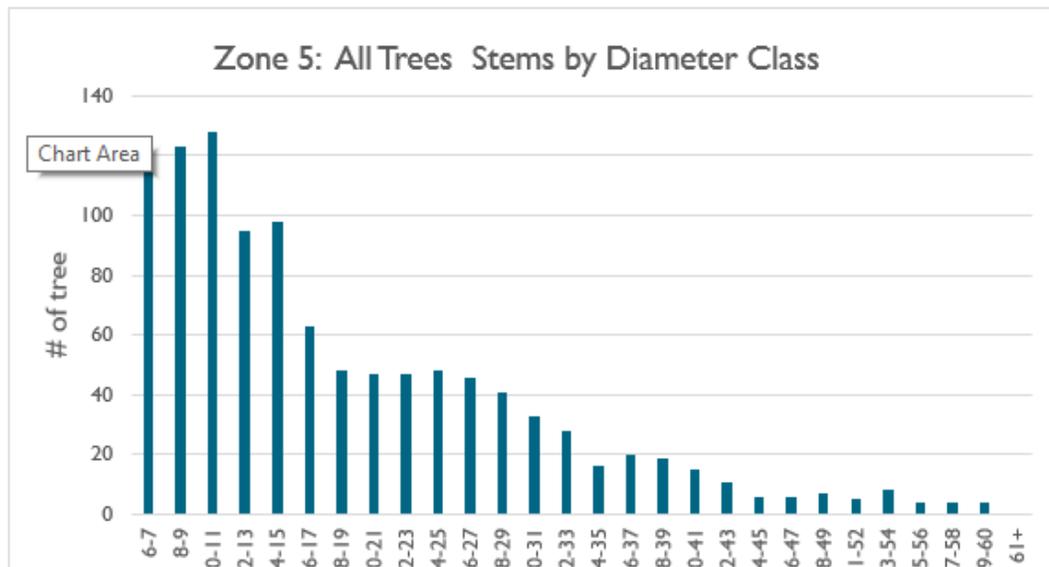
Figure 6 Number of trees by diameter class

trees in the 20" and above diameter classes in Zone 5 and 1139 trees including all trees 6" and larger. Figure 6 shows the number of trees in each 2-inch diameter class grouping.

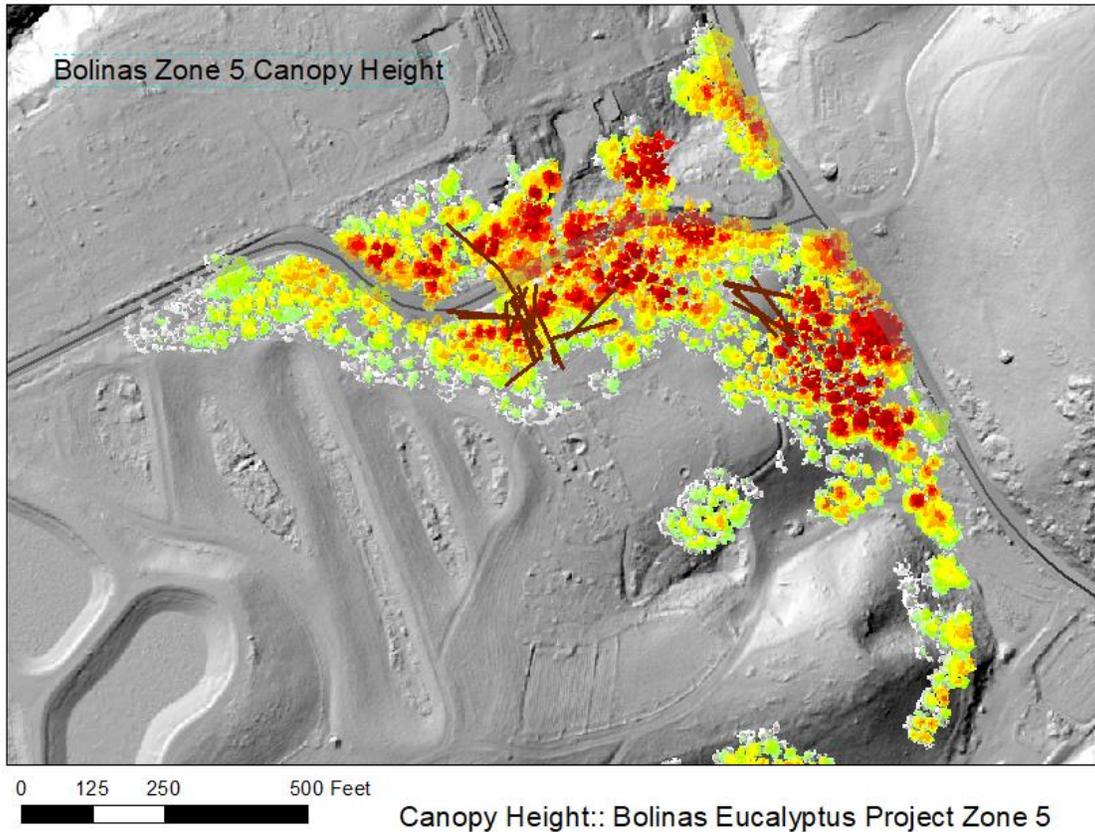
Figure 7 Canopy height: low to tall trees in white, green, yellow, orange and red respectively.

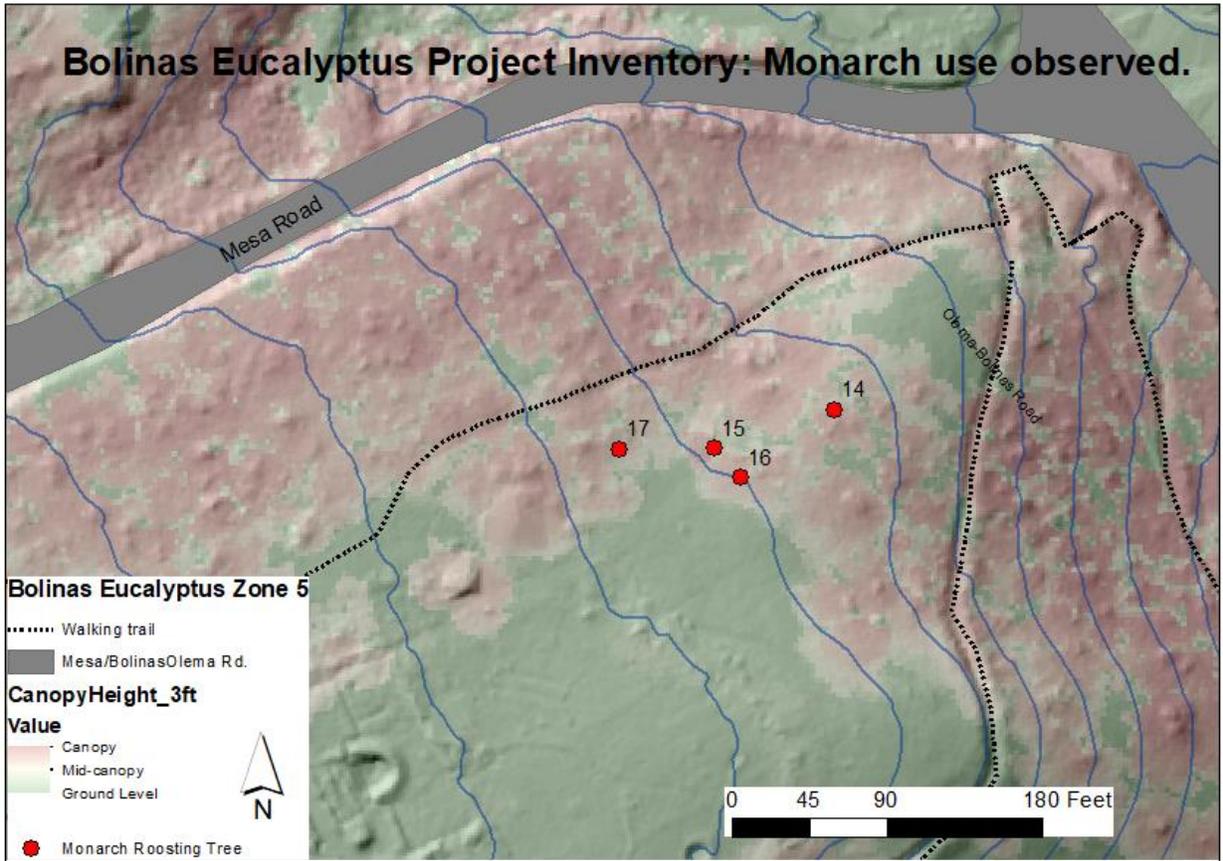
The Monarch butterfly migration occurred during the period of the inventory project and this is a phenomenon of great interest. The forester, accompanied by local butterfly experts, on a single occasion observed four blue gum trees being used by butterflies for roosting or daytime activities. Three of those trees were at the edge of the grove with sunny south-facing exposure, during calm temperate conditions which evidently created a suitable microclimate on that late-autumn day. Campbell (2022) cites many native and non-native host tree species each that “provides a dense and mature canopy”. Over time, use of the Zone 5 stand represents 1.45% of Bolinas Thanksgiving Count Monarch observations over the last 25 years (Xerces, 2023). New Year’s counts conducted from 2018 to 2023 have likewise only produced 22 Monarchs over the 7-year period, or an average of 3 butterflies a year. Given the sparse and deteriorating canopy conditions of this stand, the fact that no Monarch use has been reported at the site for 14 of the past 22 years, and supposing that the Monarchs have been utilizing coastal woodland habitats for many thousands of years, the evidence suggests that a native woodland restoration project could be developed that would enhance future Monarch habitat here.

Figure 16 Monarch use observed December 2022
