## Bolinas Community Public Utility District & Bolinas Fire Protection District

### **Hazard Tree Mitigation Report**

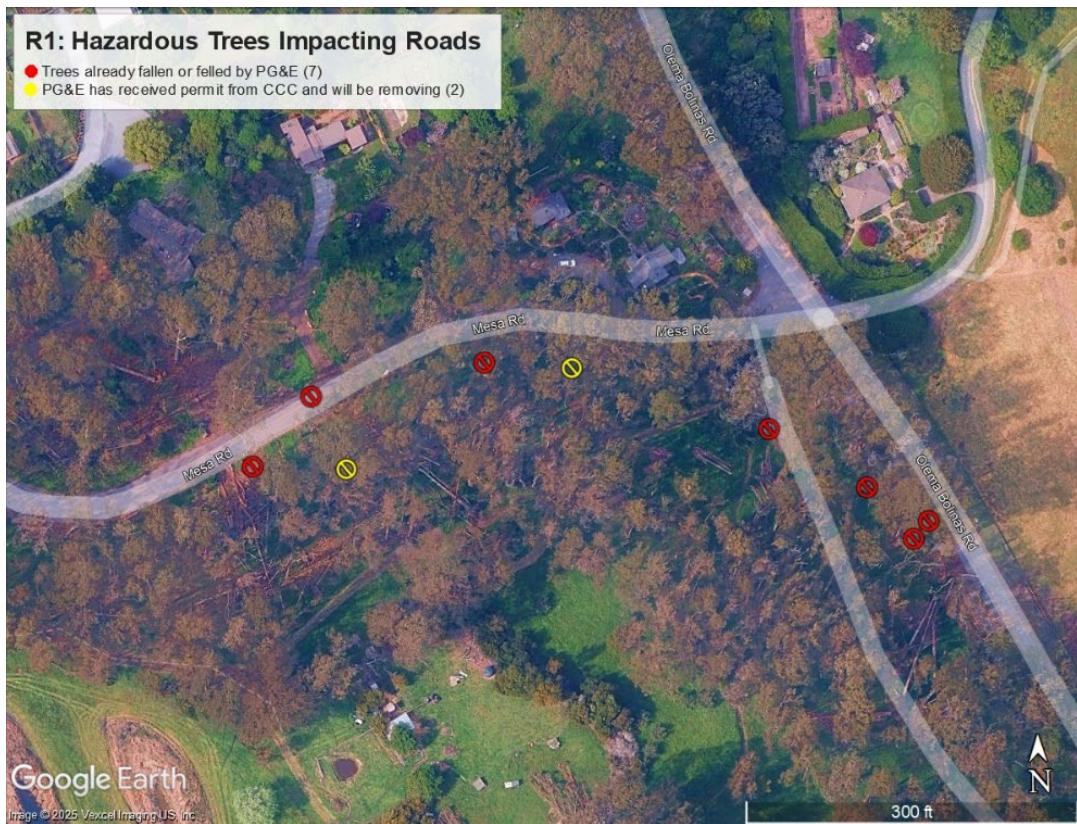
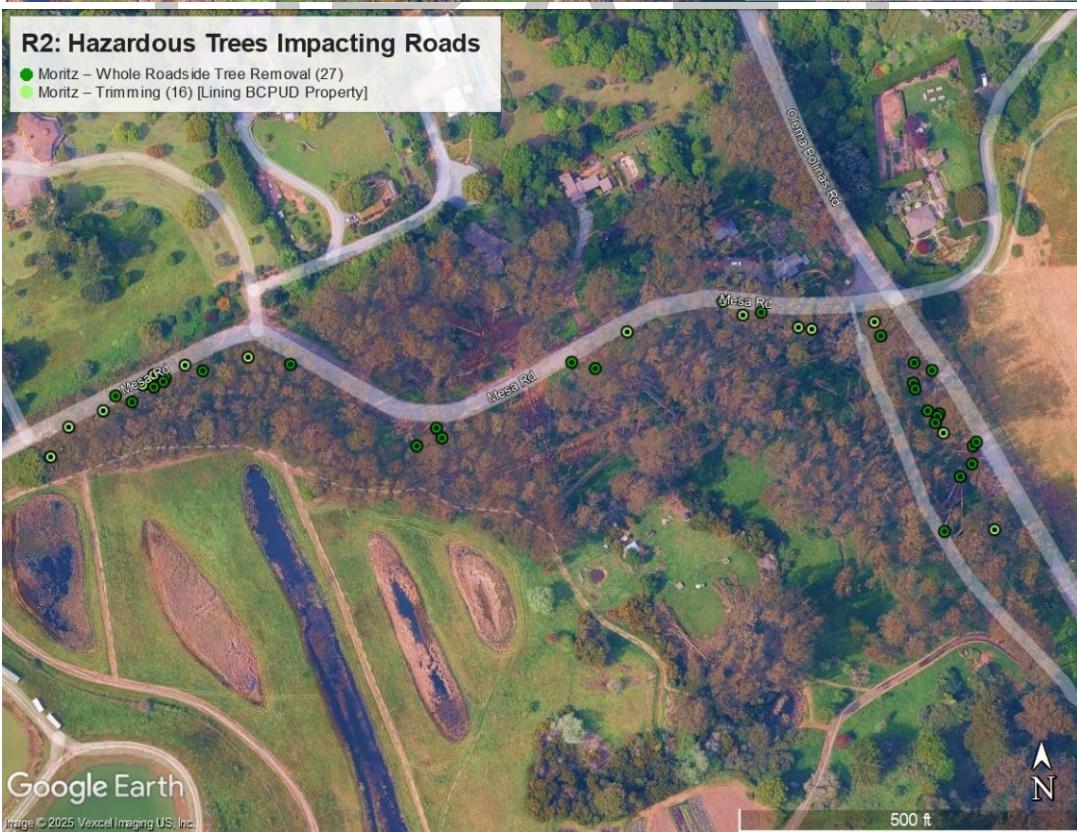
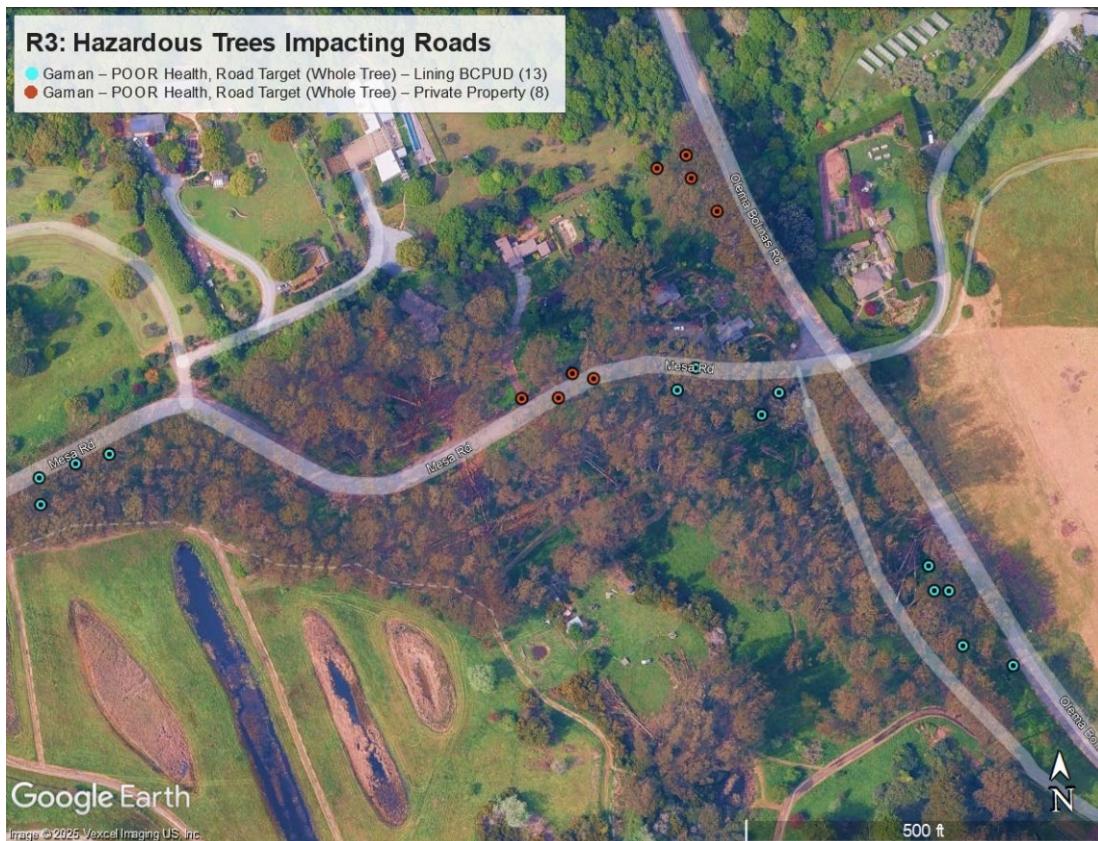
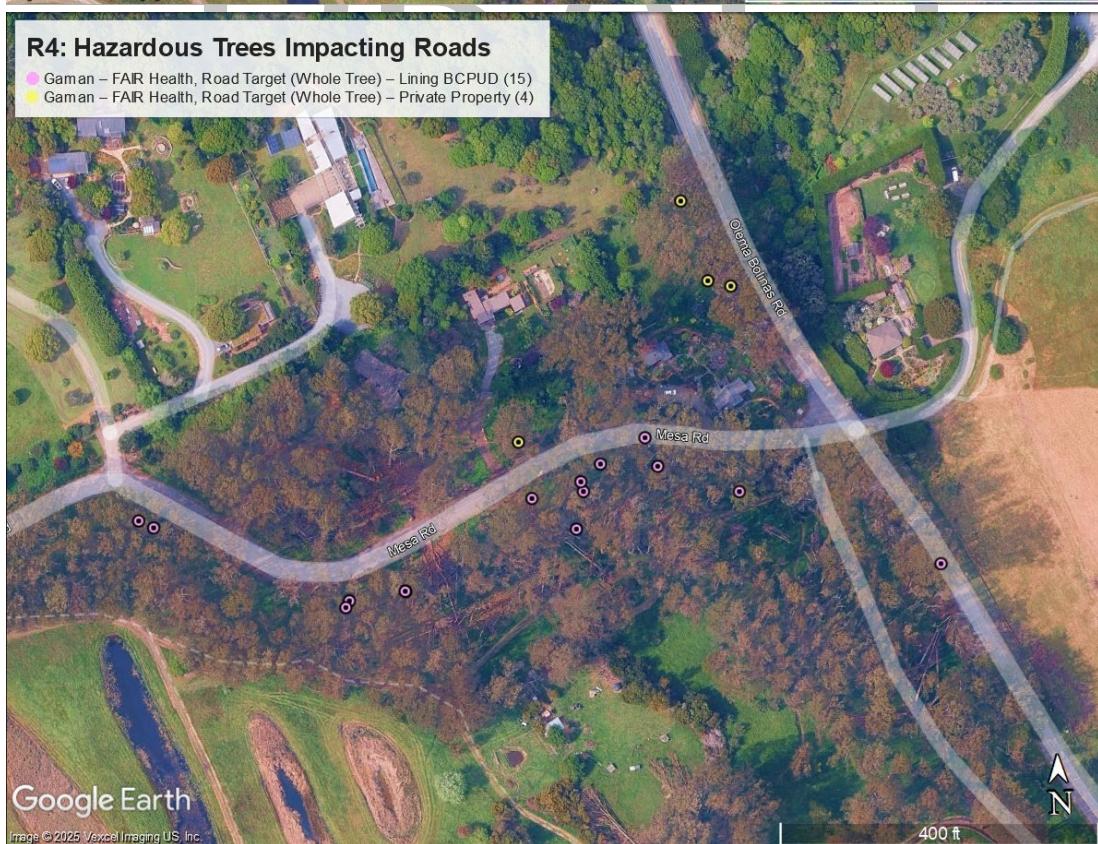
**Table 1: Hazardous Trees Impacting Roads**

Map ID	Category Name	# of Trees
R1	Trees already fallen or felled by PG&E (7) or PG&E has received permit from CCC and will be removing (2)	9
R2	Moritz – Whole Roadside Tree Removal (27) or Trimming (16) – Lining BCPUD Property	43
R3	Gaman – POOR Health, Road Target (Whole Tree) – Lining BCPUD (13) or Private Property (8)	21
R4	Gaman – FAIR Health, Road Target (Whole Tree) – Lining BCPUD (15) or Private Property (4)	19
<b>Total Road-Related Whole Tree Removals</b>		<b>76</b>
<b>Total Roadside Tree Prunings</b>		<b>16</b>

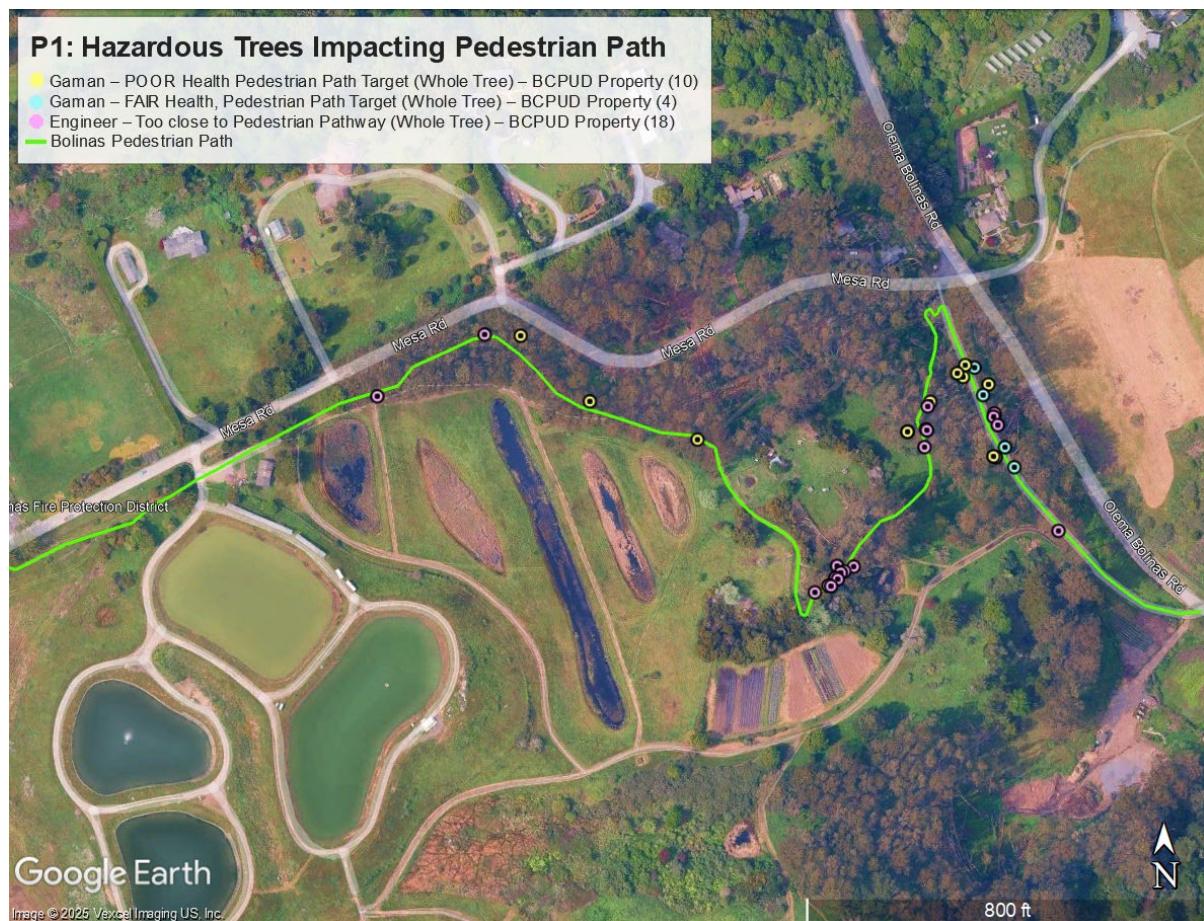
**Table 2: Hazardous Trees Impacting Pedestrian Path**

MAP ID	Category Name	# of Trees
P1	Gaman – POOR Health Pedestrian Path Target (Whole Tree) – BCPUD Property	10
P1	Gaman – FAIR Health, Pedestrian Path Target (Whole Tree) – BCPUD Property	4
P1	Engineer – Too close to Pedestrian Pathway (Whole Tree) – BCPUD Property	18
<b>Total Path-Related Whole Tree Removals</b>		<b>32</b>

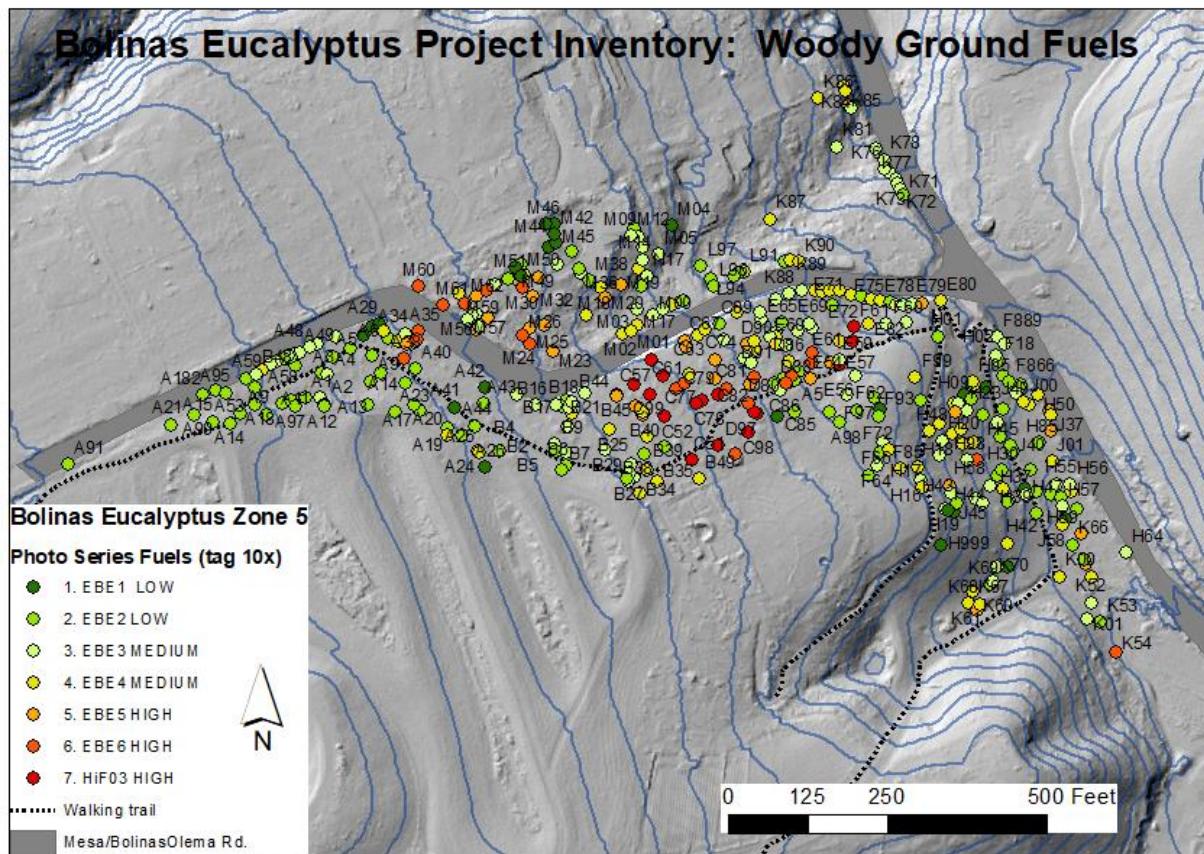
In an ideal world where the fuels reported by Wright and Vihnanek correspond perfectly with the conditions viewed in Zone 5 at Bolinas, the forest floor at present would be supporting 11 tons of woody debris per acre, but of course this is just an estimate. The fact remains, however, that the woody fuels on the forest floor vary dramatically over the area encompassed by Zone 5 as shown in the map below. Cognizant of the fire hazard, BPUD did some work in the grove in 2011 and the understory fuels were thinned out. Each year BPUD mows the area under the trees to maintain understory fuels at levels as low as possible. The map below shows the accumulation of fuels to be widely distributed (from low to high) throughout the grove.

Figure 11 Woody ground fuels (Low in green and High in red)

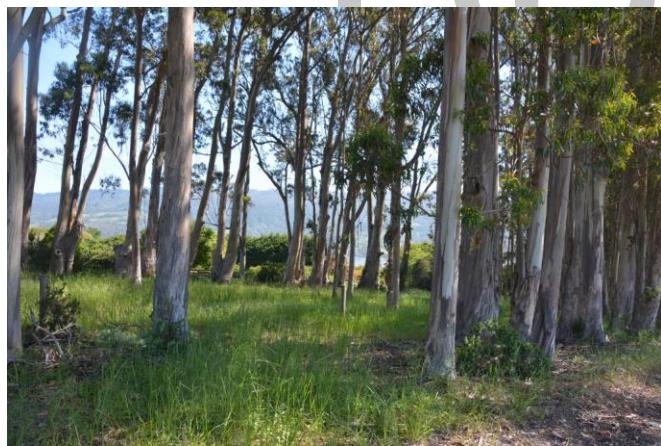
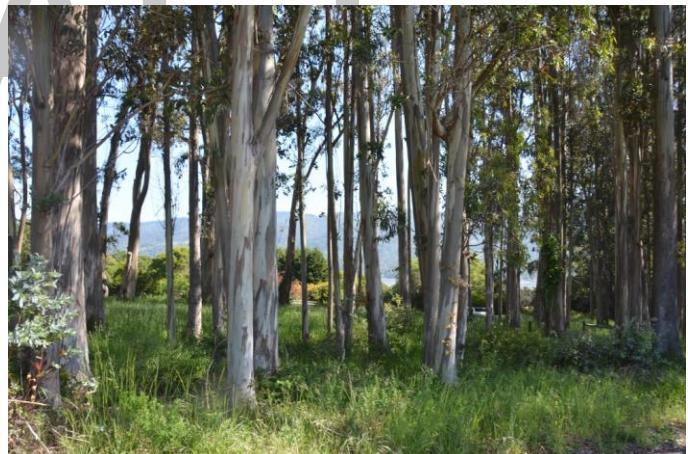
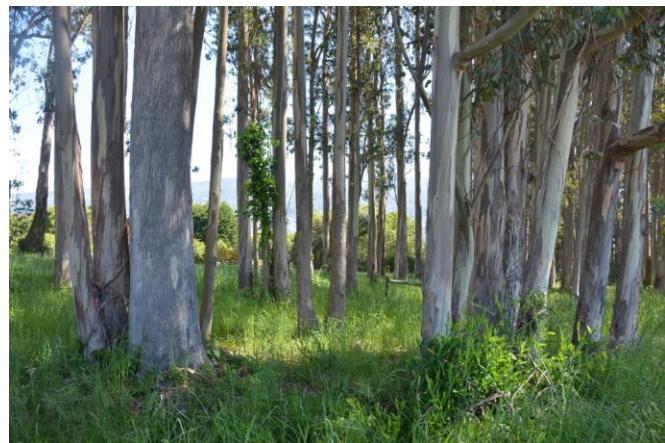
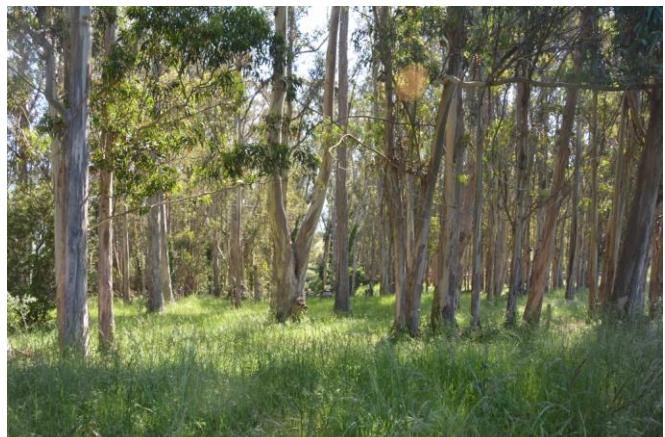
**Figure 9** - Grove Fuels in May, 2023 – Comparing grove fuels to Wright and Vihnanek Fuel load photo series.

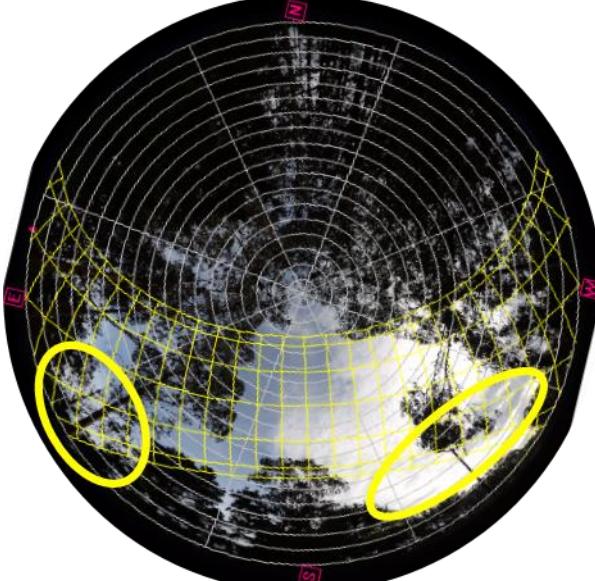
<p>Hemiphotograph 1235: Cluster site at Juniper-Kale. Vulnerability from SW, this sector is where PG&amp;E cut a eucalyptus tree that provided wind shelter. Additional wind vulnerability from SSE.</p>	<p>Hemiphotograph 1195: Alder-Vortex. Pines with open understories to SE, other wind vulnerabilities from E and NE. The relative directions of gaps varies along the row of cluster trees so short-distance movements can regain wind shelter.</p>

**Juniper-Kale: (Hemiphoto 1235)** This site has been degraded by PG&E cutting and trimming trees to protect a powerline, which has opened the site to SW winds. A new row of fast-growing Douglas-fir planted an appropriate distance from the powerline could seal this vulnerability in a decade.

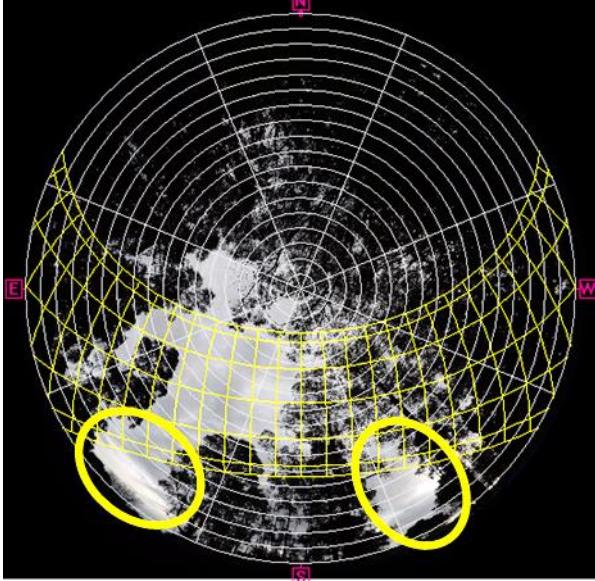
<p>Hemiphotograph 1251. Toyon site. Wind vulnerabilities from SE and SW. Resprouting eucalyptus to S allow some dappled sun mid-day near ground, and direct sun at heights..</p>	<p>Hemiphotograph 1257. At S edge of Bowl. Large Torrey Pine in SSE foreground. Large gap to SW could be filled with Torrey pines Potential monarch cluster trees in orange ellipse to NE across Bowl.</p>

**Toyon: (Hemiphoto 1251)** Sealing up the SE and SW gaps at Toyon, while maintaining the thin eucalyptus canopy to the S would establish wind shelter and dappled light. Torrey pines might be ideal, as they thrive in the area and provide dappled light in addition to wind shelter. This site is largely on the parcel adjacent to BPUD (#19303003) and landowner participation would be essential.

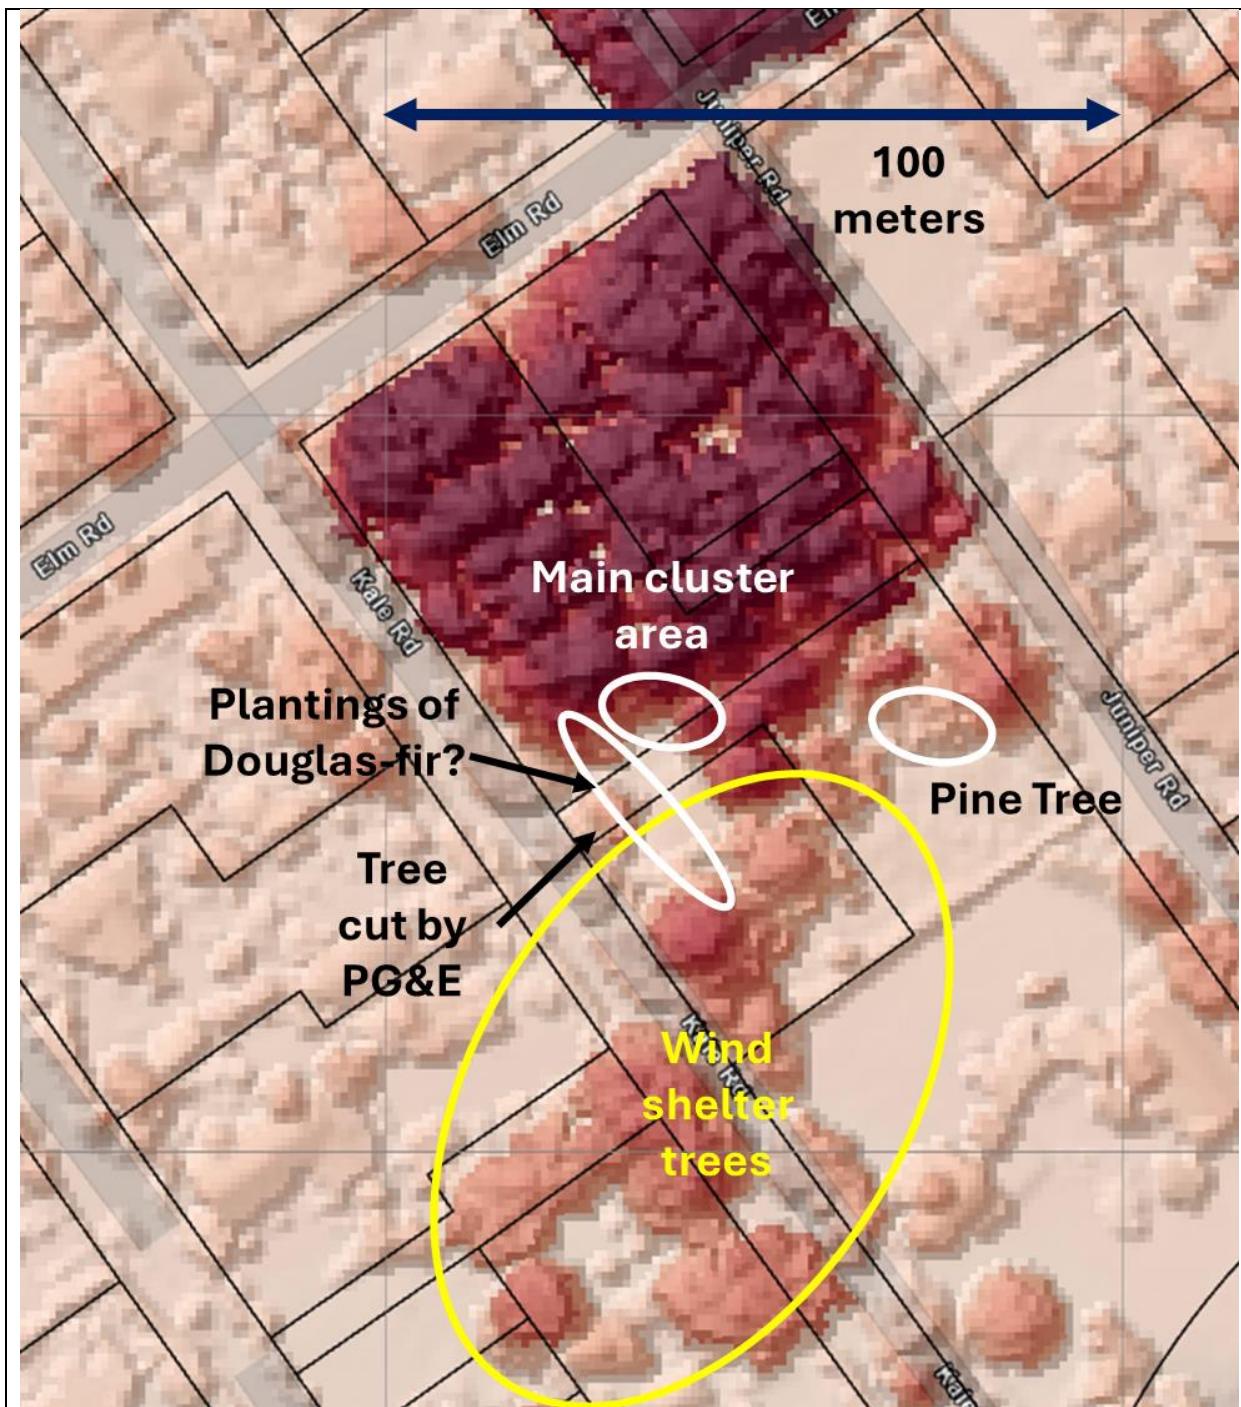
LiDAR view of Juniper-Kale. Monarchs cluster on the southern edge of the grove in a protected alcove. They also regularly sun themselves on a pine tree to the east during calm weather. The loss of the eucalyptus trees trimmed/cut by PG&E exposed the cluster area to SW winds. With some selected plantings of fast-growing Douglas-fir the wind shelter could be replaced in about a decade. The trees need to be planted far enough from the powerlines to not interfere. Most of the core site is owned by a single person, but the trees across Kale are on a different parcel.

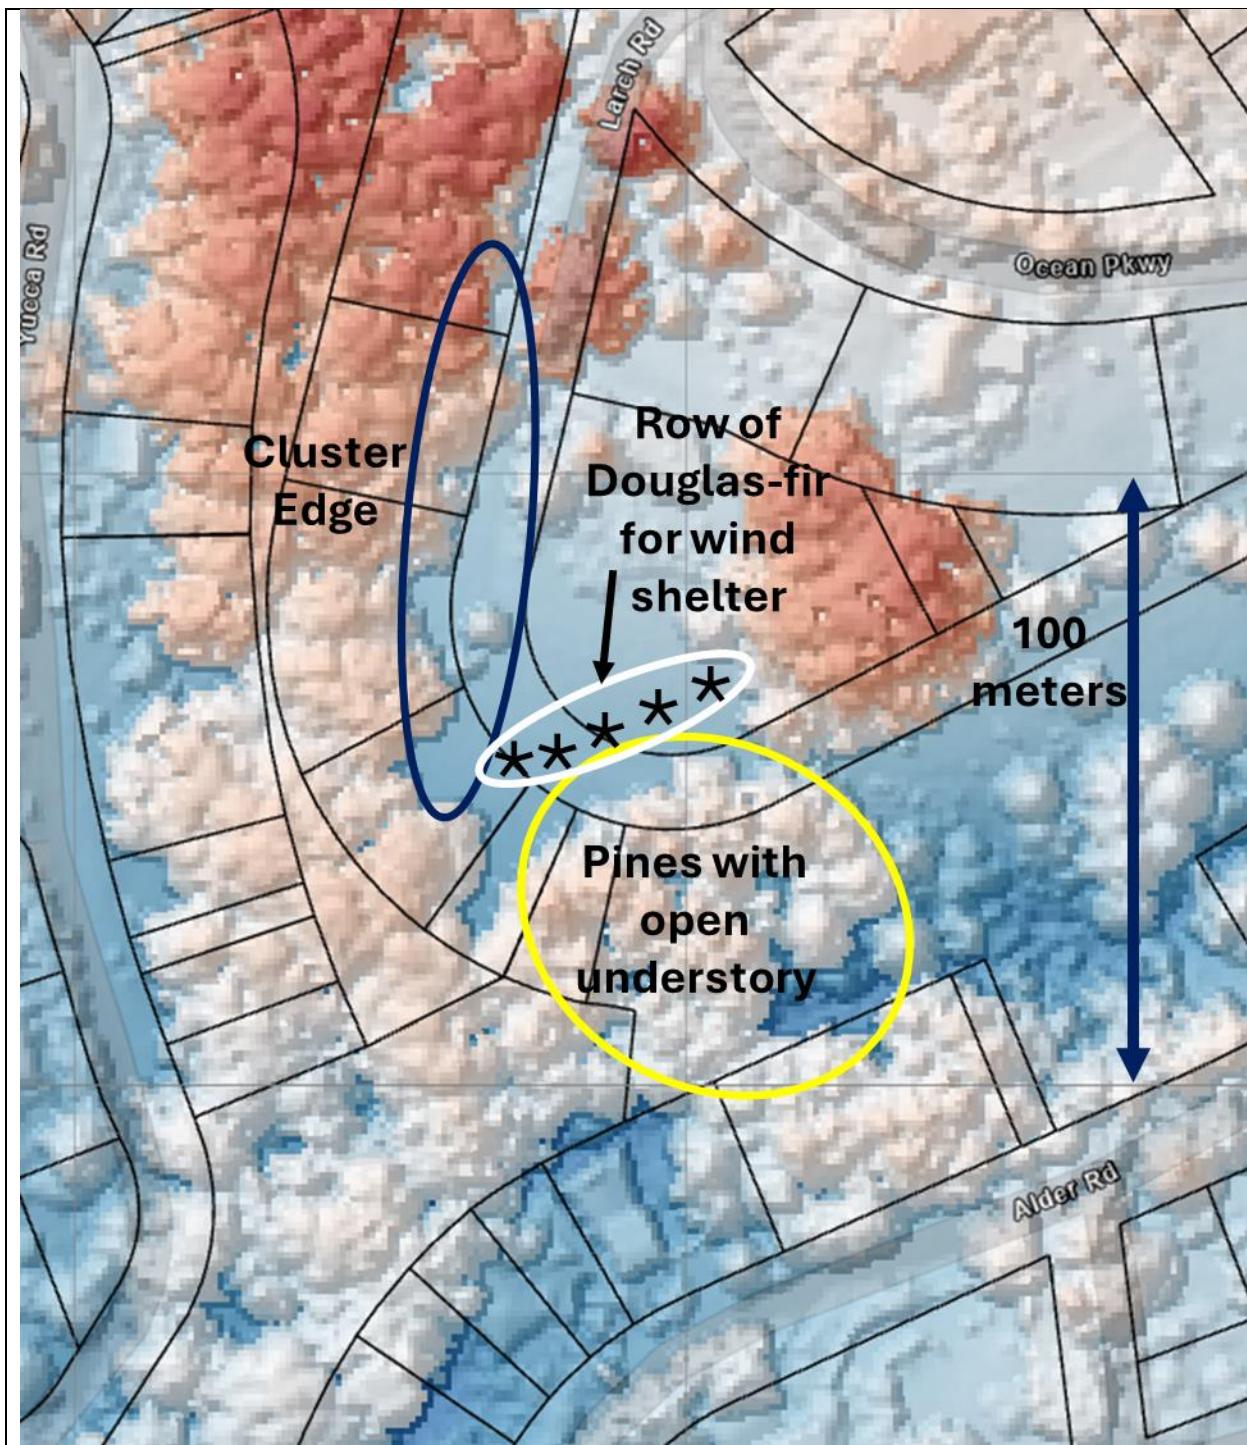
LiDAR view of Alder-Vortex. Monarchs cluster along the E edge of the dense eucalyptus along a drainage. To the SE of the cluster edge, a stand of older pines has an open understory (see Hemiphoto 1195). One possibility to ameliorate the eventual loss of wind shelter is to establish a row of Douglas-fir in the area indicated (tree spacing and number not to scale). The multiple private parcels will make this a difficult site to manage.

**Alder-Vortex (Hemiphoto 1195):** This site has some existing wind vulnerabilities that are ameliorated by short distance movements to avoid winds through the gaps. The major short-midterm threat is the loss of the older pines to the SE, some of which have already fallen. One idea is to plant a row of Douglas-fir at an optimal distance from the cluster row to eventually replace the wind shelter. The multiple ownerships of the overall site, including the wind shelter areas, could greatly complicate any management.

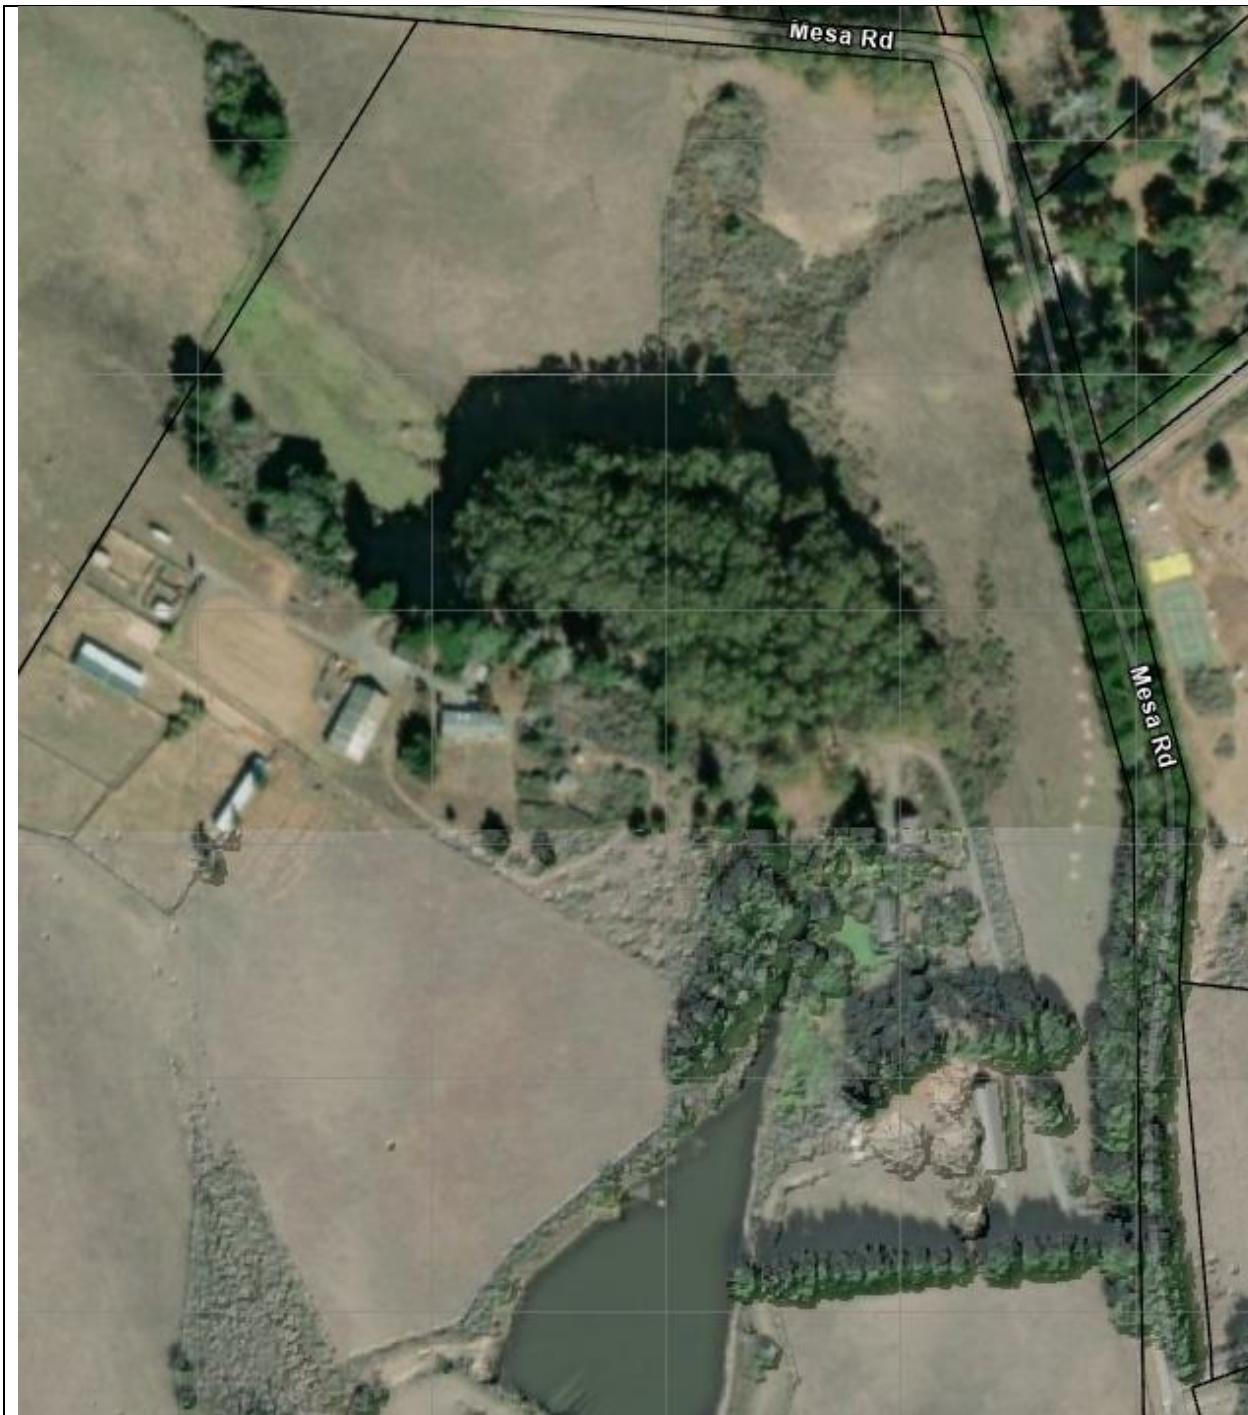
Site # 2913 – Mesa Rd. North of Bolinas. This grove falls outside the current LiDAR analysis extent. The grove has potential – it may be too dense for monarchs, but a detailed microclimate analysis with hemiphotos and LiDARr is warranted. Selective thinning and gap creation may work here. Diverse nectar plants have been established on the property with assistance from Xerces Society, and the landowner is willing to consider monarch habitat improvements.

**Mesa Rd. North of Bolinas:** This site is just outside the LiDAR analysis footprint (but is within the 2019 LiDAR flight and can be analyzed. The dense stand in the drainage appears to have good wind shelter but may be too dense and dark for monarchs. It would benefit from a detailed LiDAR and hemiphotograph analysis. Numerous nectar plants have been established on the property with assistance from the Xerces Society, and the owner is willing and eager to improve the site for monarchs.
