June 28, 2017

### **RE:** Preliminary Erosion Assessment and Conceptual Treatments for Bolinas PUD Trail

You have asked us to investigate causes and potential treatments for erosion and drainage problems along the Bolinas PUD trail between Mesa Road and Olema-Bolinas Road. Below, we offer our assessment of trail conditions and propose recommendations for possible improvements.

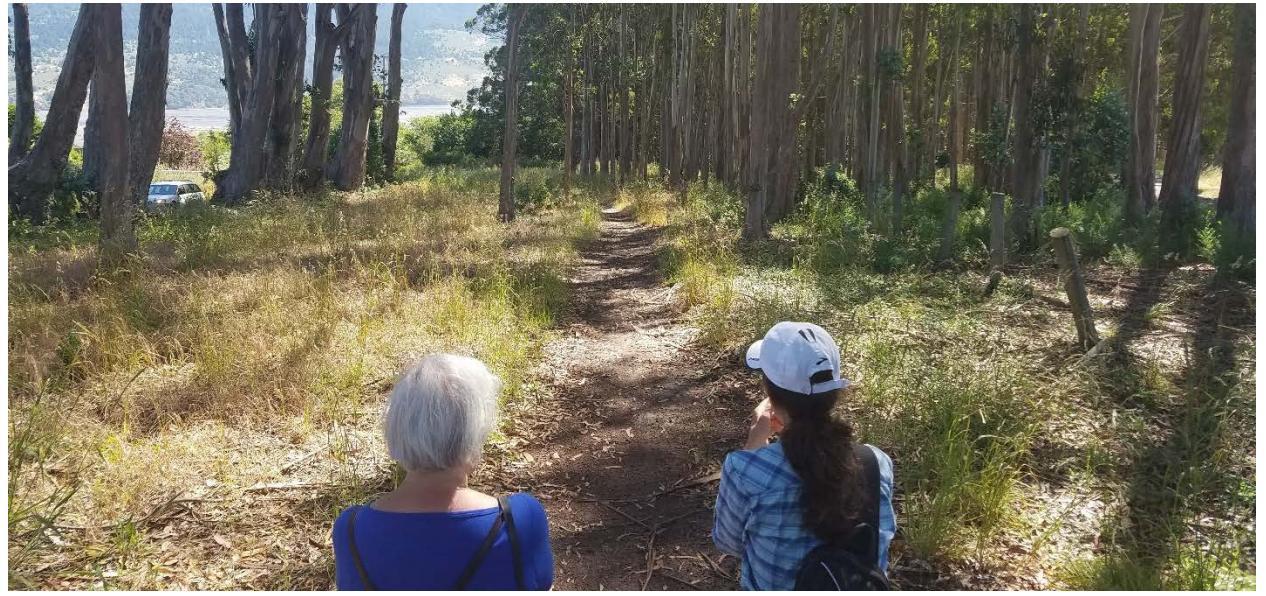
**Site 1**: Bike path next to Mesa Road, west in road bend. Runoff is concentrating along trail and should be diverted off trail to minimize future gullying. Trail is now in good shape. Poison oak is encroaching the trail near the Mesa Road bend and should be removed from the edge of the trail to prevent people going off-trail to avoid contact.

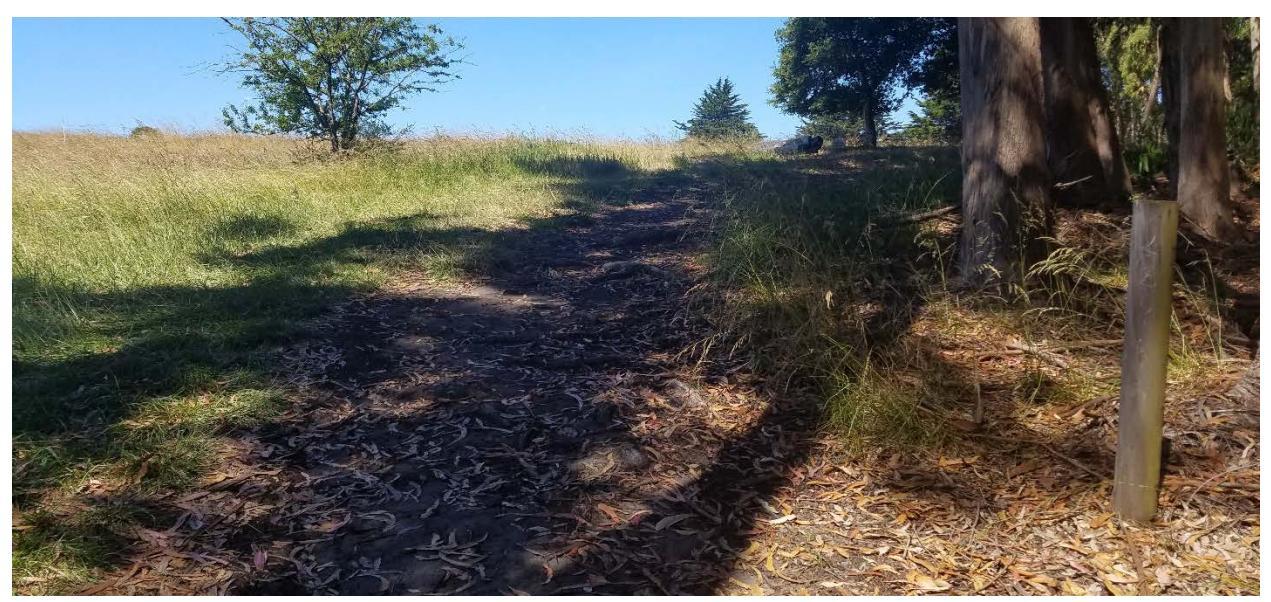
**Site 2**: Eucalyptus roots are exposed, but also helping to stabilize soil and the trail. We recommend leaving the roots in place as much as possible. Diverting runoff from the trail may help prevent future erosion from concentrating runoff. Root areas could also be covered with soil.

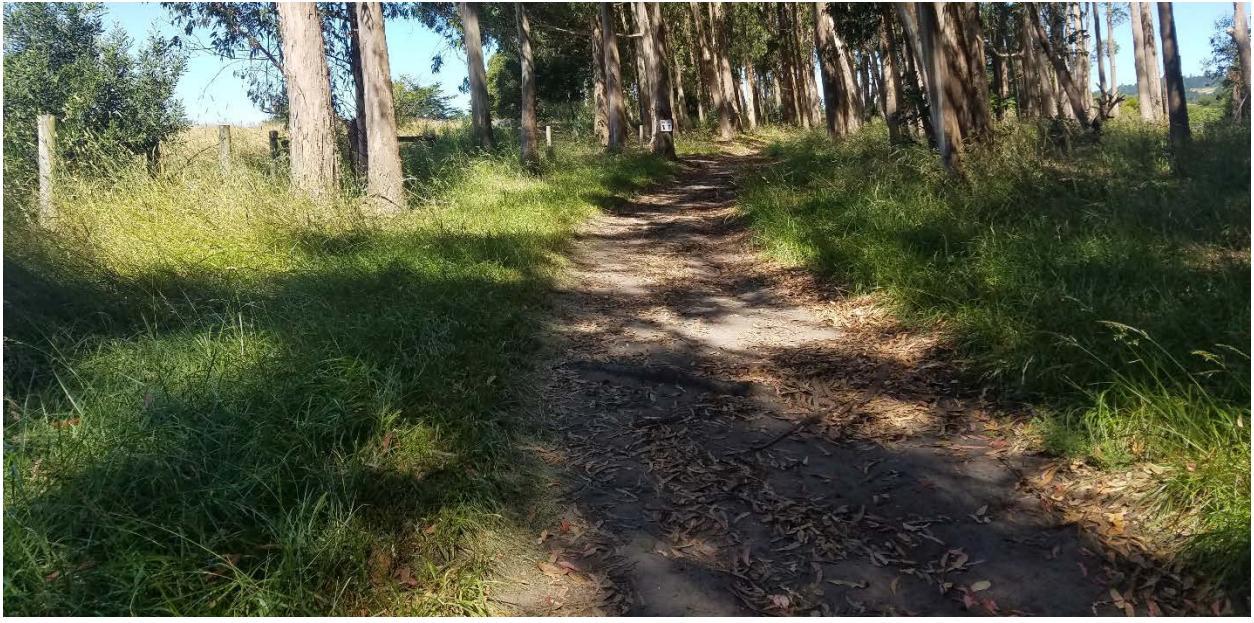
Site 3: The trail is in good condition now. Diverting runoff from the trail may help prevent future erosion.

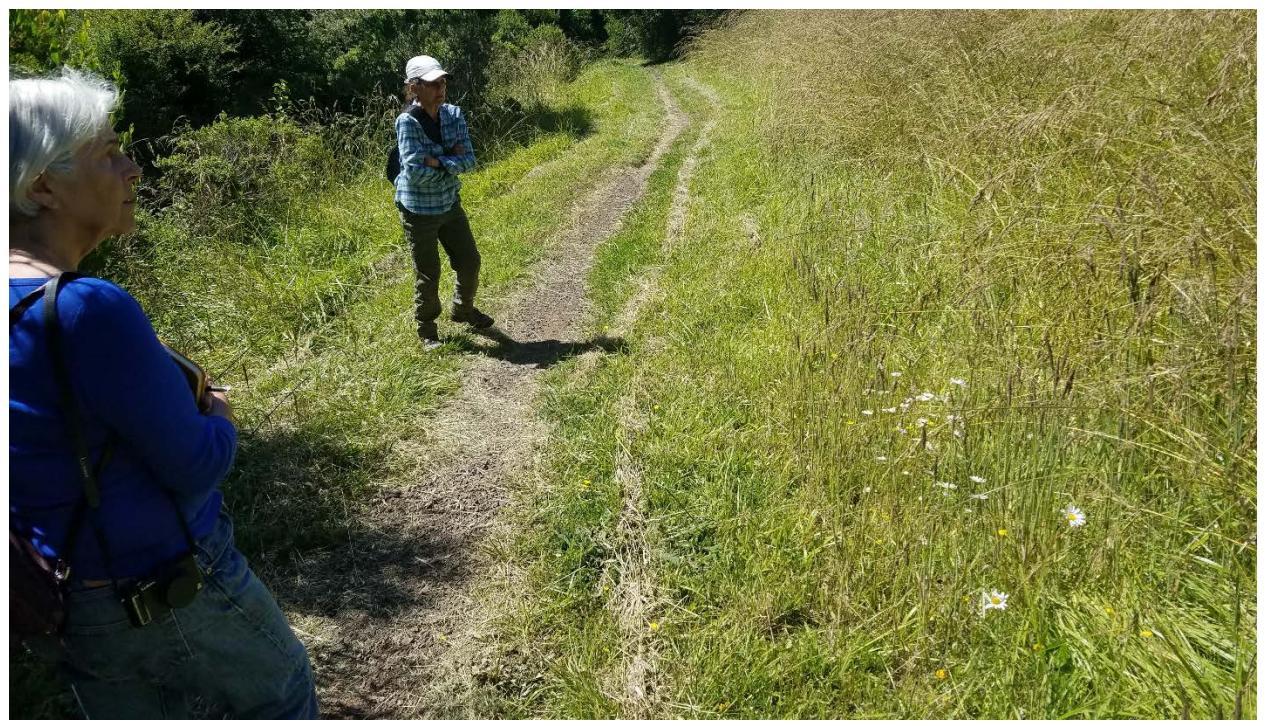
**Site 4**: The trail is in good condition now, thanks in part to extensive grass cover and drainage lenses. Trail is reported to be wet in winter. Adding additional drainage lenses or outsloping the trail will assist drainage across the trail. Adding wood chips can help make the wet sections passable. More frequent mowing (or grazing) will encourage foot and bike traffic to stay on the trail even if it wet.

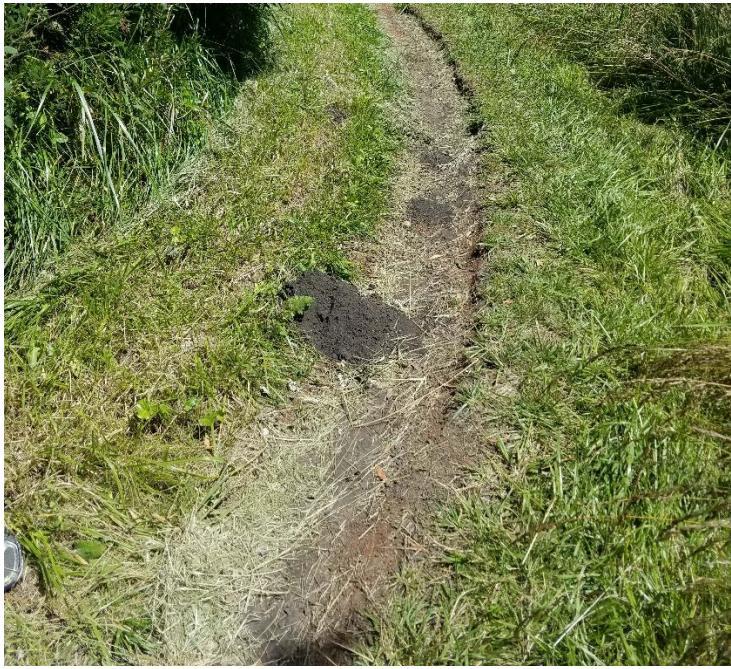
**Site 5**: The bend in the trail collects runoff and has eroded in the center of the trail, presumably because of this concentrated runoff and preferential wear from walking and biking in the center. We recommend rolling dips and ditches to divert water off the trail towards the outside of the bend. In addition, we recommend filling the eroded path and regrading the trail so that it slopes downhill.

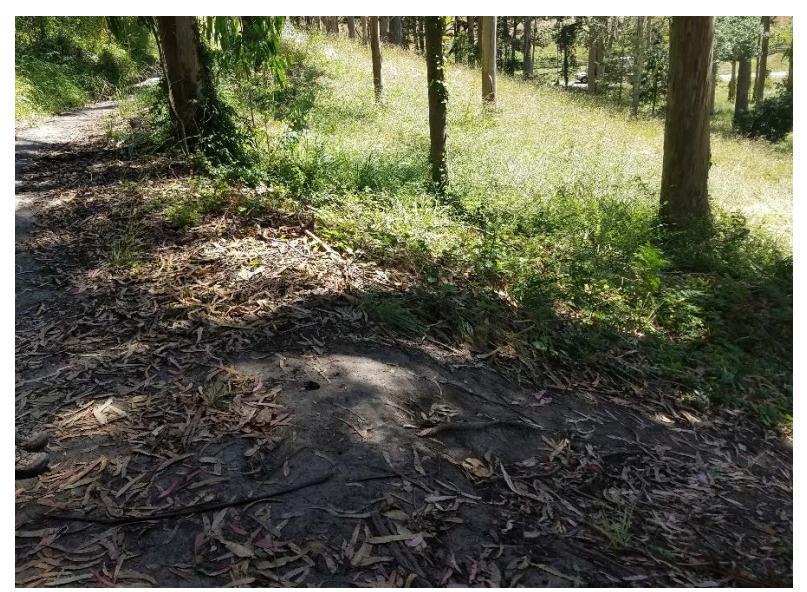
**Site 6**: An informal (shortcut) footpath appears to have been created on a steep slope below the trail along the hillslope grade. We recommend creating a slightly longer path (connecting to the trail just north of the current alignment) and fencing off and planting the existing trail. The existing trail will continue to be bare and susceptible to erosion unless treated. If realignment of the trail is not feasible, we recommend rolling dips to divert runoff, and mulching, planting, and fencing off the edges of the trail to minimize the extent of bare soil.

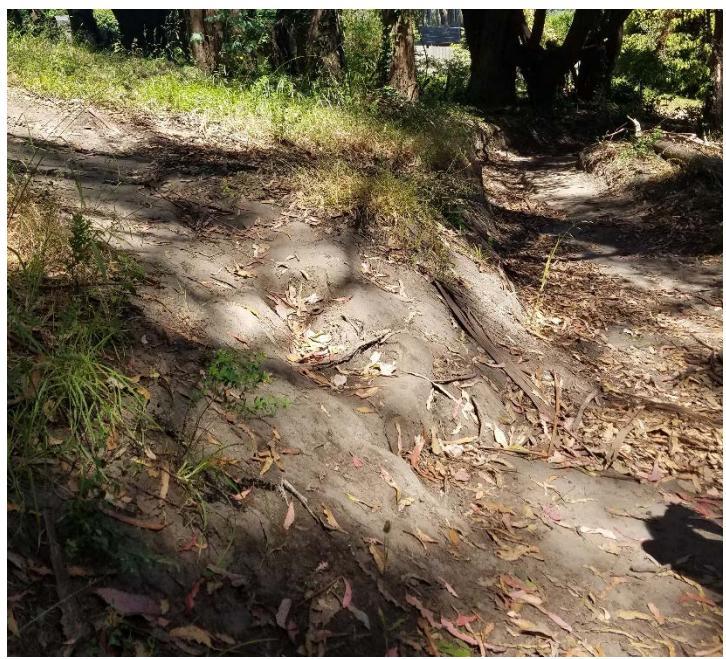
**Site 7**: The horse trail is over steepened and eroded at the junction with the bike trail. We recommend planting and placing jute erosion control matting to discourage shortcutting. We also recommend building wood/log-framed steps or realigning the trail to reduce the slope. We recommend consulting a horse-trail specialist to receive advice about best practices for horses (such as step material, height, and spacing). Above the junction, the trail is concentrating runoff. We recommend rolling dips and ditches to divert water off the trail.

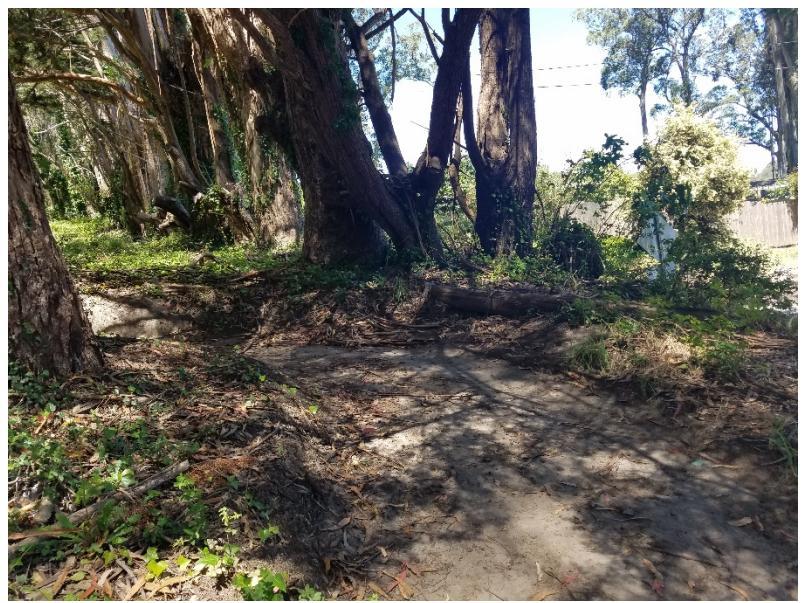
**Site 8**: The bend near Mesa Road is collecting drainage and accumulating leaf litter. We recommend diverting water off the trail as much as possible (e.g. down the decommissioned trail above the pictured bend). Existing gullies can be filled and compacted to minimize flow collecting in the trail. Below this curve the trail would be improved by installing rolling dips to divert water off the trail.
